## REF REPORT – HAZMAT ASSESSMENT BUILDING – MN03, MN05, MN09

Manning Base Hospital Redevelopment  
**26 York St**  
**Taree NSW 2430**

June 2023

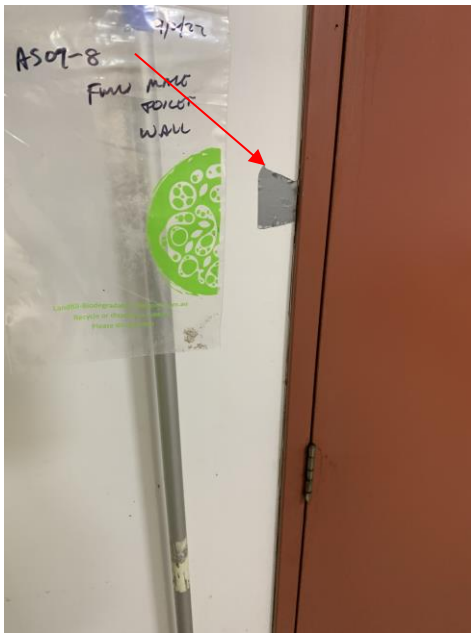
Photo 1:

AS09 – 8: No asbestos detected

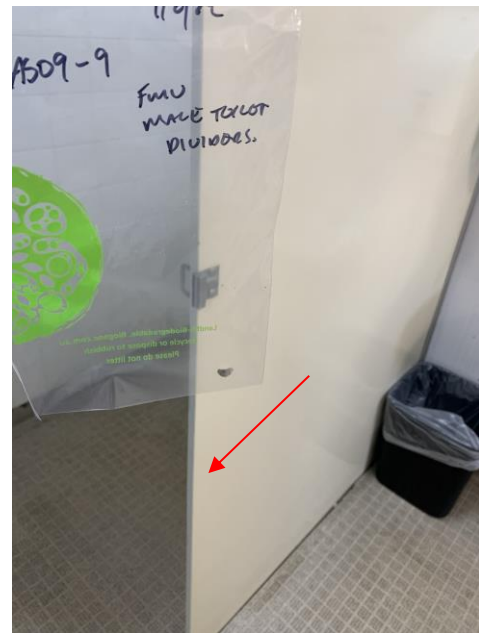
Photo 2:

AS09 – 9: No asbestos detected

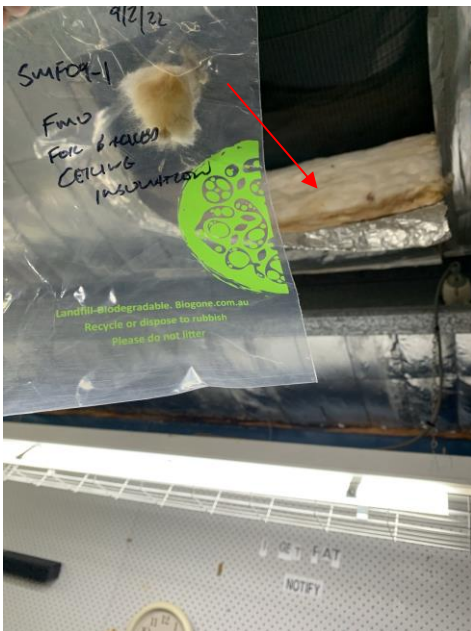
Photo 3:

SMF09 – 1: Synthetic mineral fibre detected

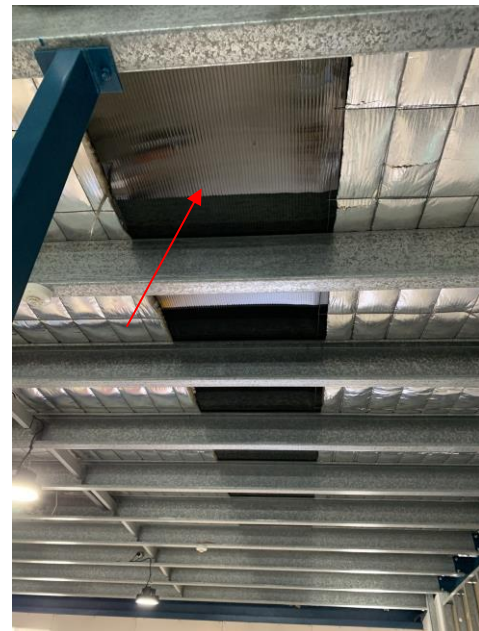
Photo 4:

SMF: Corrugated roof sheeting

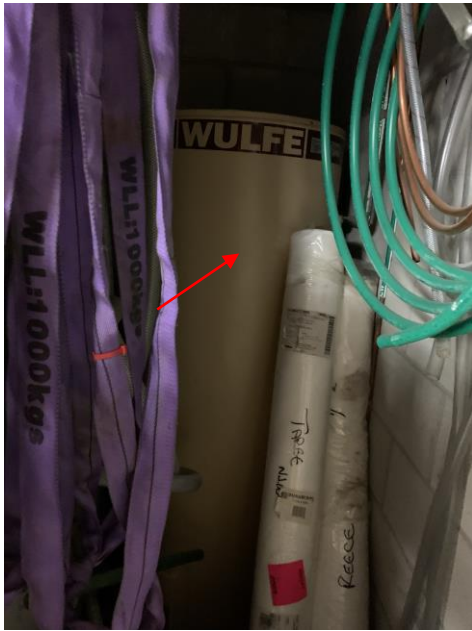
Photo 5:

SMF: Hot water system insulation

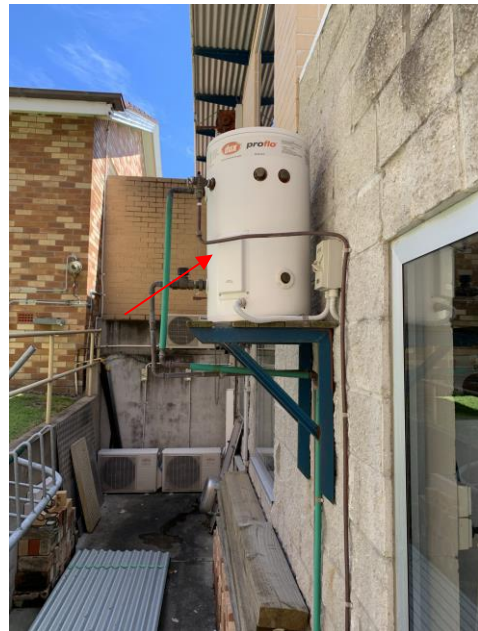
Photo 6:

SMF: Hot water system insulation

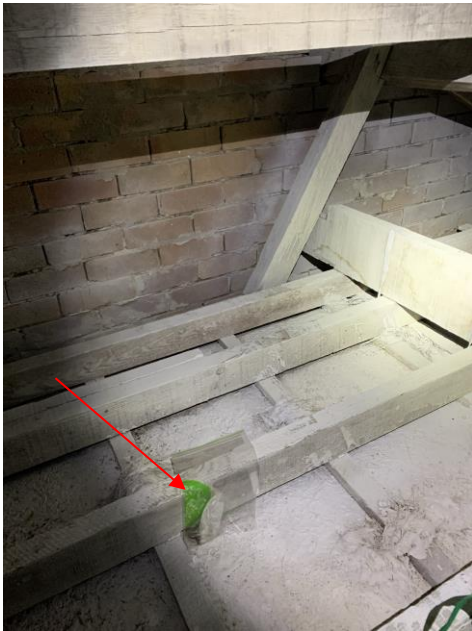
**Photo 1:**

AS10 – 1: No asbestos detected

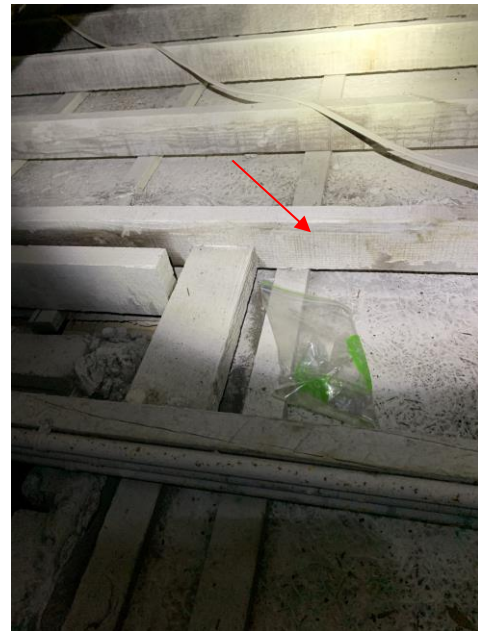
**Photo 2:**

AS10 – 2: No asbestos detected

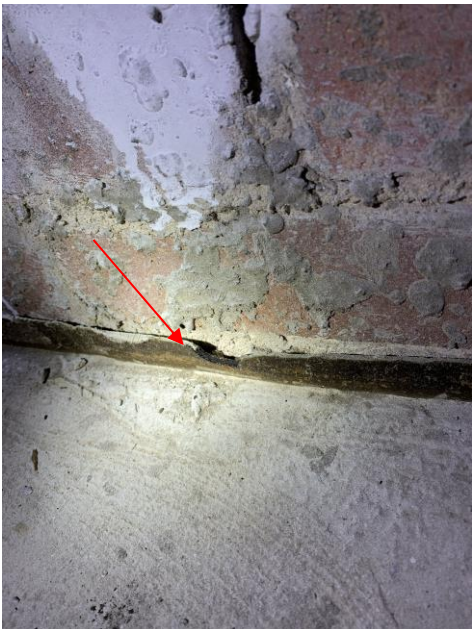
**Photo 3:**

AS10 – 3: No asbestos detected

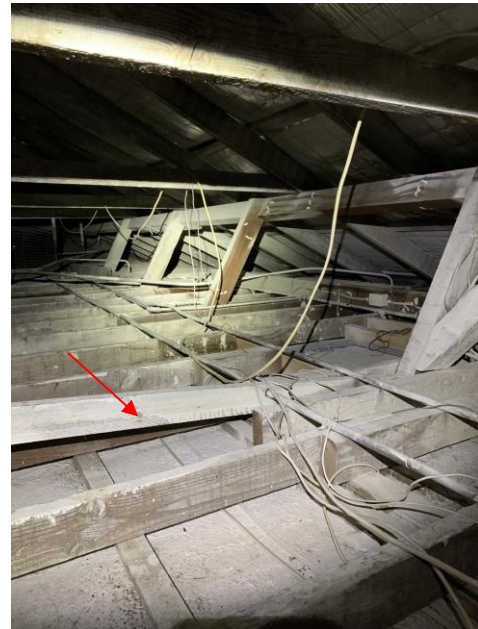
**Photo 4:**

Assume Amosite asbestos (non-friable)

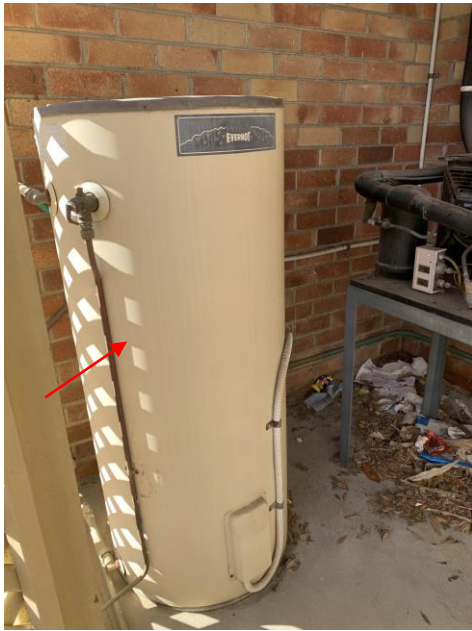
Photo 5:

SMF: Hot water system insulation

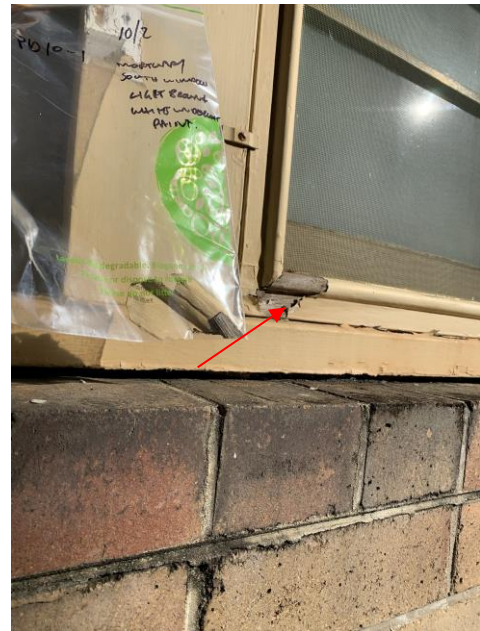
Photo 6:

PB10 - 1: >0.1%

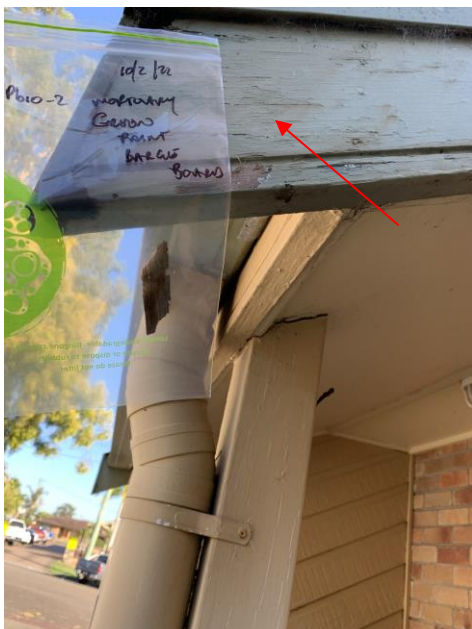
Photo 7:

PB10 - 2: >0.1%

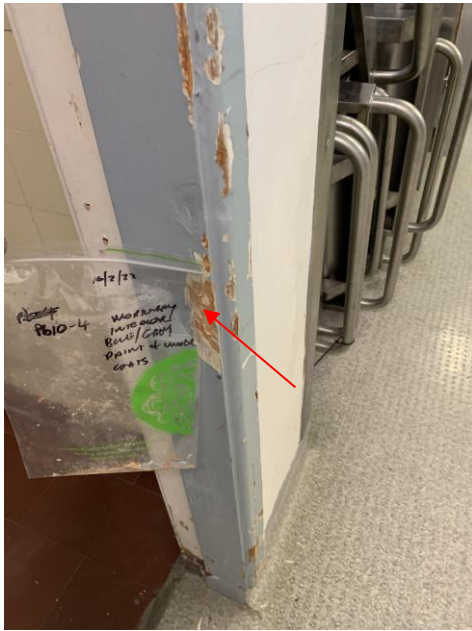
Photo 9:

PB10 – 4:  $>0.1\%$

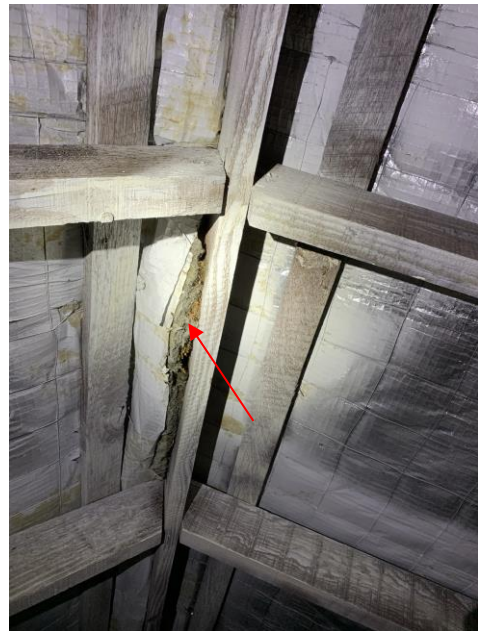
Photo 10:

SMF: Foil backed insulation

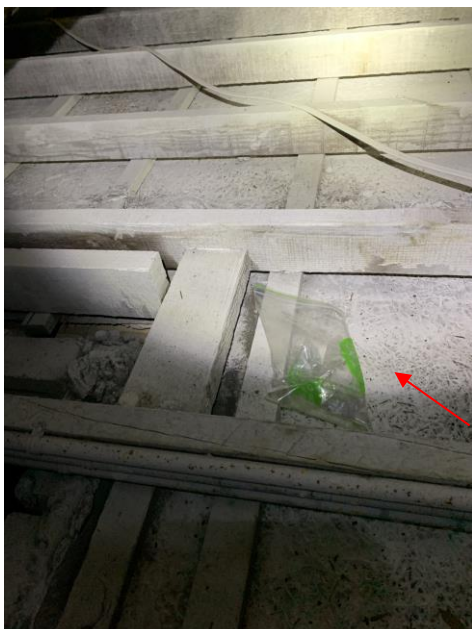
Photo 11:

DS10 – 1:  $>4.3\text{mg}/\text{m}^2$

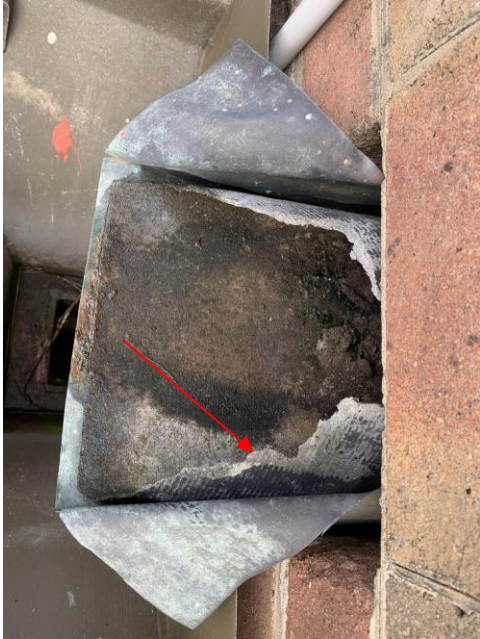
Photo 1:

AS08 – 1: Chrysotile asbestos detected

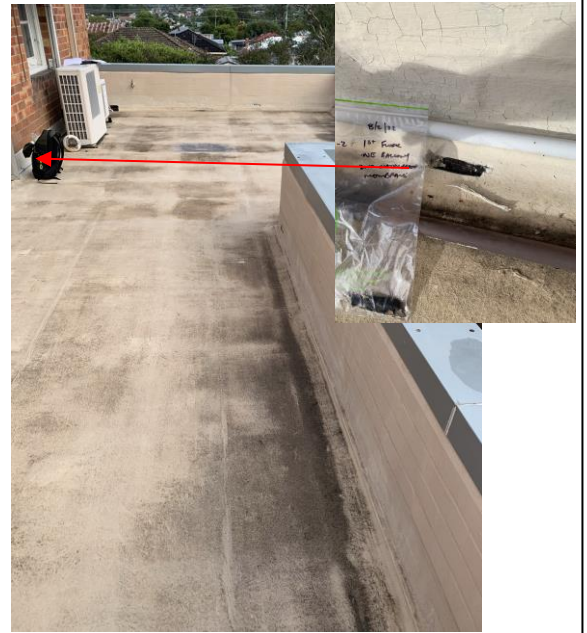
Photo 2:

AS08 – 2: No asbestos detected

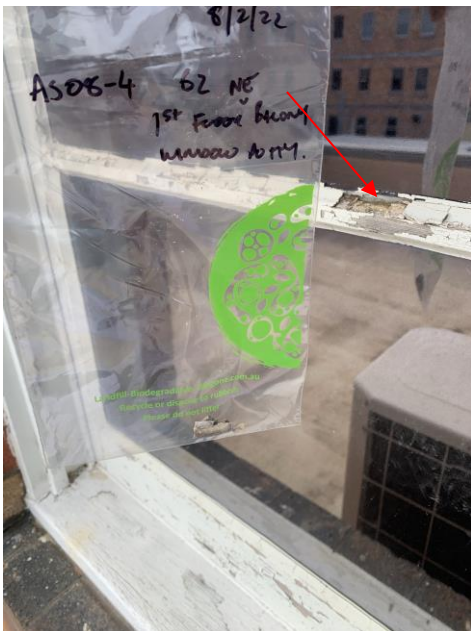
Photo 3:

AS08 – 4: No asbestos detected

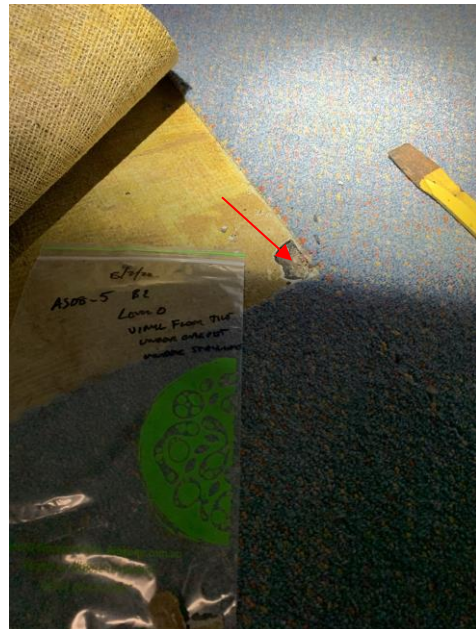
Photo 4:

AS08 – 5: No asbestos detected

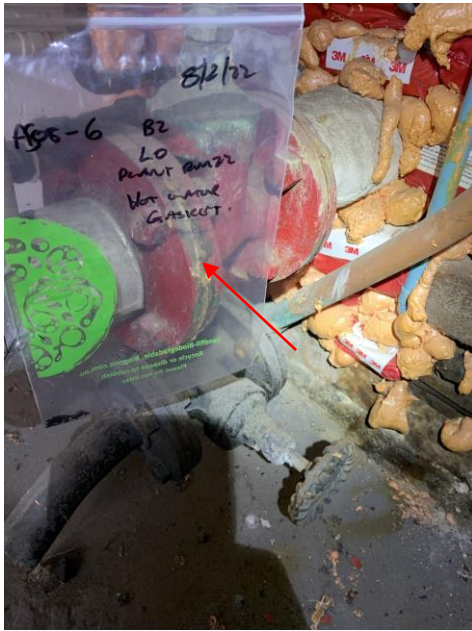
Photo 5:

AS08 – 6: No asbestos detected

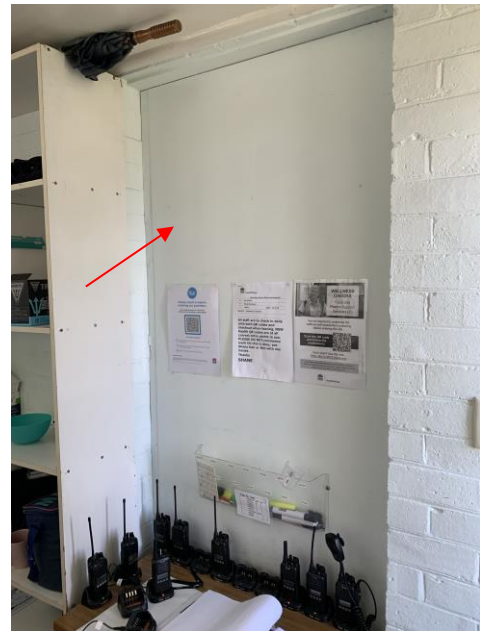
Photo 6:

AS08 – 6.1: No asbestos detected

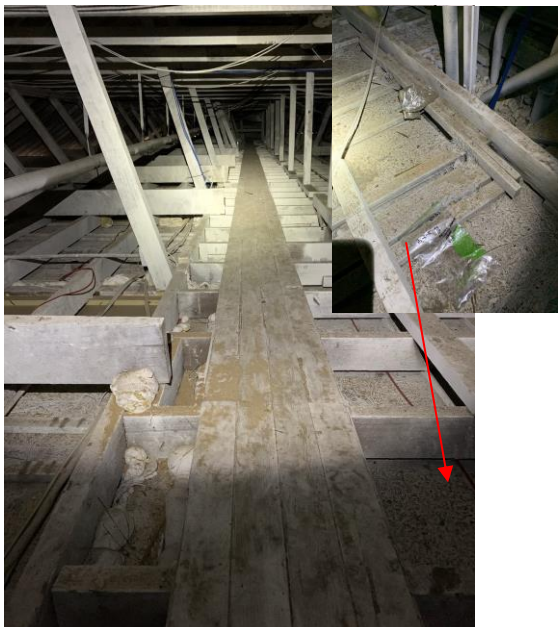
Photo 7:

AS08 – 8: No asbestos detected

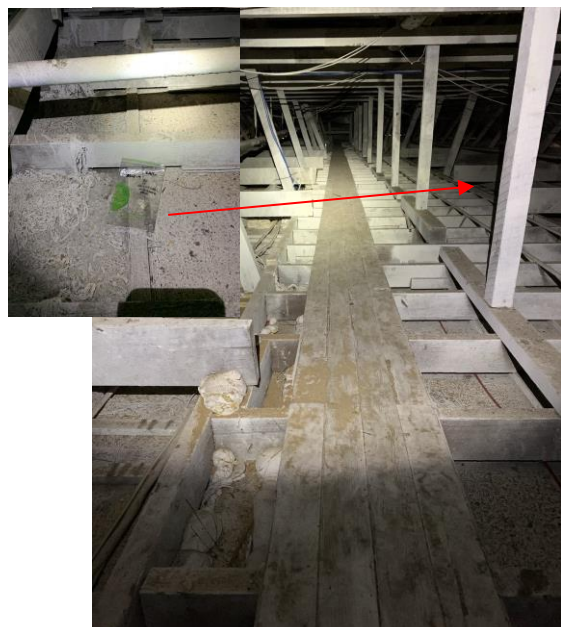
Photo 8:

AS08 – 9: No asbestos detected

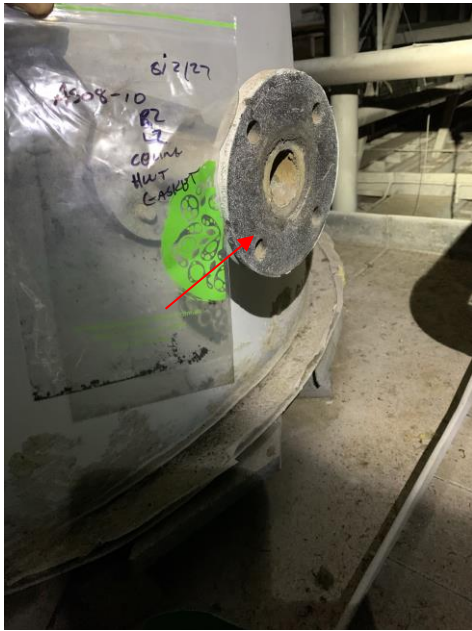
Photo 9:

AS08 – 10: No asbestos detected

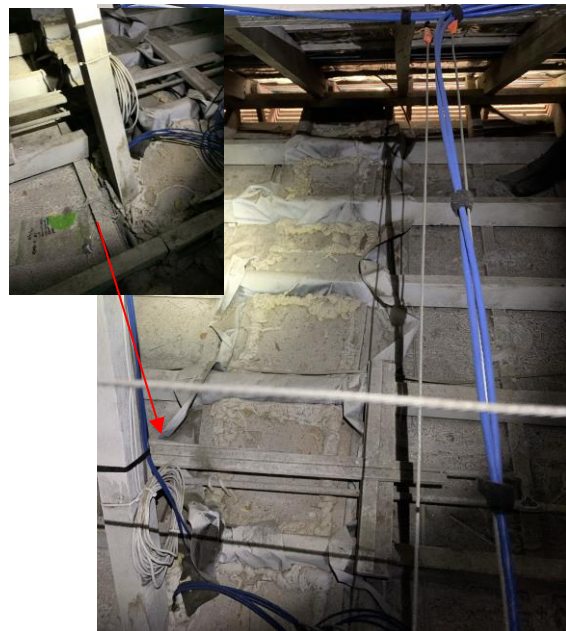
Photo 10:

AS08 – 11: No asbestos detected

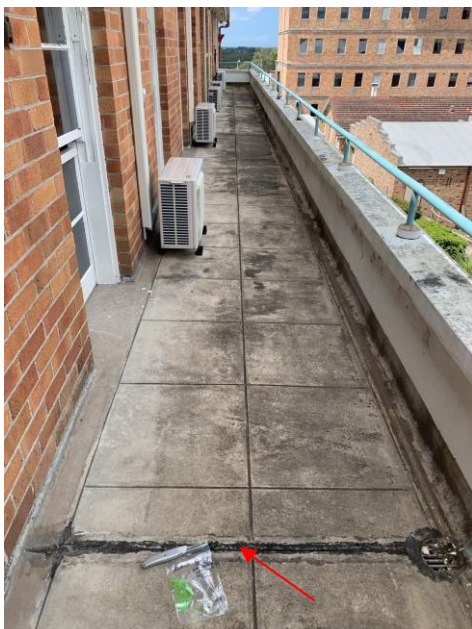
Photo 11:

AS08 – 13: **Chrysotile asbestos detected**

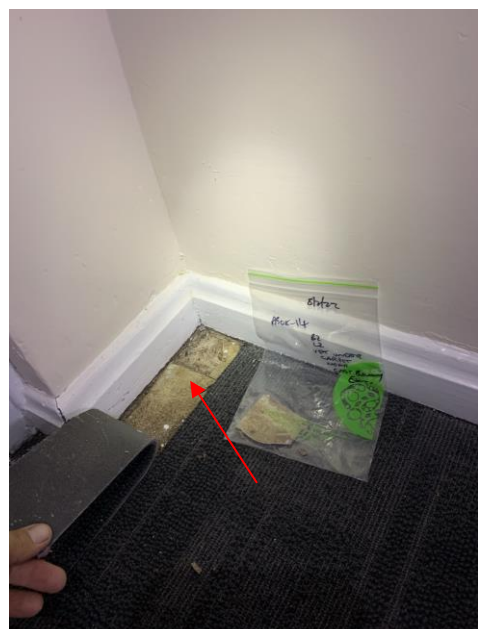
Photo 12:

AS08 – 14: No asbestos detected

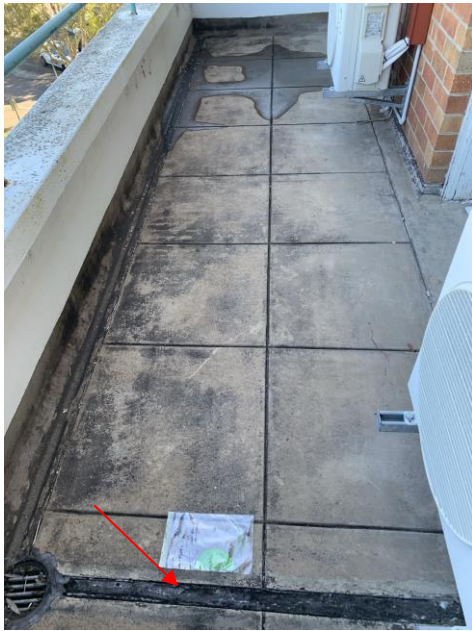
Photo 13:

AS09 – 2: Chrysotile asbestos detected

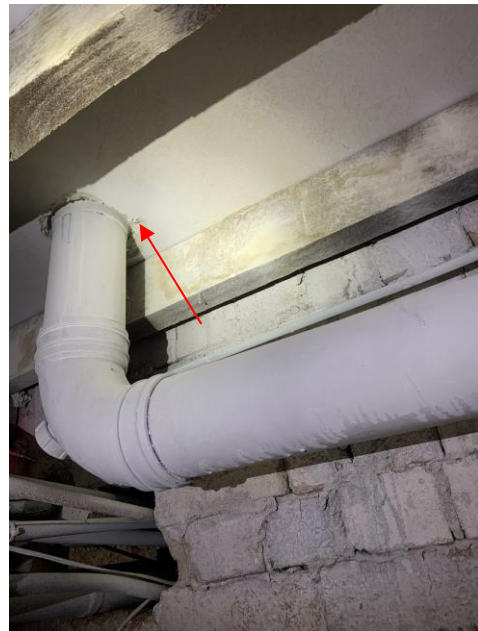
Photo 14:

AS09 – 5: No asbestos detected

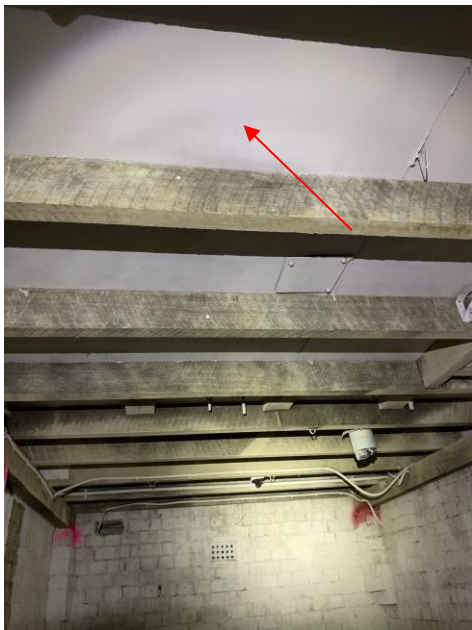
Photo 15:

AS09 – 6: No asbestos detected

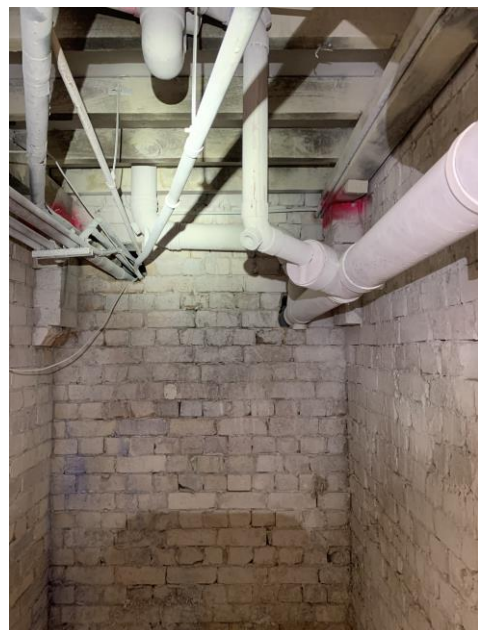
Photo 16:

Example of subfloor surfaces following remediation in 2015. Porous and semi-porous surfaces encapsulated with white spray paint. Assumed non-friable contaminated material

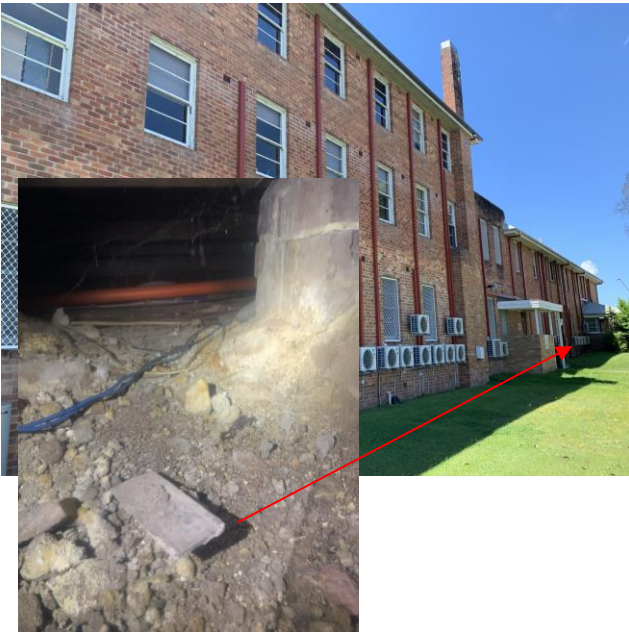
Photo 17:

Assumed chrysotile, amosite and crocidolite debris

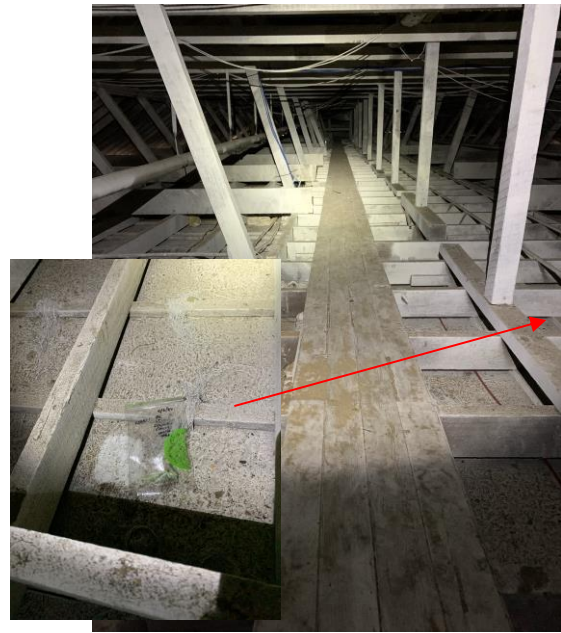
Photo 18:

DS08 – 1:  $>4.3\text{mg}/\text{m}^2$

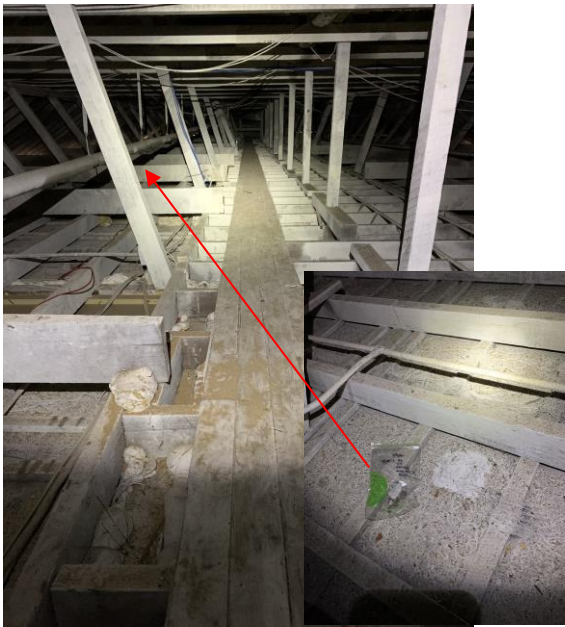
Photo 19:

DS08 – 2:  $>4.3\text{mg}/\text{m}^2$

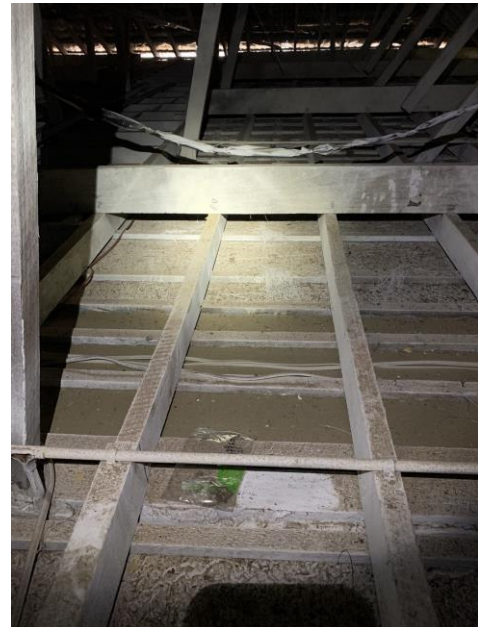
Photo 20:

DS08 – 3:  $>4.3\text{mg}/\text{m}^2$

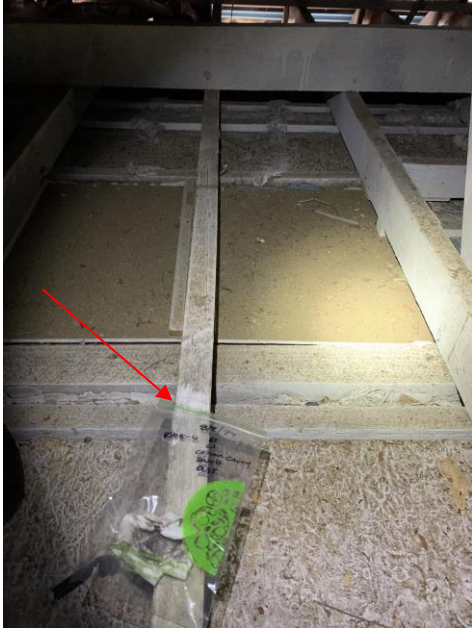
Photo 21:

DS08 – 4:  $>4.3\text{mg/m}^2$

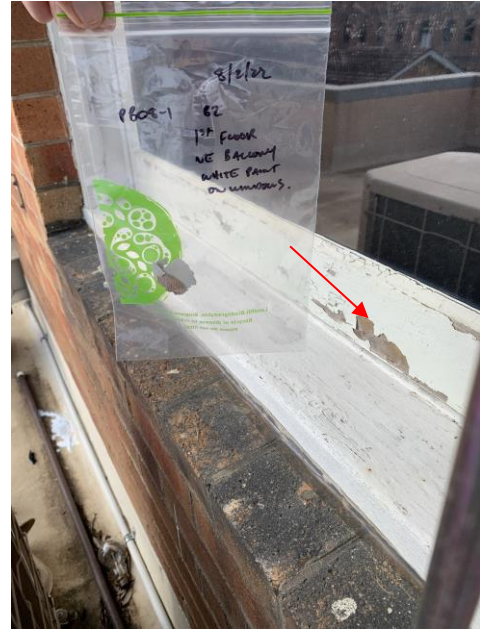
Photo 22:

PB08 – 1:  $>0.1\%$

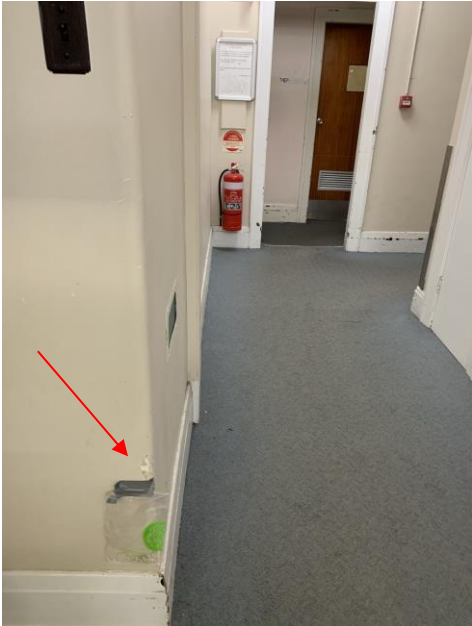
Photo 23:

PB08 – 2:  $>0.1\%$

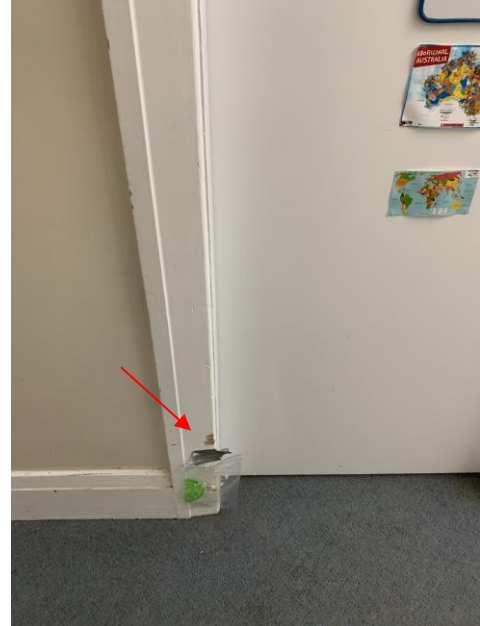
Photo 24:

PB08 – 3:  $>0.1\%$

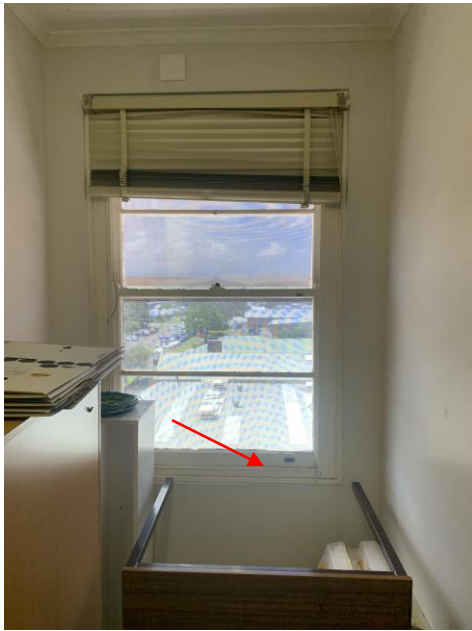
Photo 25:

PB08 - 4: >0.1%

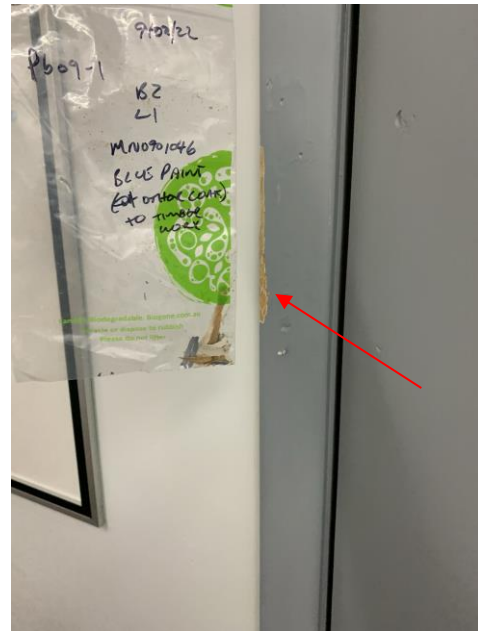
Photo 26:

PB09 - 1: >0.1%

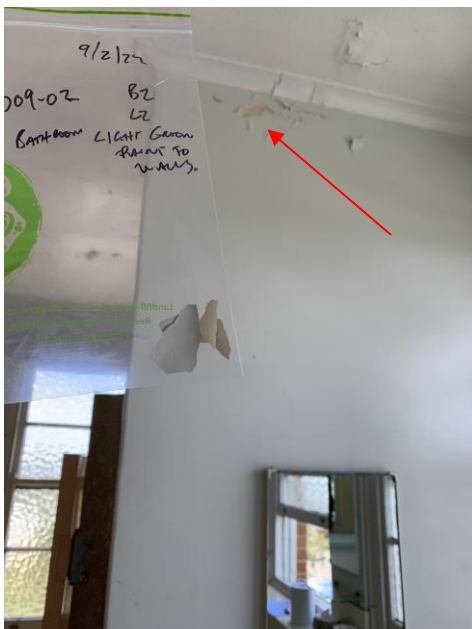
Photo 27:

PB09 - 2: >0.1%

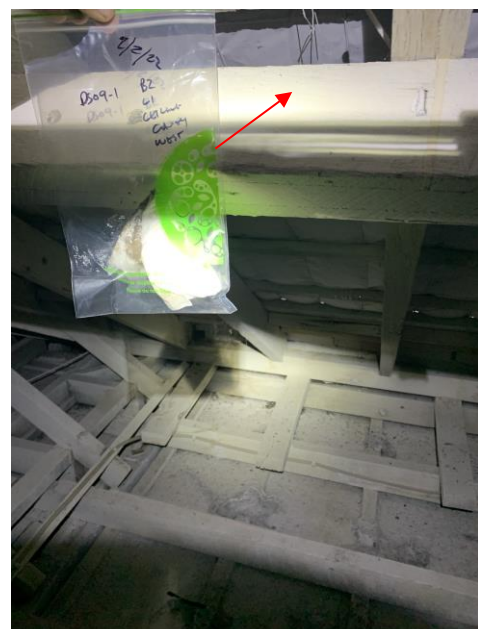
Photo 28:

DS09 - 1: >4.3mg/m<sup>2</sup>

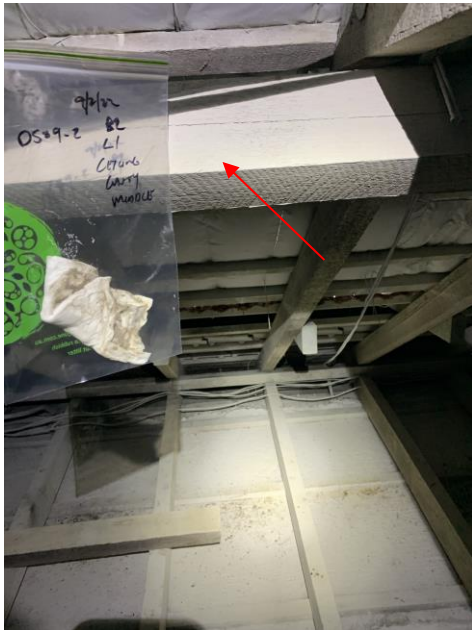
Photo 29:

DS09 – 2:  $>4.3\text{mg}/\text{m}^2$

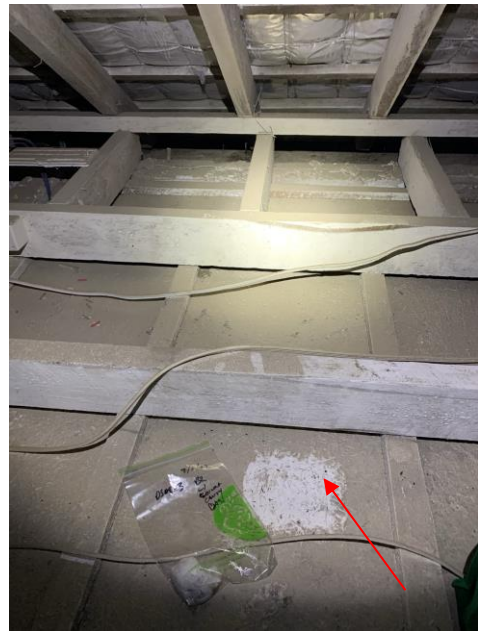
Photo 30:

DS09 – 3:  $>4.3\text{mg}/\text{m}^2$

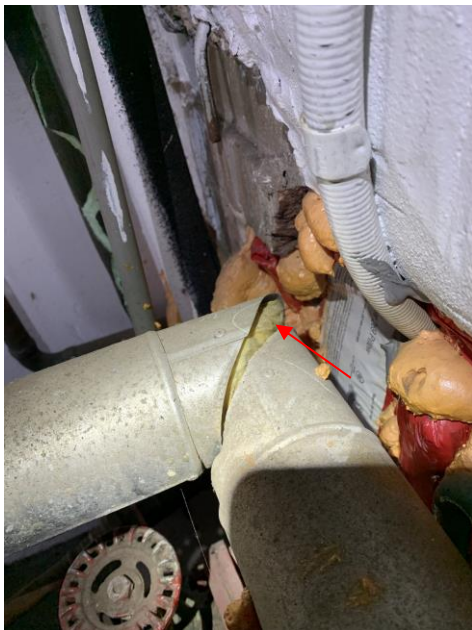
Photo 31:

SMF encased on pipework

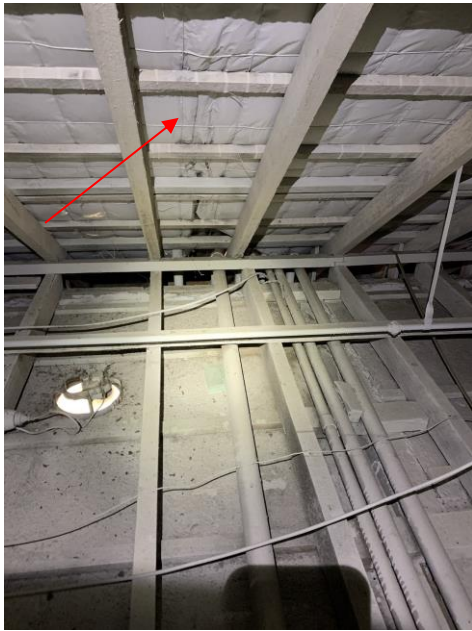
**Photo 33:**

**SMF** – Foiled back insulation Level 01 “west wing”

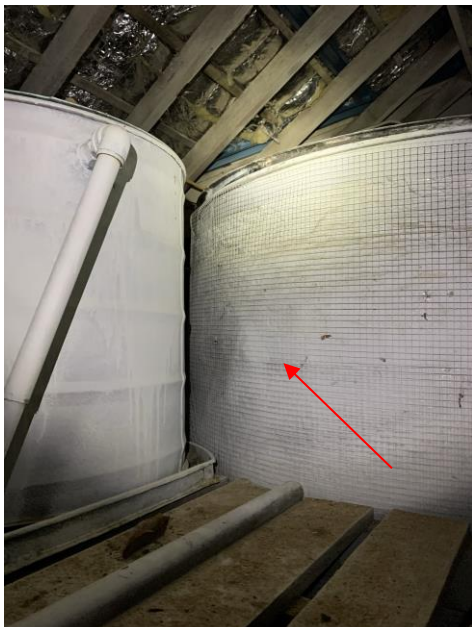
**Photo 35:**

**SMF** - Foil backed insulation to water storage tanks Level 02 “north wing”

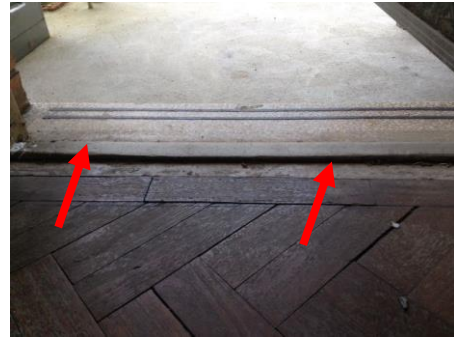
Photo No. 001: South-western entrance

The Moulded Fibre Cement door jamb to the at south-western entrance was tested and **proved to be an asbestos-containing material**

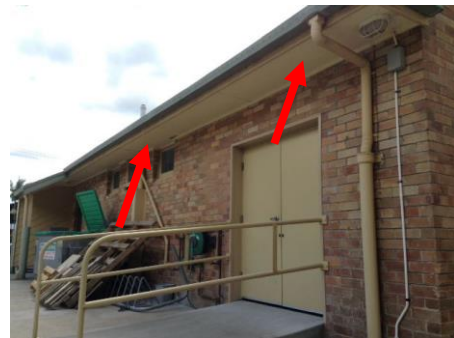
Photo No. 002: Original building

The FFCS eave soffit lining to the original building was previously tested by others and **proved to be an asbestos-containing material**

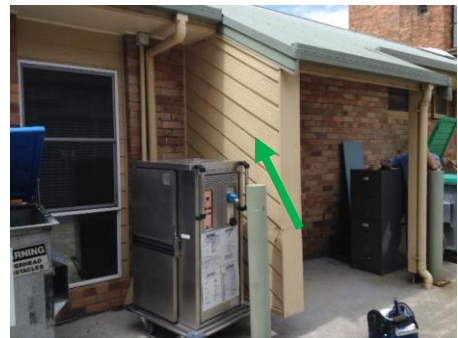
Photo No. 008: South-Western Entrance

The FFCS wall cladding to the partition adjacent to the south-western entrance was tested and **proved NOT to be an asbestos containing material**

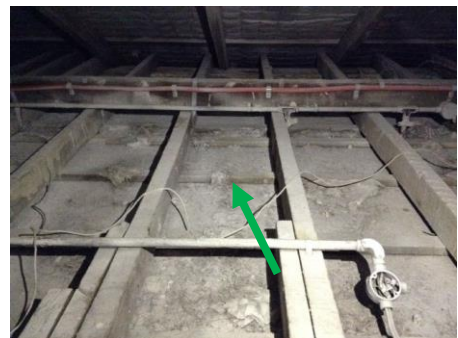
Photo No. 009: Mortuary

The lagging debris in the ceiling cavity of the mortuary has been remediated and as such has **proved NOT to be an asbestos containing material**

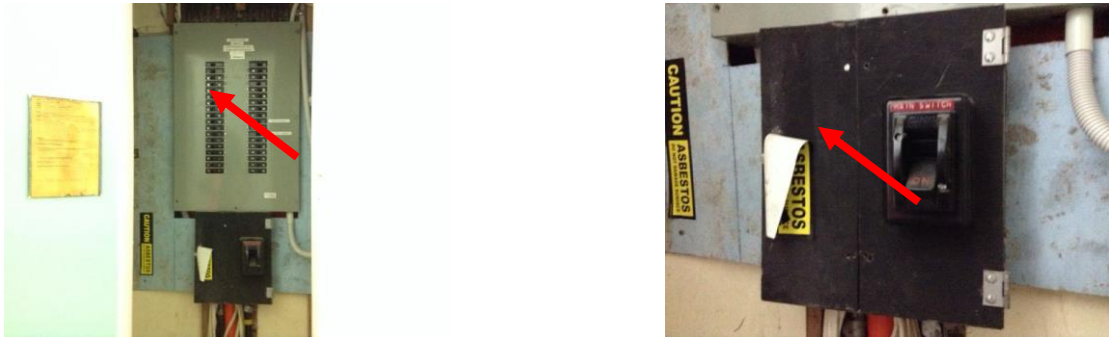
Photo No. 010: Ground Floor MN0900056

The FFCS insulation panels the two electrical switchboards in MN0900056 were unable to be sampled **but SHALL be regarded as an asbestos-containing material**

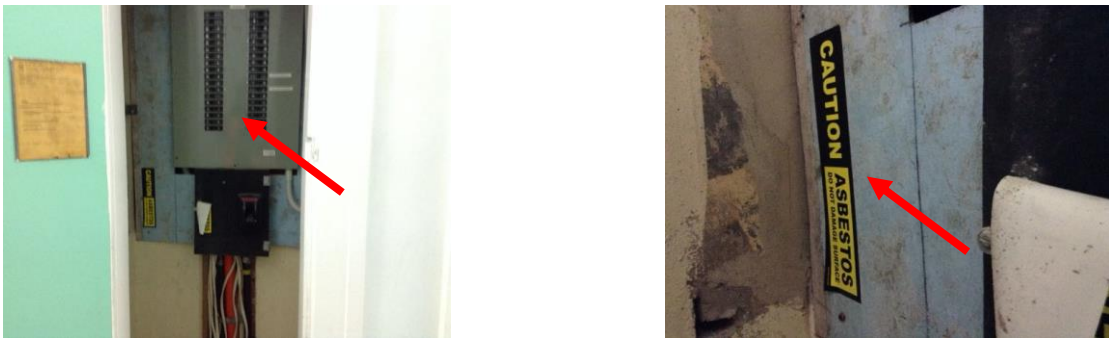
Photo No. 011: Ground Floor MN0900056

The FFCS infill panel behind the electrical switchboard in MN0900056 was unable to be sampled **but, SHALL be regarded as an asbestos-containing material**

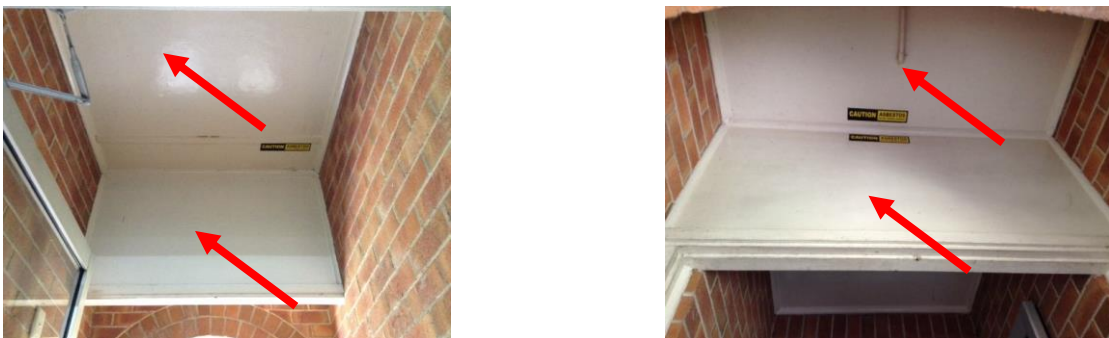
Photo No. 012: Ground Floor, North Eastern Entrance Alcove

The FFCS infill panel and soffit lining to the north-eastern entrance alcove were previously tested by others and **proved to be an asbestos containing material**

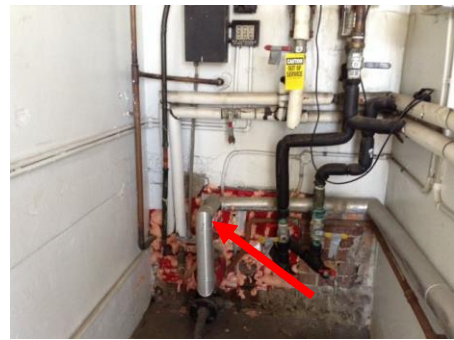
Photo No. 014: Subfloor of Eastern Wing

The thermal “lagging” insulation to pipework in the subfloor of the eastern wing was previously tested by others and **proved to be an asbestos containing material**

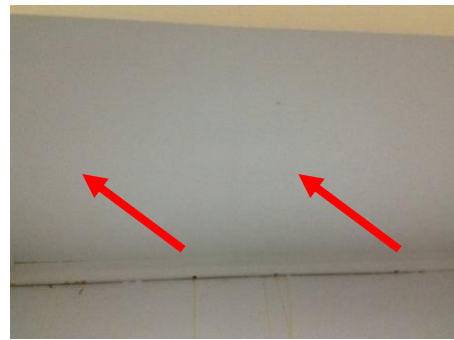
Photo No. 017: 1st Floor, upper cupboard to MN0901042

The FFCS ceiling lining to the upper cupboard in MN0901042 **SHALL be regarded as an asbestos-containing material**

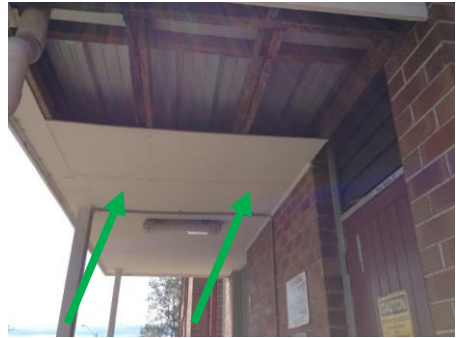
Photo No. 018: Entry Portico (off Room MN0900037)

The FFCS awning soffit lining to the entry portico was previously tested and **proved NOT to be an asbestos containing material**

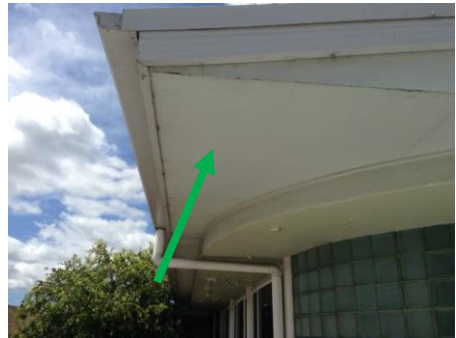
Photo No. 019: 1st Floor Eaves

The FFCS eave soffit lining and infill panels to the eastern wing were tested and **proved NOT to be an asbestos containing material**

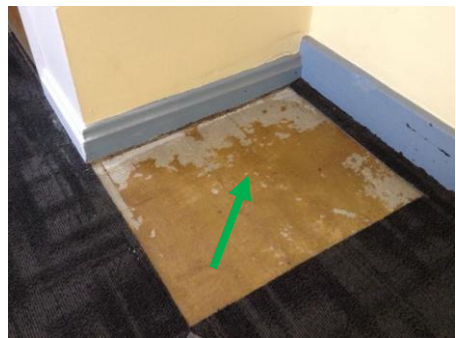
Photo No. 020: 2nd Floor (West Wing)

The VFTs to the 2nd floor of the West Wing were tested and **proved NOT to be an asbestos containing material**

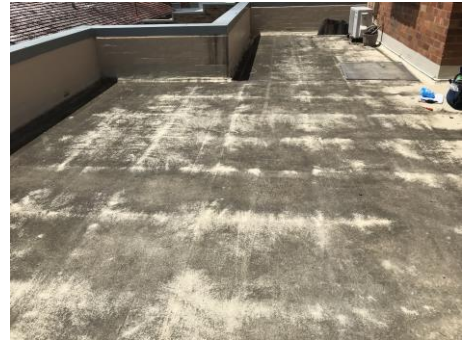
Photo No. 021: 2nd floor Eastern Balcony

The mastic joint adhesive in the surface of the 2nd floor eastern balcony was referred to sample AB08 and **proved NOT to be an asbestos containing material**

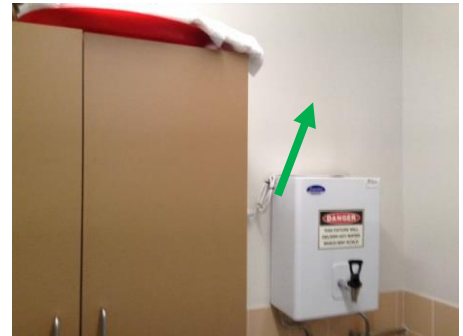
Photo No. 022: Ground Floor Room MN090010

The FFCS wall lining to Room MN090010 was tested and **proved NOT to be an asbestos containing material**

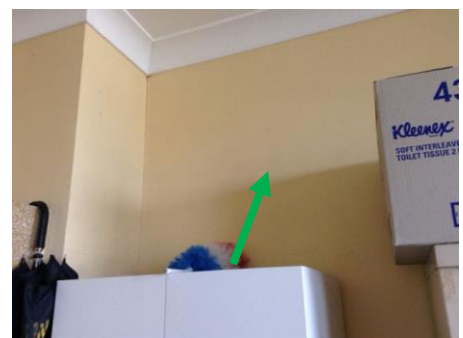
Photo No. 023: Ground Floor Room MN090024

The FFCS wall lining to Room MN090024 was tested and **proved NOT to be an asbestos containing material**
