# STATE SIGNIFICANT DEVELOPMENT ASSESSMENT REPORT

## BUILDINGS – MN06, MN07 & MN08

Manning Base Hospital Redevelopment  
**26 York St**  
**Taree NSW 2430**

July 2023  
*Survey conducted in March 2022*

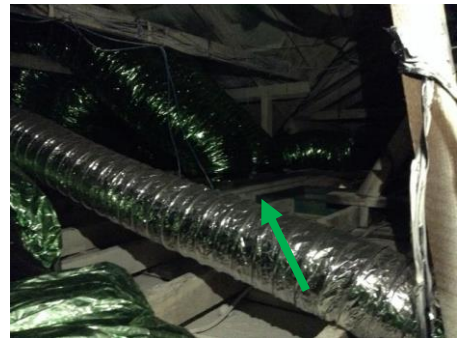
Photo No. 0112: Pharmacy Ceiling Cavity

The thermal insulation "lagging" debris to pipework in the ceiling cavity was remediated and has now **proved NOT to be asbestos containing.**

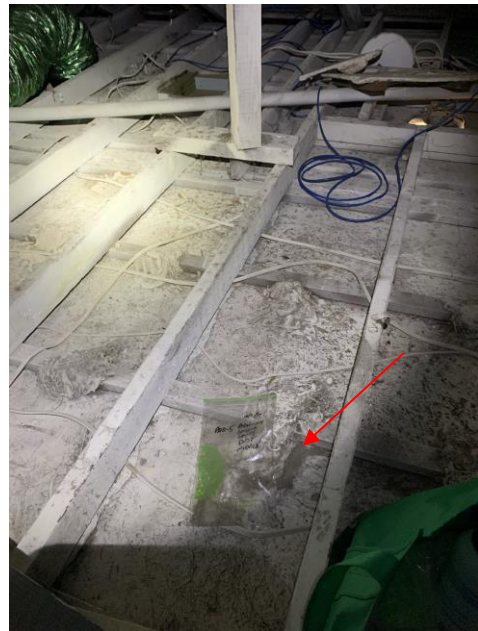
**Photo 2:**

AS10 – 5: **Chrysotile, Amosite and Crocidolite** asbestos detected

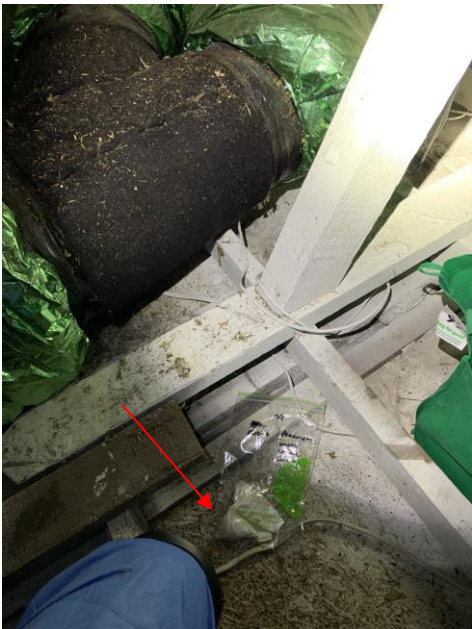
**Photo 3:**

DS10 – 4: **>4.3mg/m<sup>2</sup>**

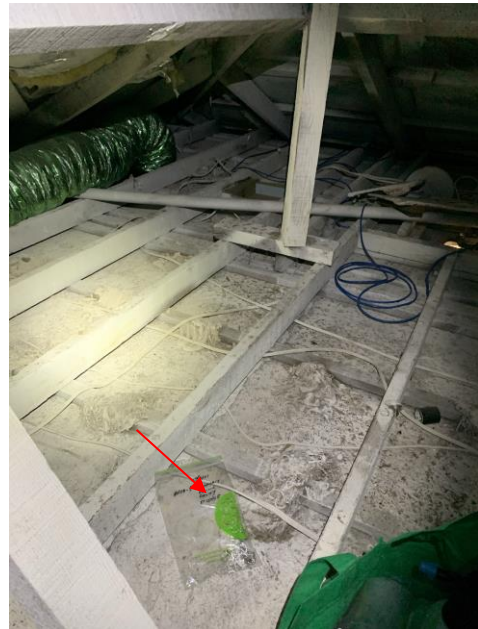
**Photo 4:**

DS10 – 5: **>4.3mg/m<sup>2</sup>**

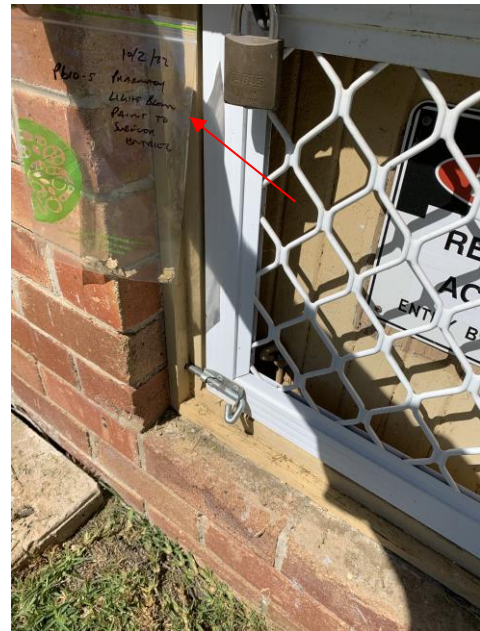
Photo 6:

PB10 – 5:  $>0.1\%$

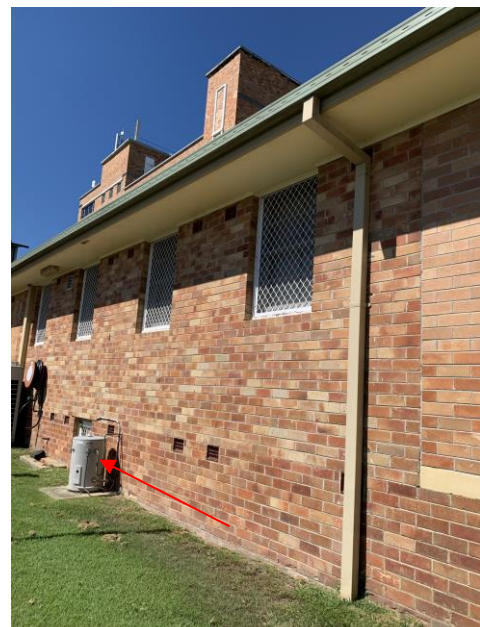
Photo 8:

SMF: Hot water system insulation

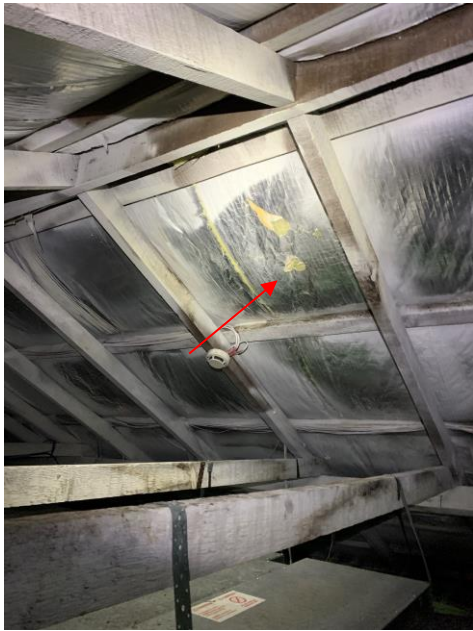
Photo 9:

SMF: Foil back insulation

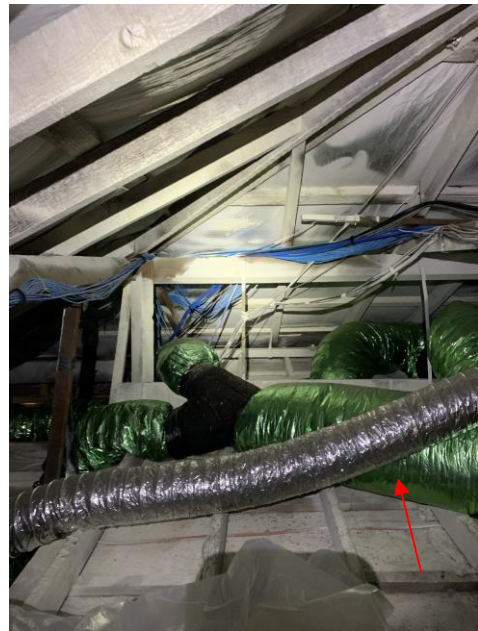
Photo 10:

SMF: Foil back insulation

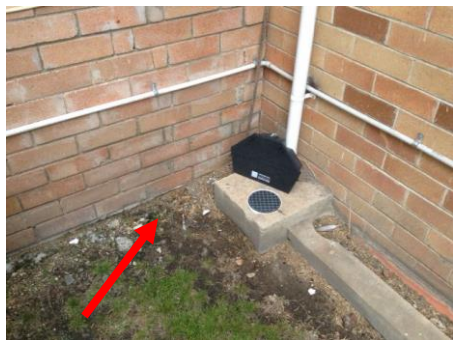
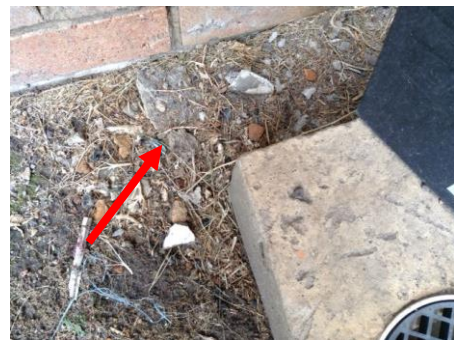
Photo No. 002: External

The FFCS fragments outside the building (near the subfloor entrance) were referred to sample 8 from the previous register and **SHALL be regarded as an asbestos-containing material**

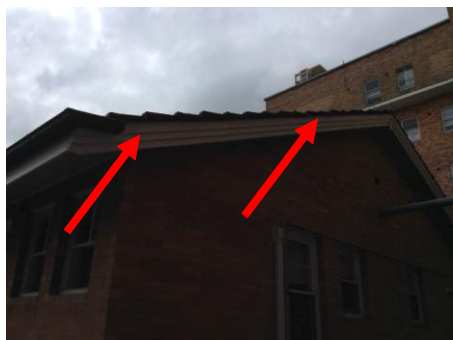
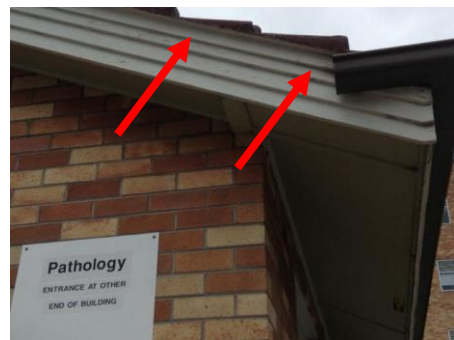
Photo No. 003: External

The FFCS gable end tile support strip was referred to the previous sample 8 and **SHALL be regarded as an asbestos-containing material**

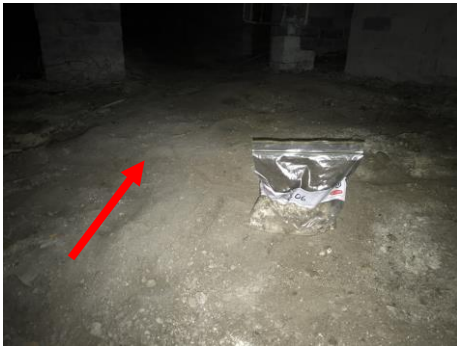
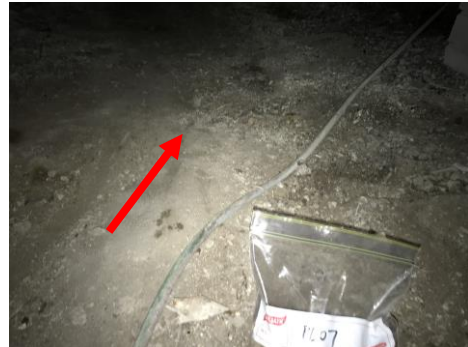
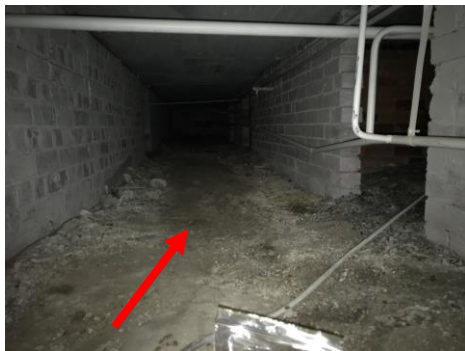
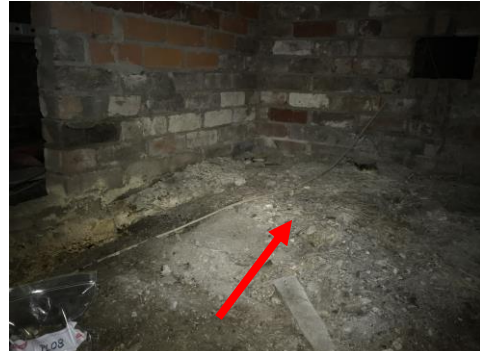
Photo No. 017: Subfloor

The soil to the subfloor was tested and **proved to contain free fibres of amosite asbestos likely associated with now removed 'lagged' pipe work.**

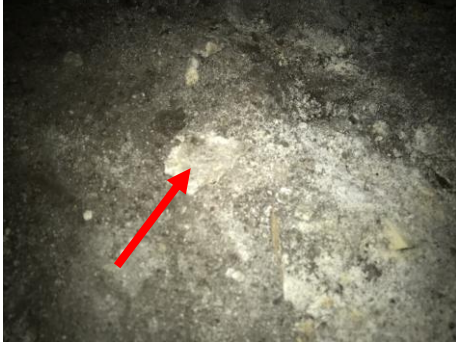
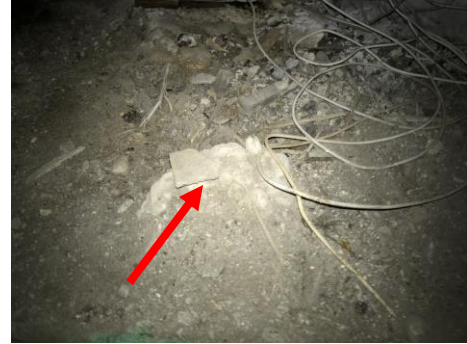
Photo No. 018: Subfloor

The fragments of FFCS to the subfloor was tested and **proved to be an asbestos containing material**

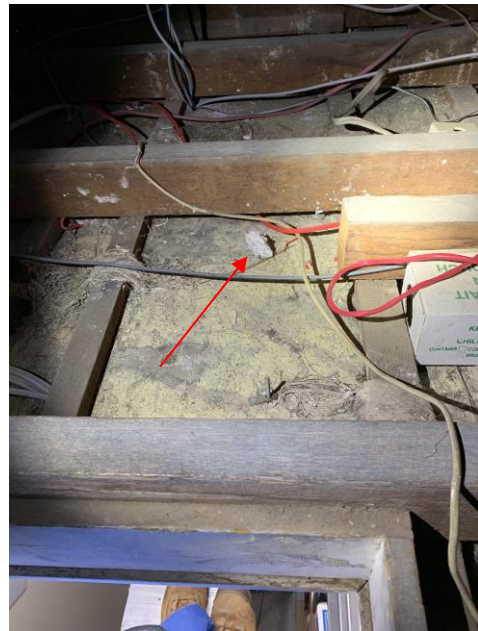
Photo 10:

AS14 – 10: **Chrysotile, Amosite and Crocidolite** asbestos

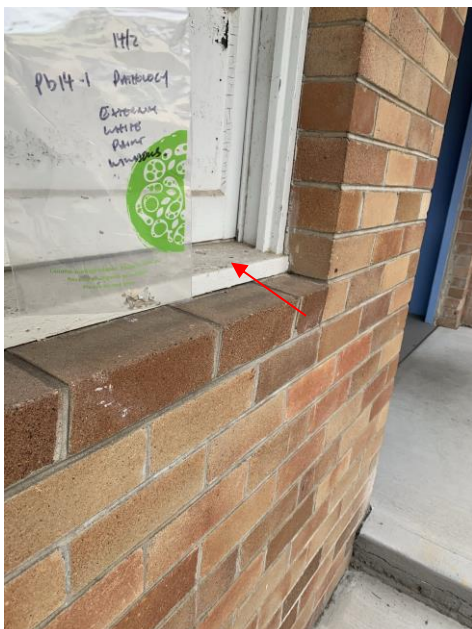
Photo 11:

Pb14 – 1: **>0.1%**

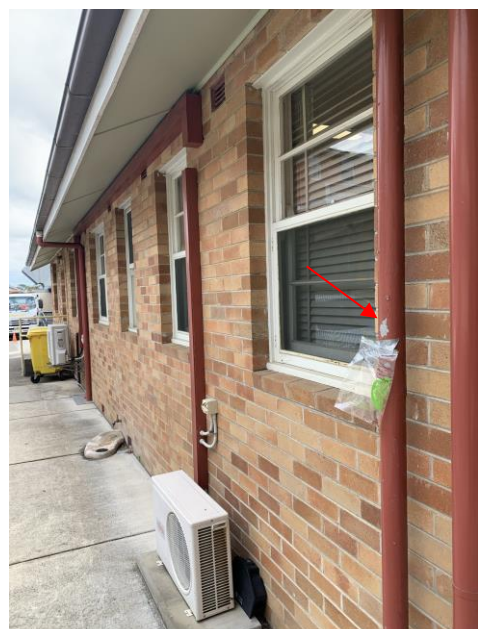
Photo 12:

Pb14 – 2: **>0.1%**

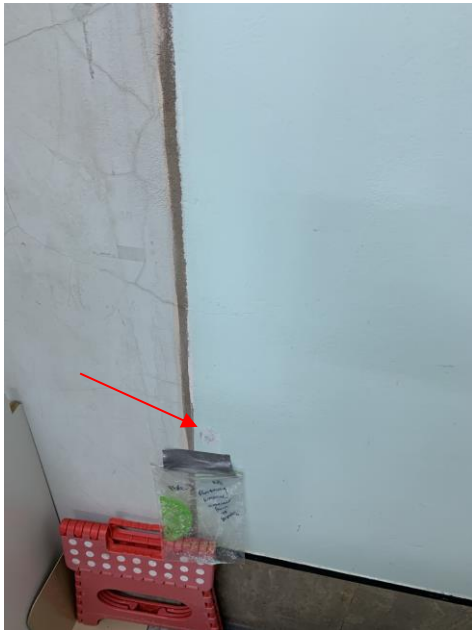
Photo 13:

Pb14 – 3: >0.1%

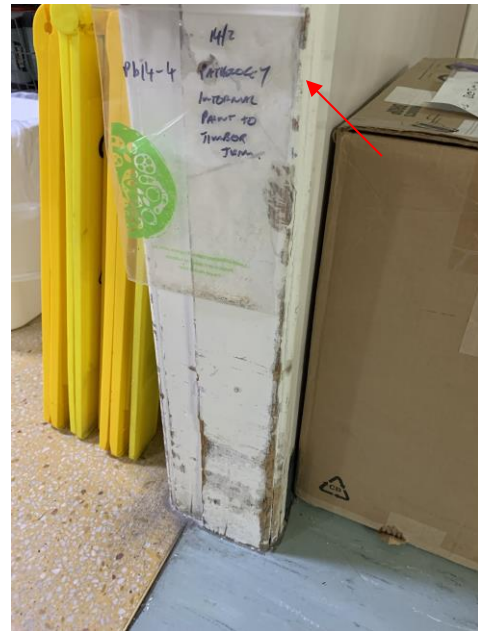
Photo 14:

Pb14 – 4: >0.1%

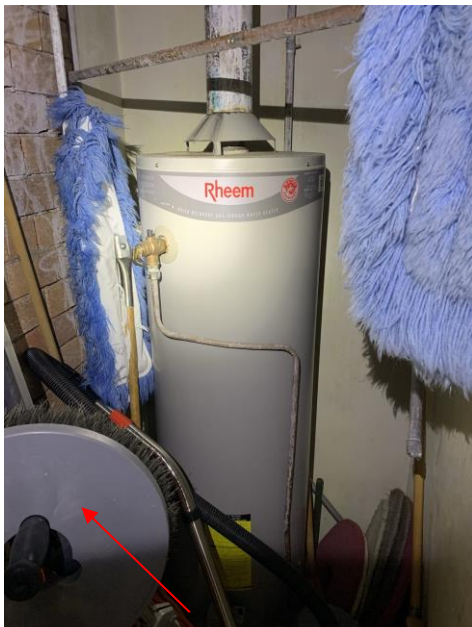
Photo 15:

SMF – Insulation in encased hot water system

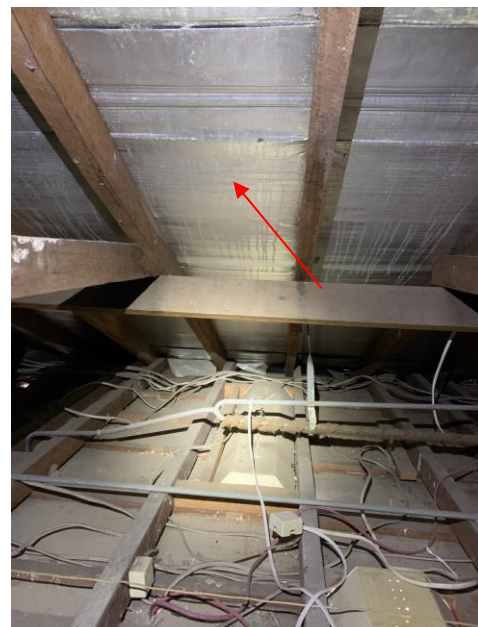
Photo 16:

SMF – Foiled back insulation

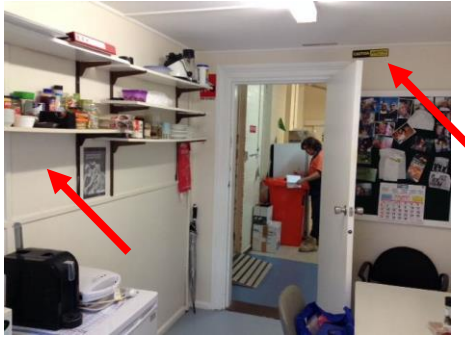
Photo No. 022: Room MN0800015

The FFCS wall lining to Room MN0800015 was referred to Sample 20 and **SHALL** be regarded as an asbestos-containing material

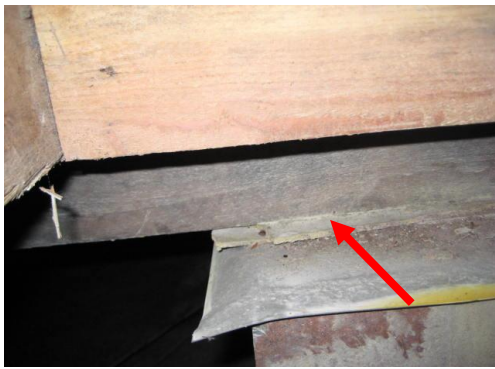
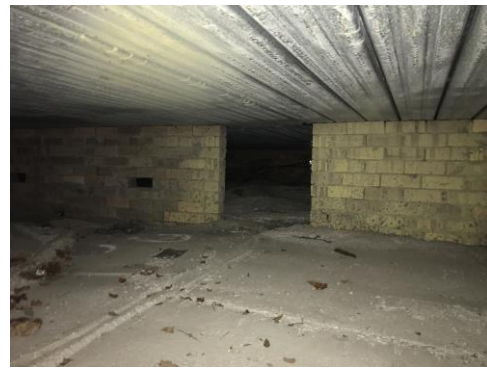
Photo No. 023: Subfloor

The FFCS pier packers to the subfloor **SHALL** be regarded as an asbestos-containing material

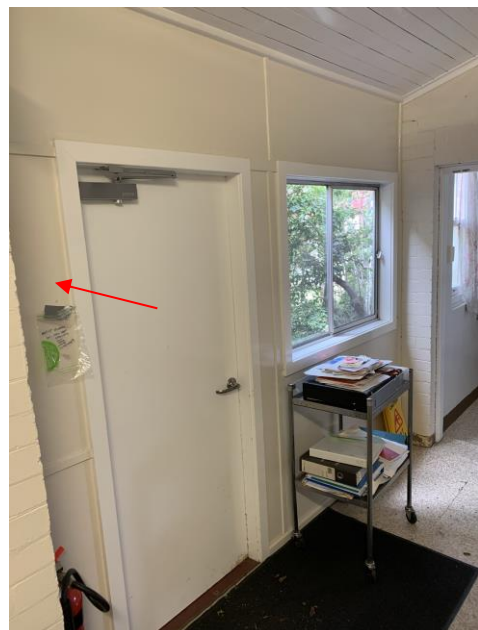
Photo 8:

AS15 – 15: **Chrysotile asbestos**

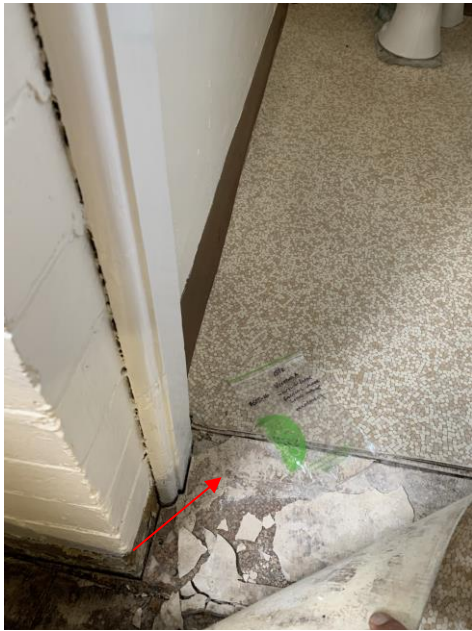
Photo 9:

AS15 – 16: **Chrysotile asbestos**

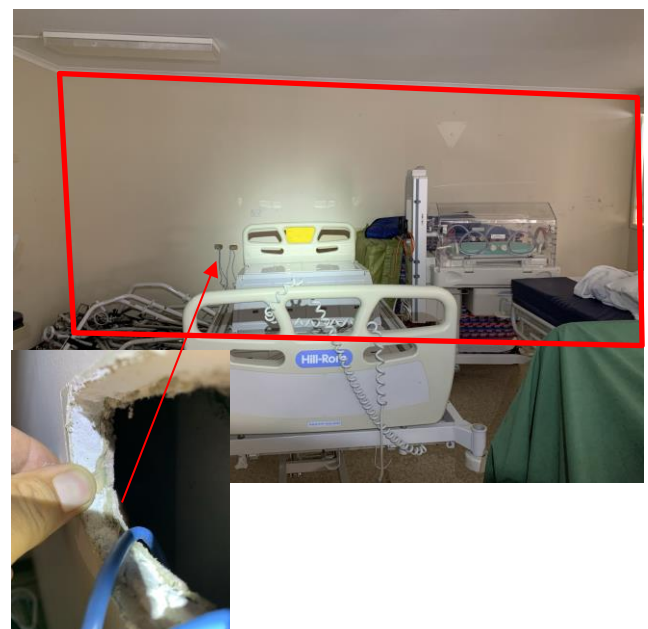
Photo 12:

AS15 – 21: **Chrysotile asbestos**

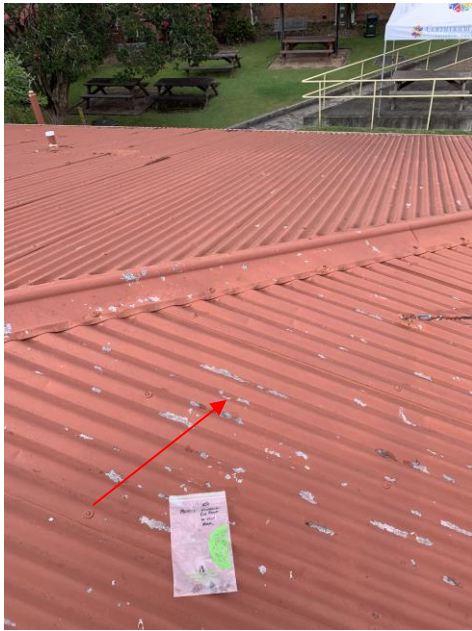
Photo 13:

PB15 – 1: >0.1%

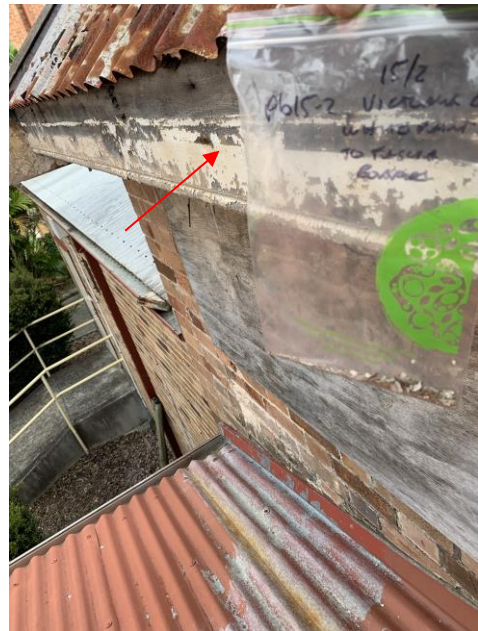
Photo 14:

PB15 – 2: >0.1%

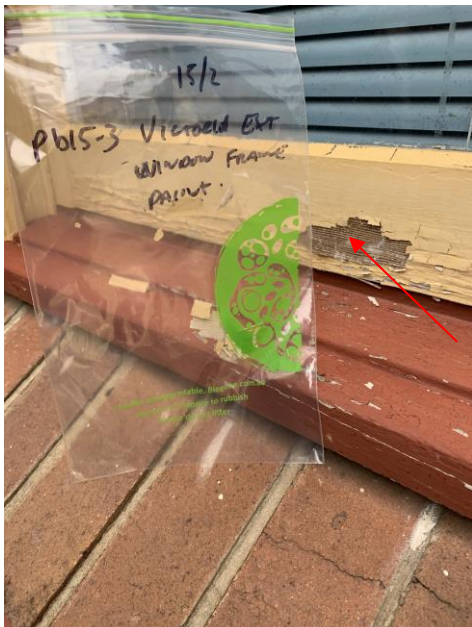
Photo 15:

PB15 – 3: >0.1%

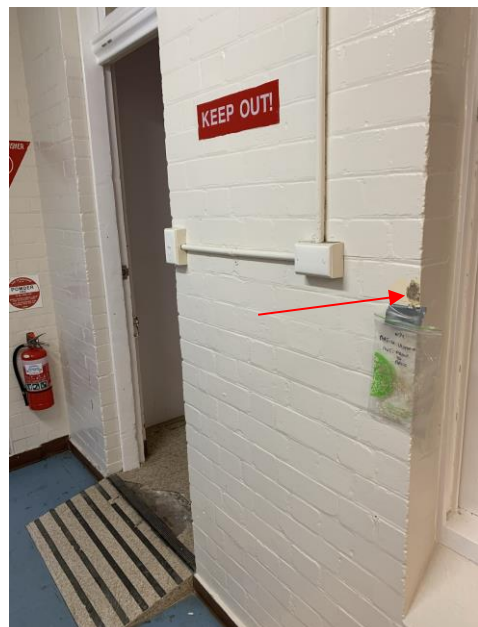
Photo 16:

PB15 – 4: >0.1%

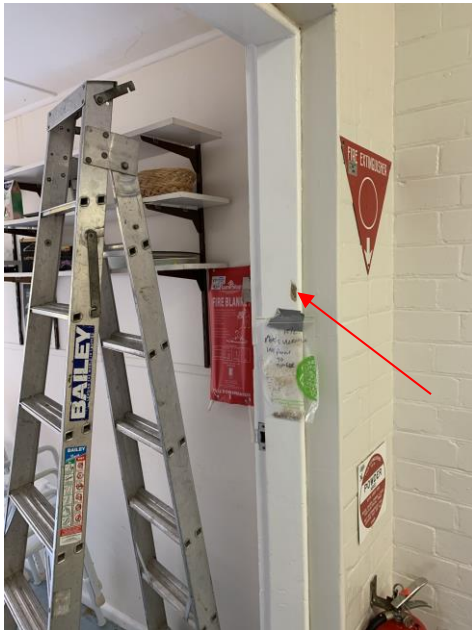
Photo 17:

PB15 - 5: >0.1%

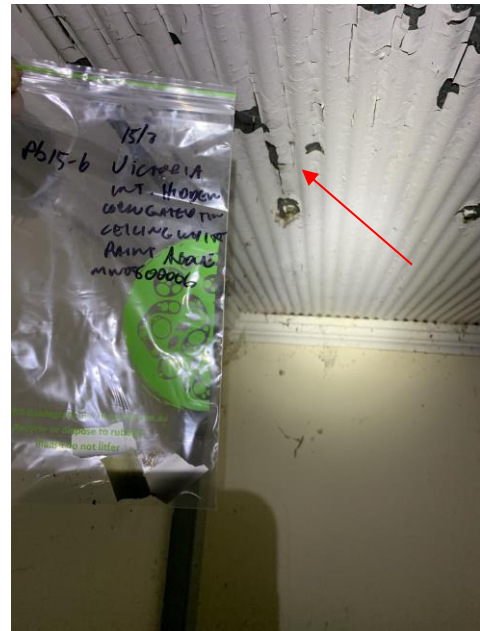
Photo 18:

PB15 - 6: >0.1%

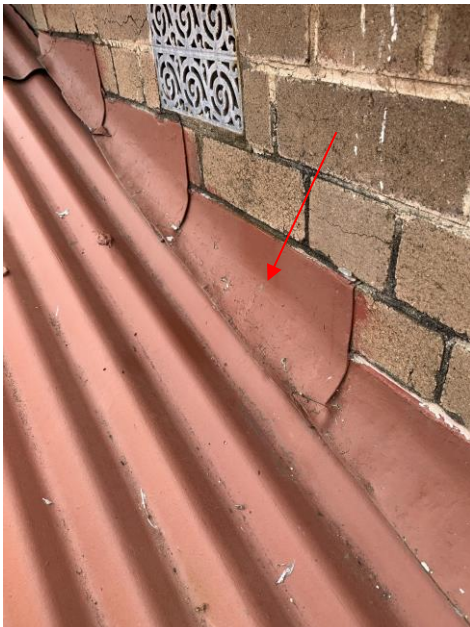
Photo 19:

Lead: Flashing

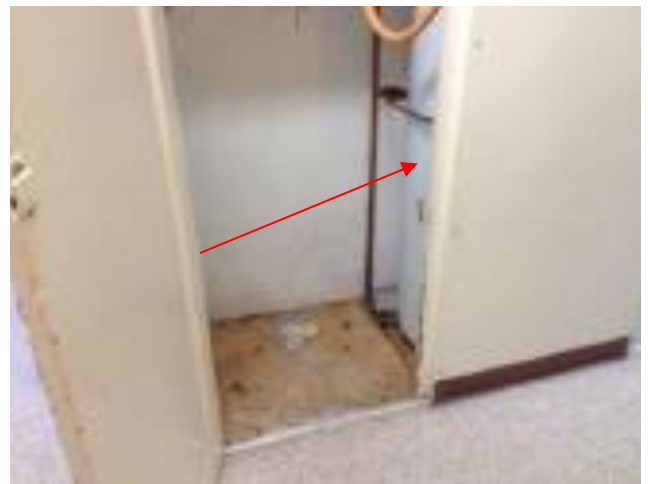
Photo 20:

SMF: Hot water system insulation

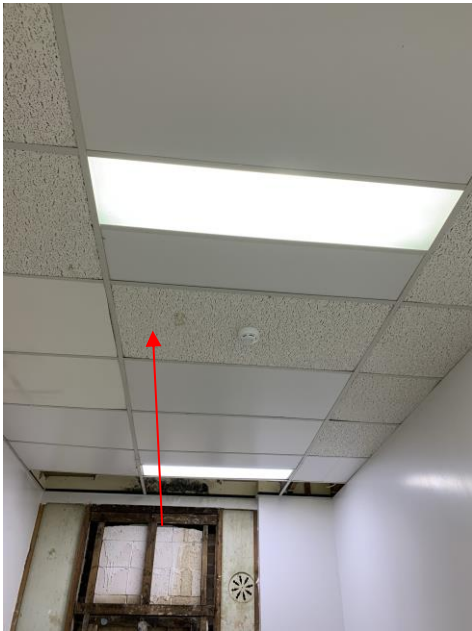
**Photo 21:**

SMF: Ceiling tiles
