## Hazardous Building Materials Register

**Ambulance Awning & LPG & O2 Tank Frames  
7 Pacific Street  
BATEMANS BAY NSW 2536**

**Inspection Date: 8/04/2024**

**Report Number: 12740.01.HMSR**

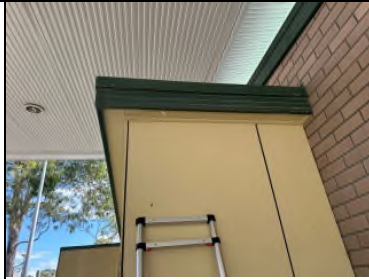
ID	Location	Material Type	Sample No.	Analysis Result	Extent	Condition	Accessibility	Friability	Disturbance Potential	Risk Status	Reinspect Date	Control Priority	Control Recommendation	Photos
ASB64455	Exterior - Eaves around western entrance Eaves lining	Fibre Cement Sheeting	12740/AS002	Negative No Asbestos Detected	-	-	-	-	-	-	-	-	-

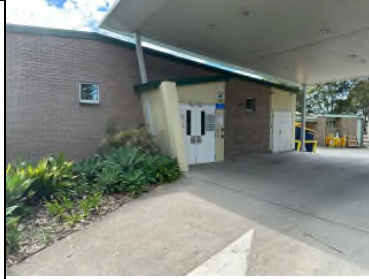
<b>Fibre Cement Sheeting</b>
ASB64453	Exterior Wall panels around building entrances	Fibre Cement Sheeting	12740/AS001	Negative No Asbestos Detected	-	-	-	-	-	-	-	-	-

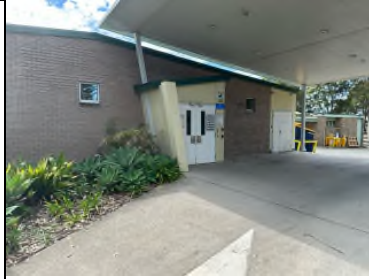
<b>Fibre Cement Sheeting</b>
LDP436	Exterior Exterior surfaces throughout – Green paint	Lead Paint	12740/LP002	Negative <0.001% lead paint	-	-	-	-	-	-	-	-	-

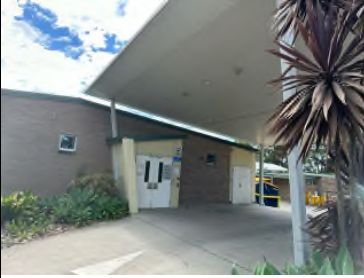
ID	Location	Material Type	Sample No.	Analysis Result	Extent	Condition	Accessibility	Friability	Disturbance Potential	Risk Status	Reinspect Date	Control Priority	Control Recommendation	Photos
LDP437	Exterior Exterior surfaces throughout – White paint	Lead Paint	12740/ LP001	Negative <0.001% lead paint	-	-	-	-	-	-	-	-	-

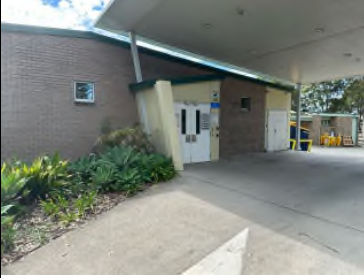
<b>White Paint</b>														
LDP438	Exterior Exterior surfaces throughout – Yellow paint	Lead Paint	12740/ LP003	Negative 0.098% lead paint	-	-	-	-	-	-	-	-	-
