Royal Prince Alfred Hospital Redevelopment (RPAH Redevelopment)

Construction Noise and Vibration Monitoring Report 20

Client Doc. No. RPA-ACO-ACL-RPT-MW-000023 - Rev A

Project ID	20230239.17
Document Title	Construction Noise and Vibration Monitoring Report
Attention To	CPB Contractors Pty Limited

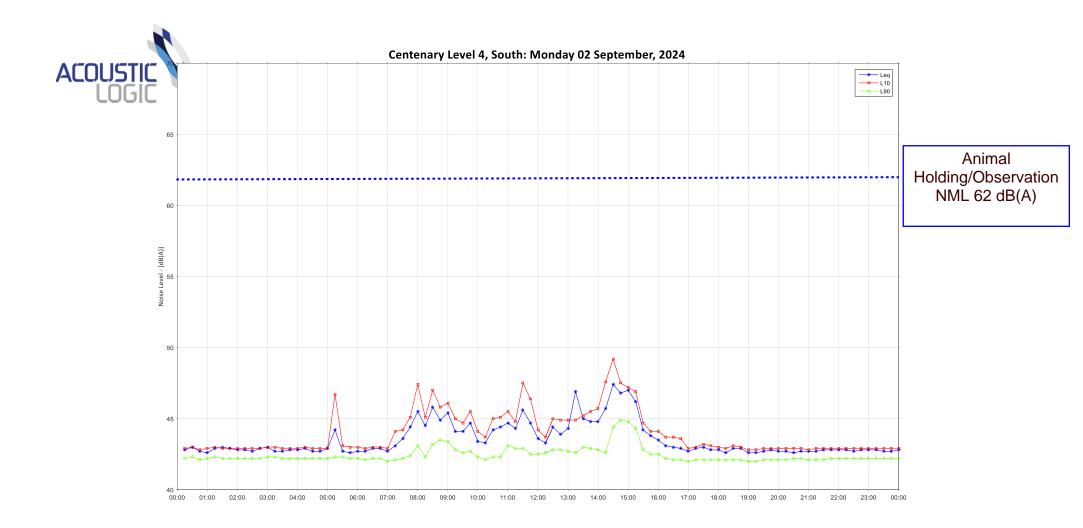
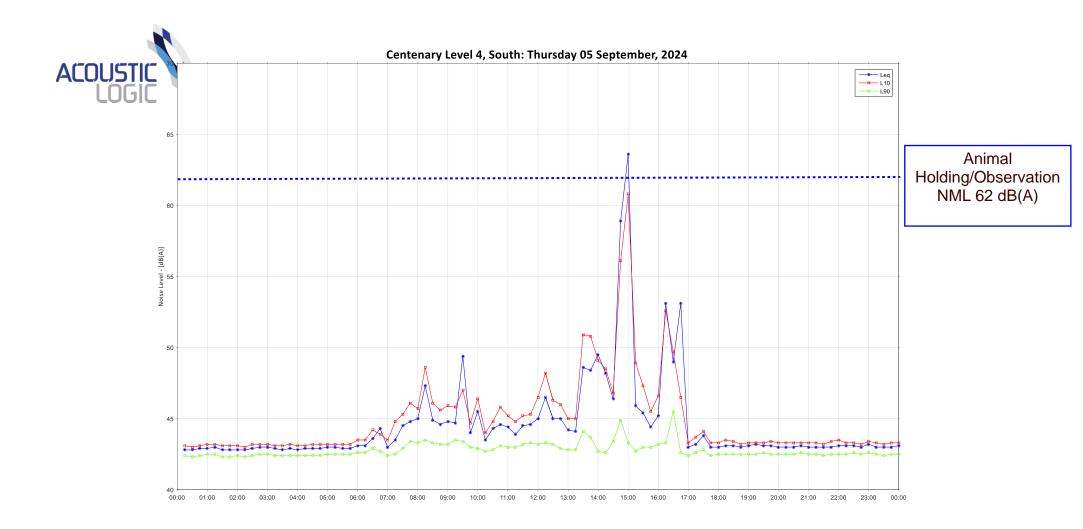
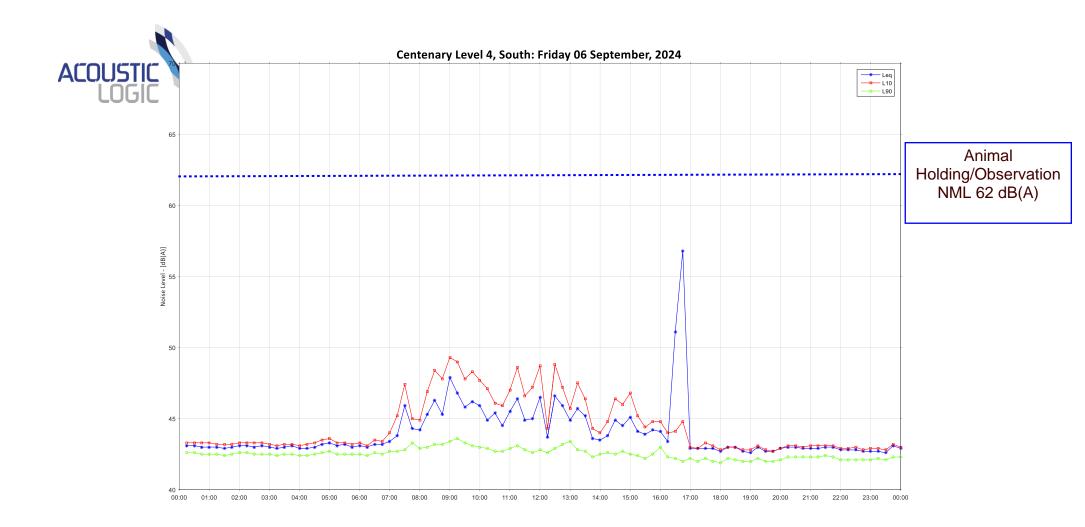
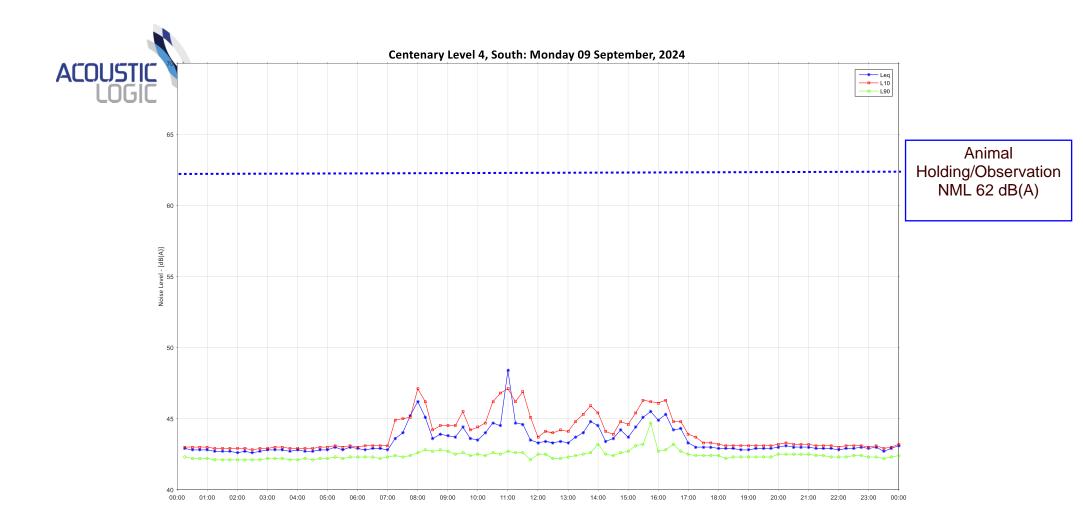
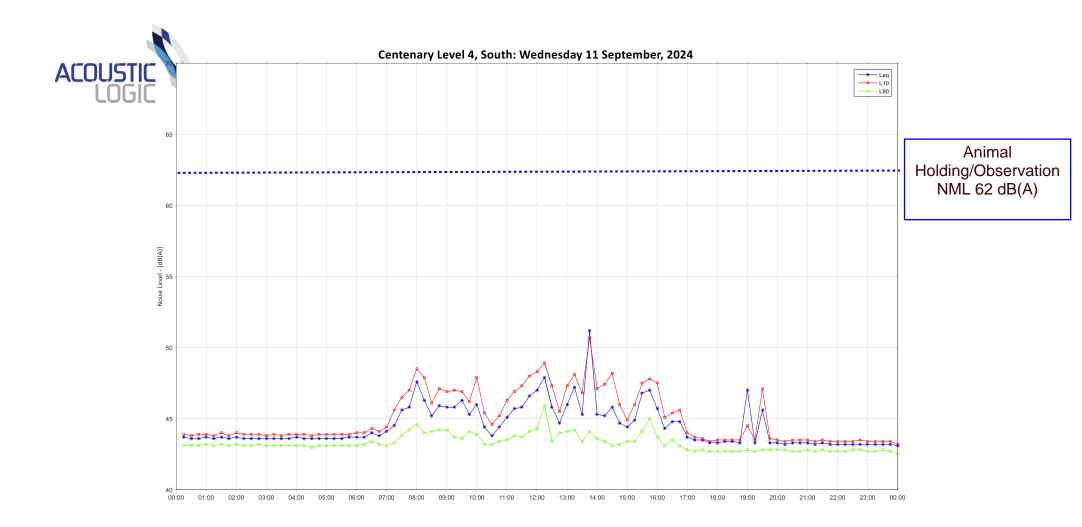
CENTENARY INSTITUTE – LEVEL 4 SURGERY ROOM (SOUTHERN FAÇADE)

For the Holding, Breeding and Observation Rooms

- Noise levels were observed to be measured marginally (≤3 dB) above the NML within the holding/breeding/observation room on the following dates:
 - o 04/09/2024
 - o **05/09/2024**
 - o 10/09/2024
- Noise levels were above the NML for longer than one 15-minute period on the 10th September only.
- For all other days noise levels were not above the NML for more then one 15 minute period in a row and hence it is likely that these events were caused by internal operational activity within the space, as opposed to construction works, noting that construction works are typically continuous in nature.
- All other measured levels above the NML have been found to occur outside of construction hours.
- Ongoing monitoring to continue within the holding/breeding/observation spaces.

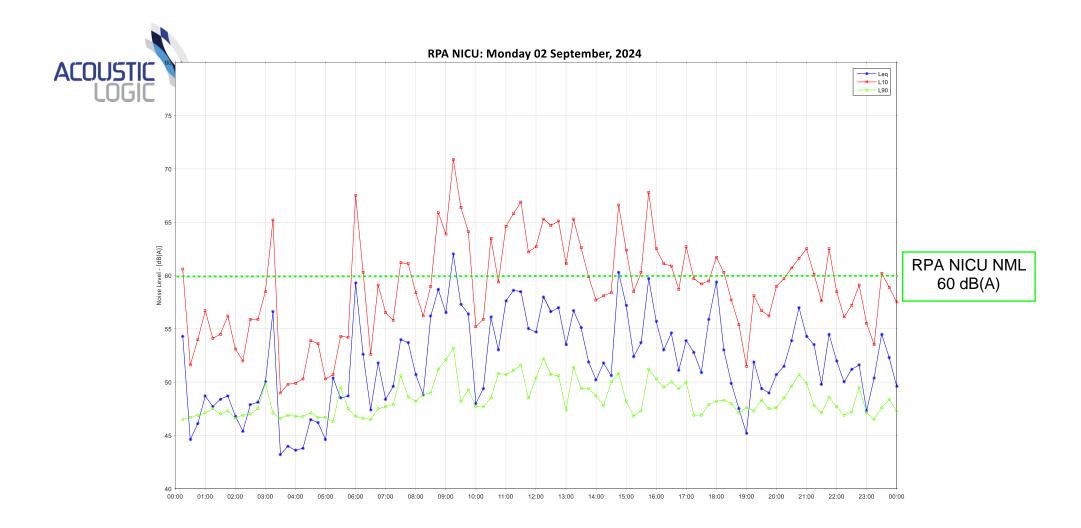
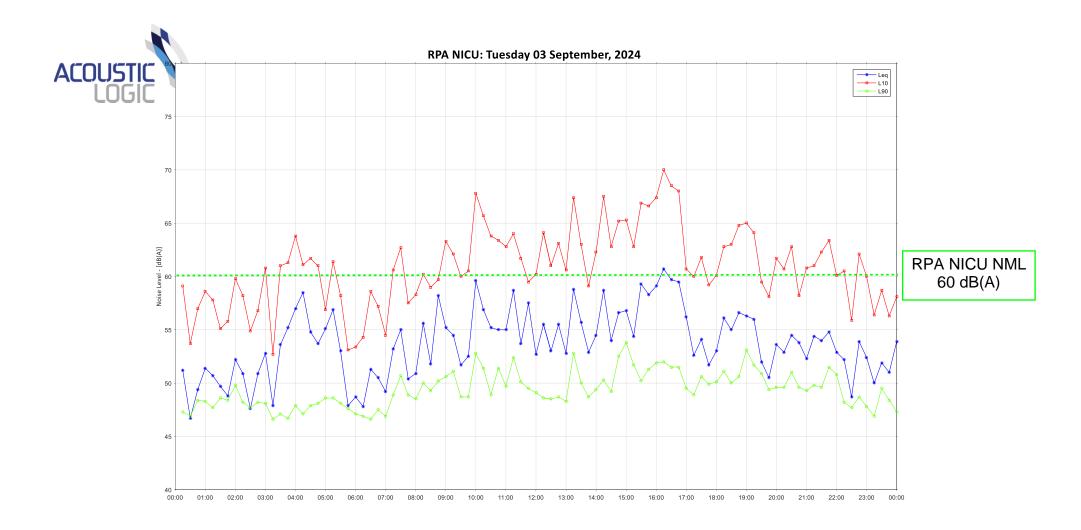
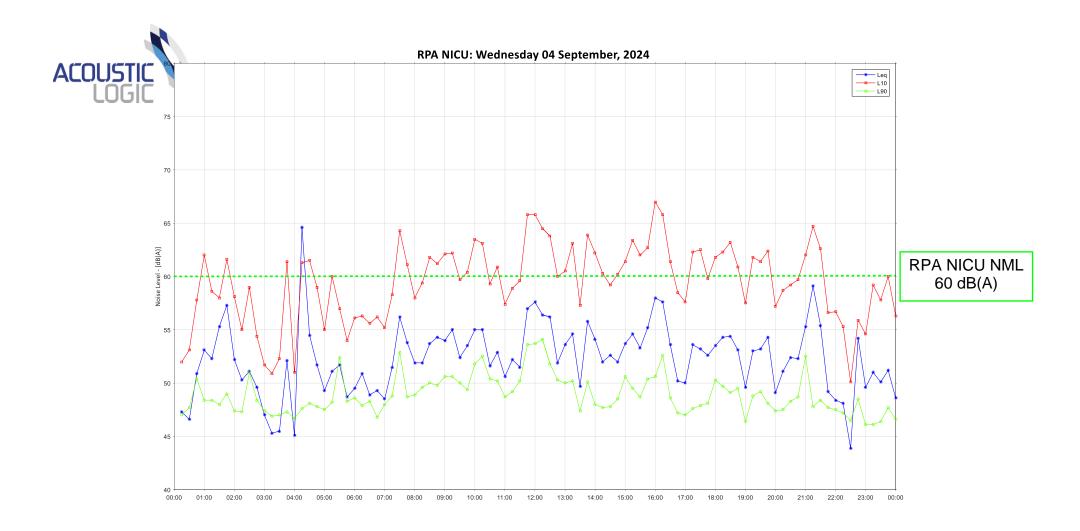
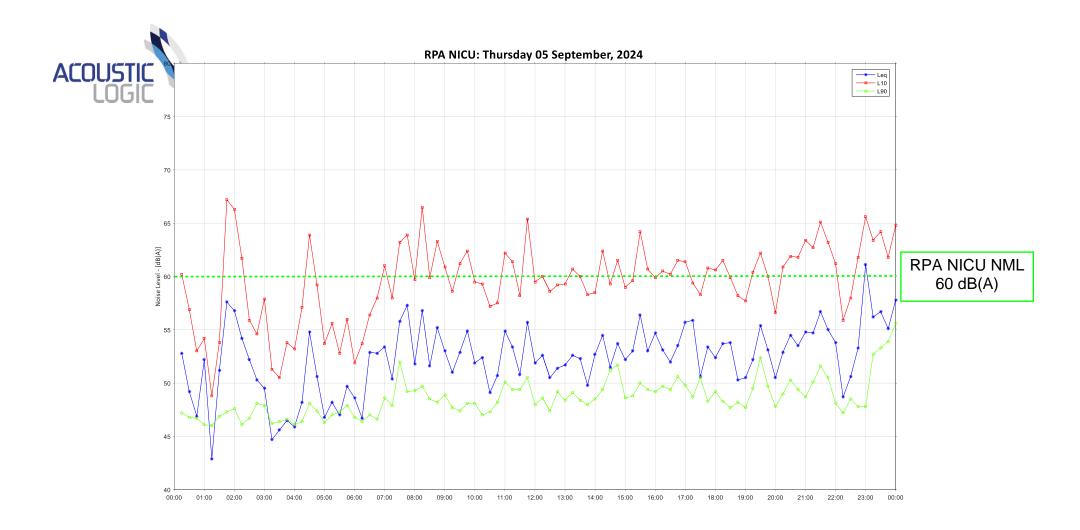
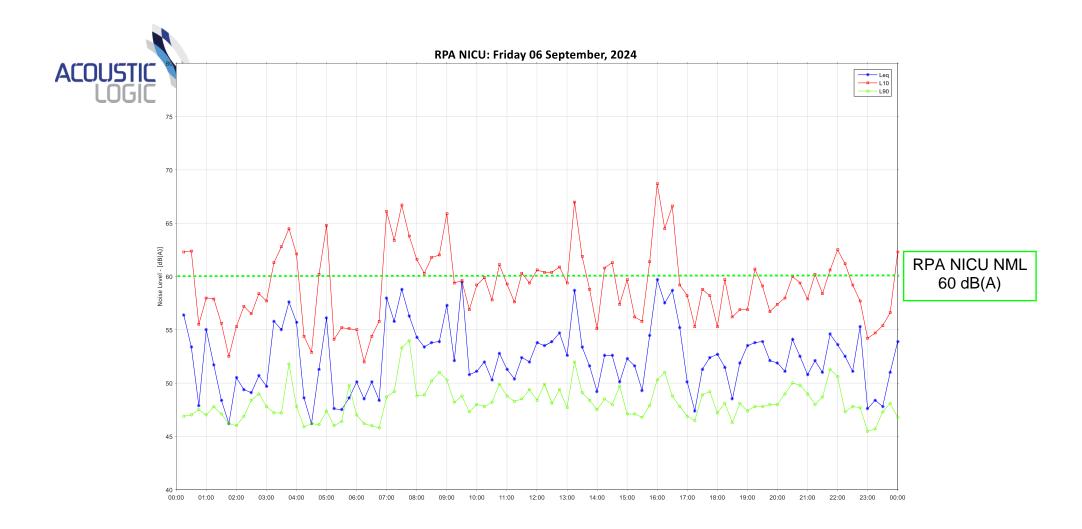
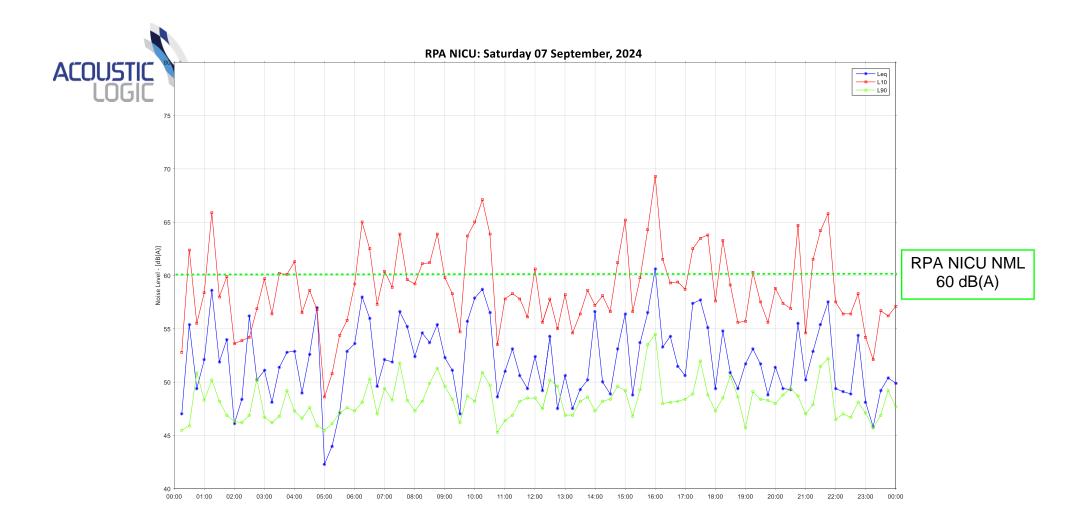
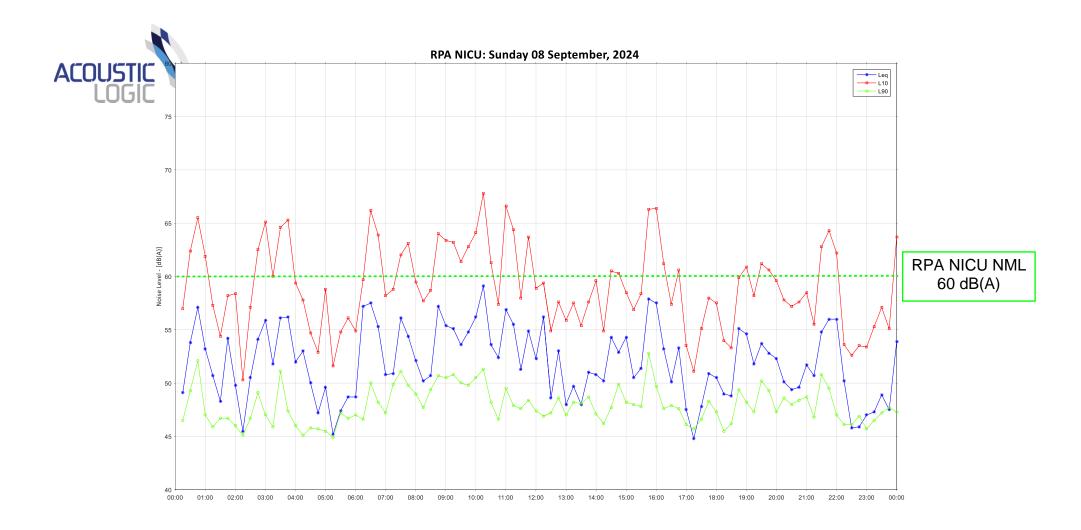
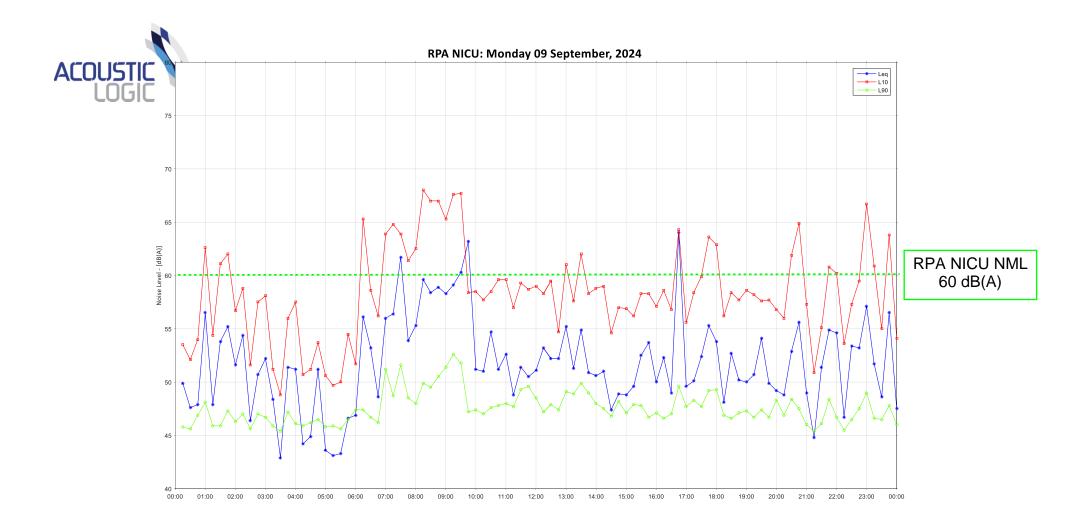
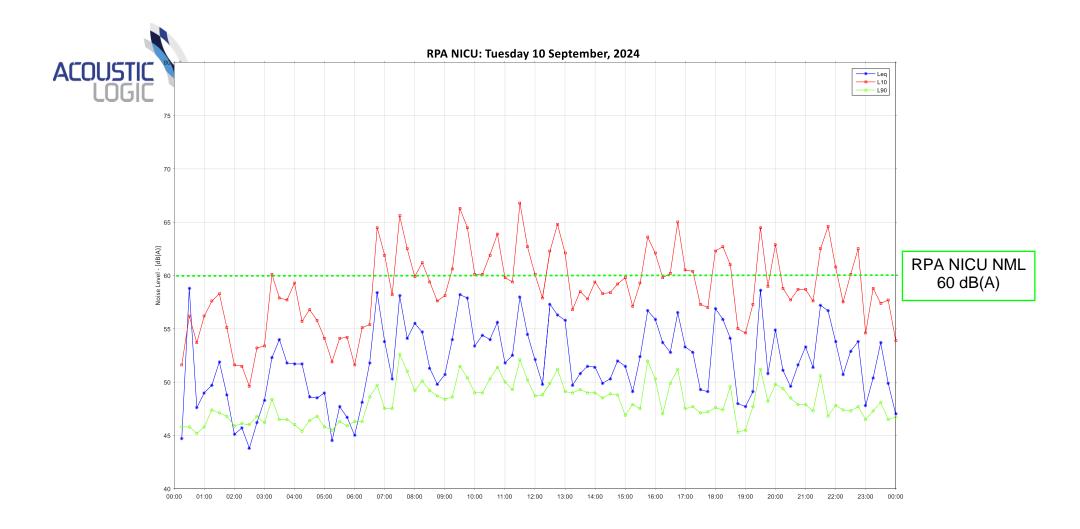
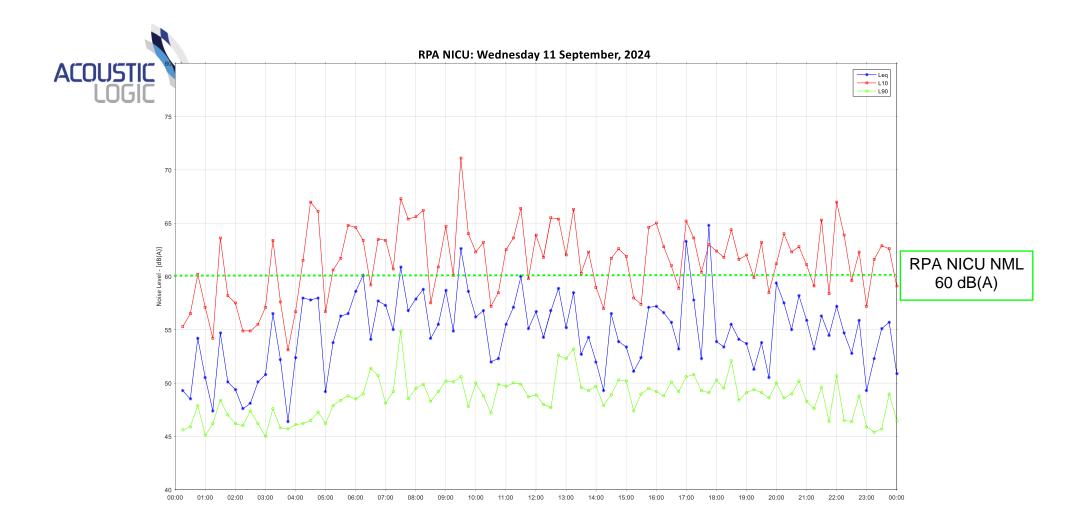
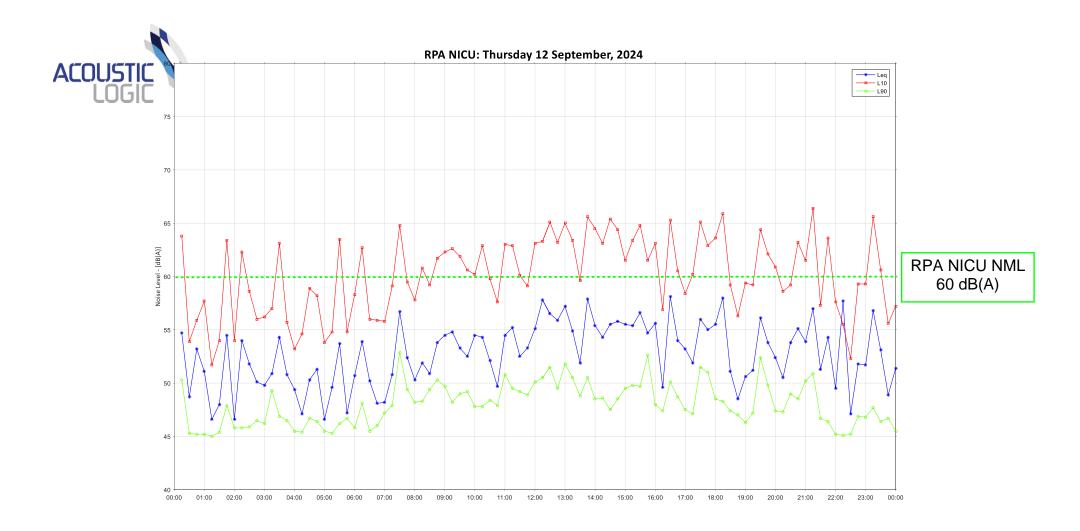
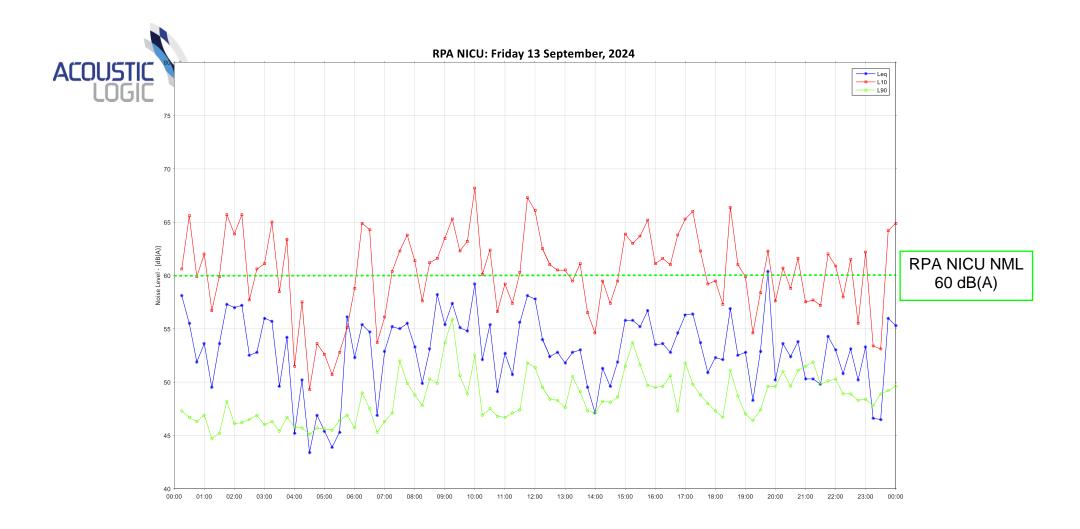
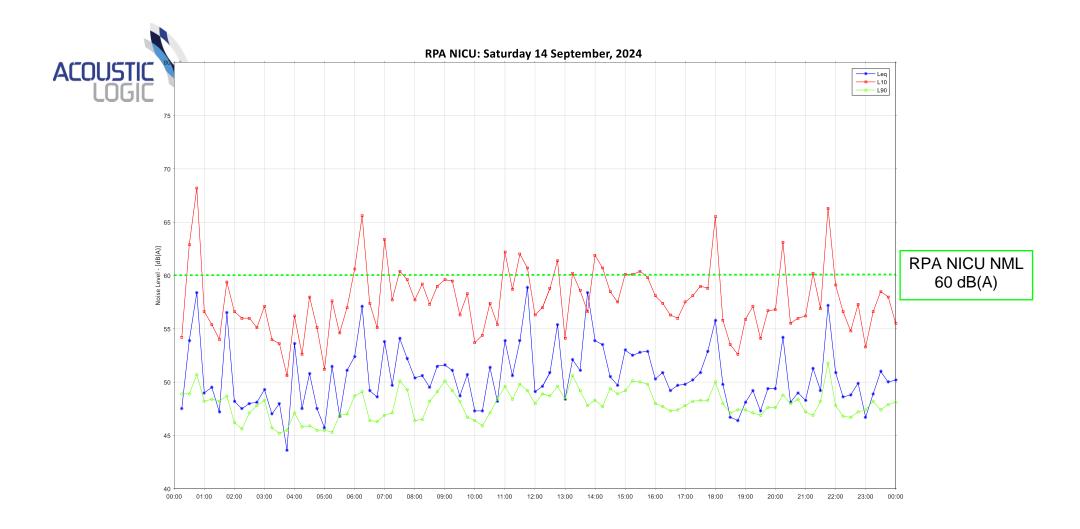
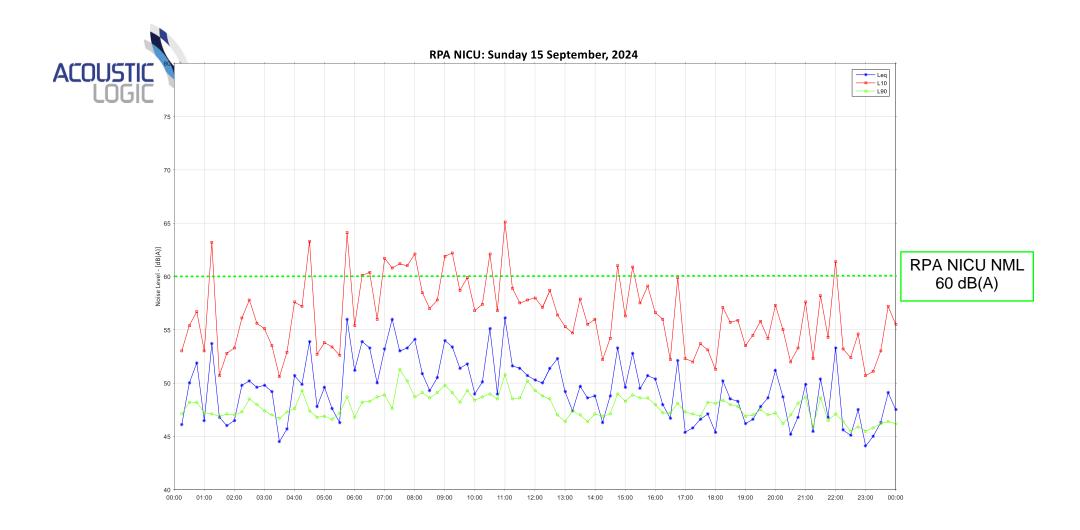
RPA HOSPITAL MAIN BUILDING – LEVEL 3 NICU

- The monitor is located underneath a benchtop and against two individual walls within the NICU area on Level 03 of the hospital main building. Due to the reflections experienced at the monitoring location due to this, a 5dB correction has been conservatively applied to the noise levels measured at the monitoring station.
- Noise levels were observed to be measured above the NML within the NICU space on the following dates:
 - o 02/09/2024
 - o 03/09/2024
 - o 07/09/2024
 - o 09/09/2024

- Exceedances of the NML on the 4th September were outside of construction hours.
- Noise levels within construction hours were never observed to be above the NML for longer than one 15-minute period, and hence it is likely that these events were caused by internal operational activity within the space, as opposed to construction works, noting that construction works are typically continuous in nature.
- The maximum exceedance of the NML was 4 dB, with the vast majority of exceedances being minor 3 dB or less exceedances above the NML.
- Ongoing monitoring to continue within the NICU space.

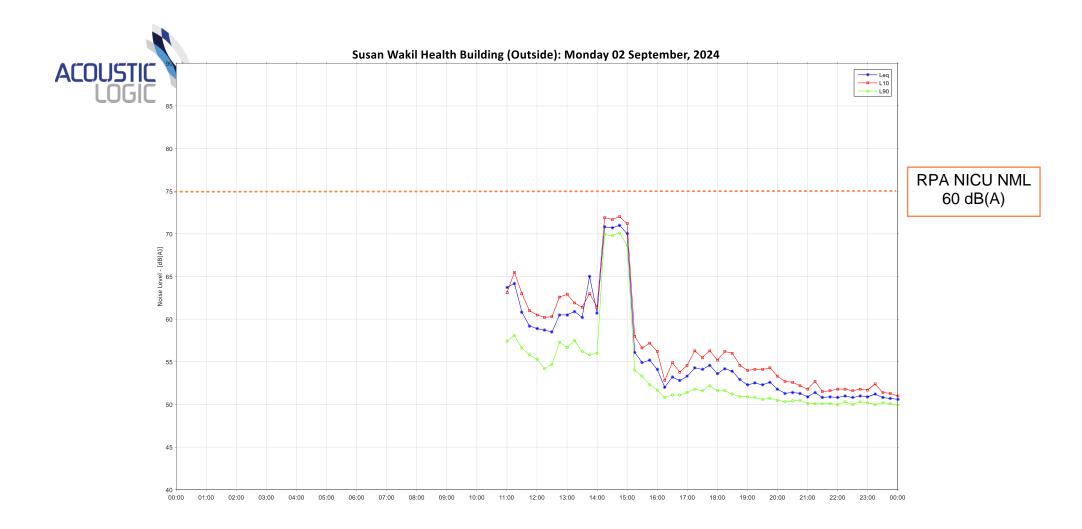
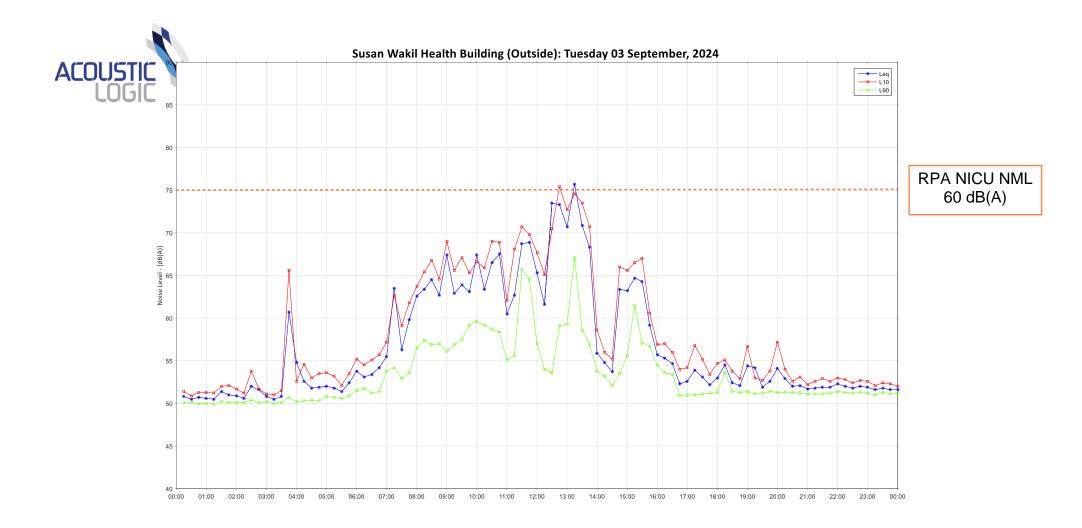
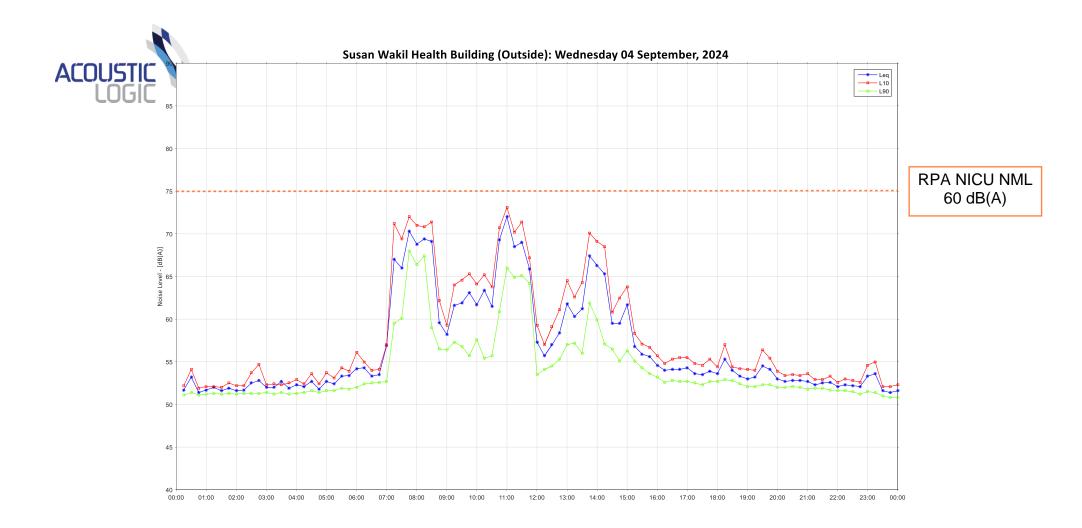
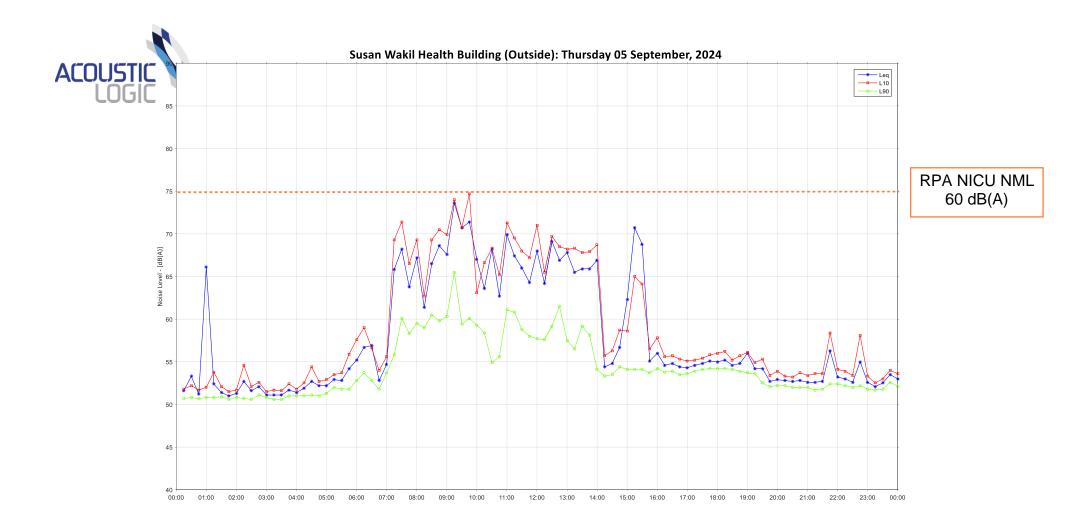
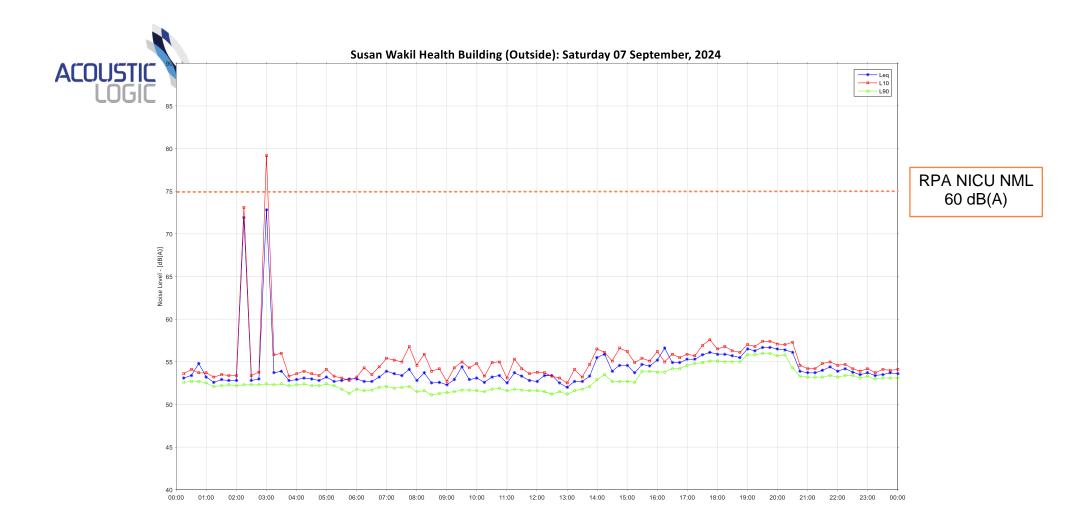
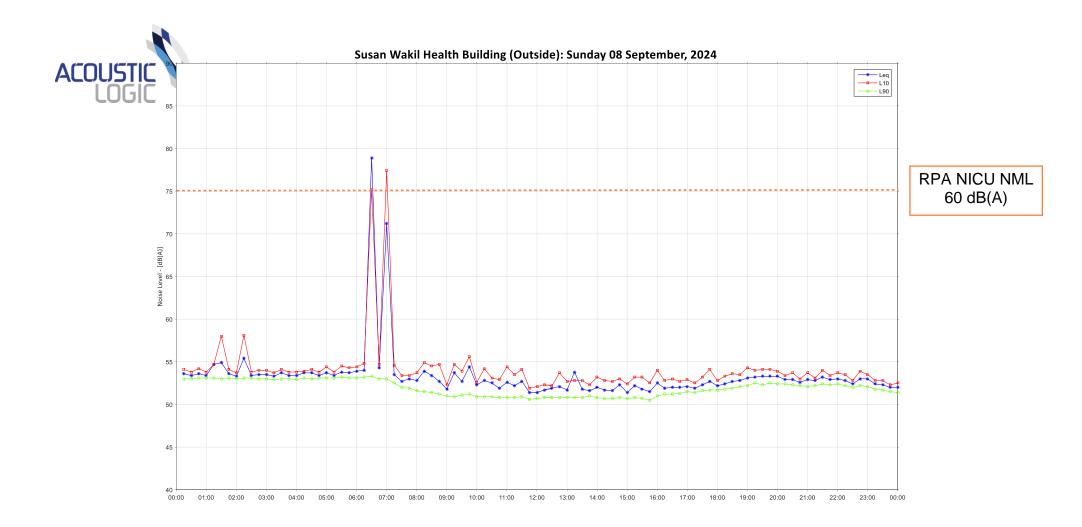
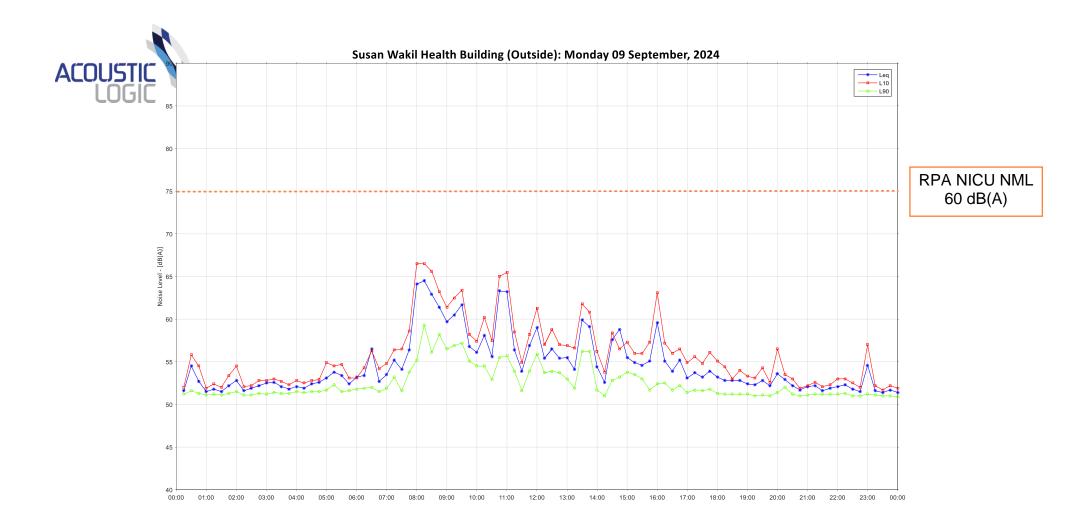
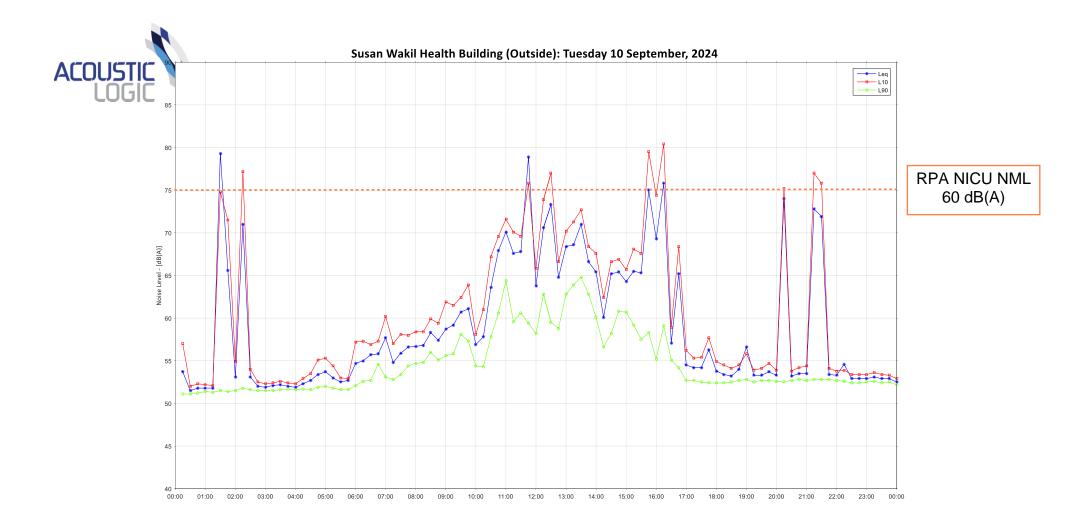
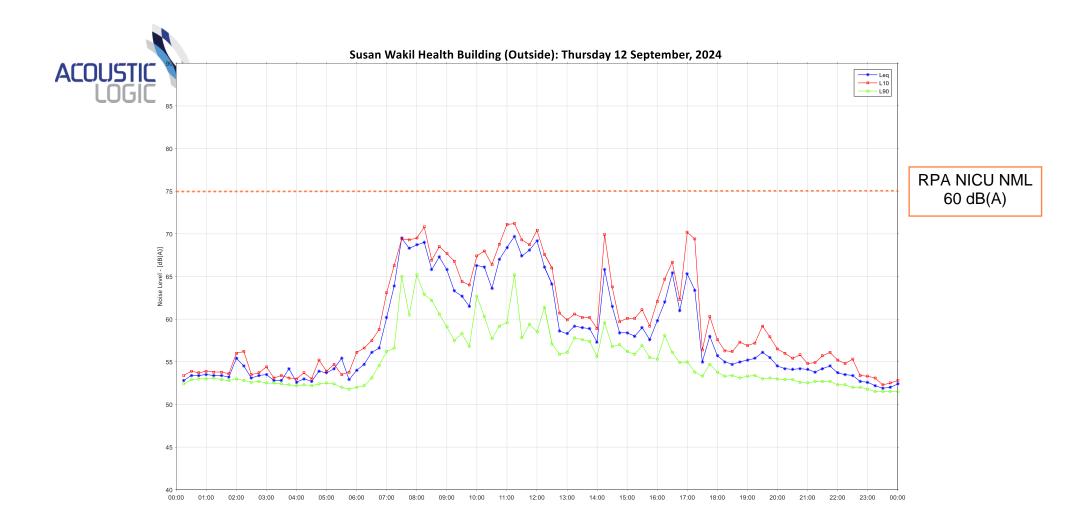
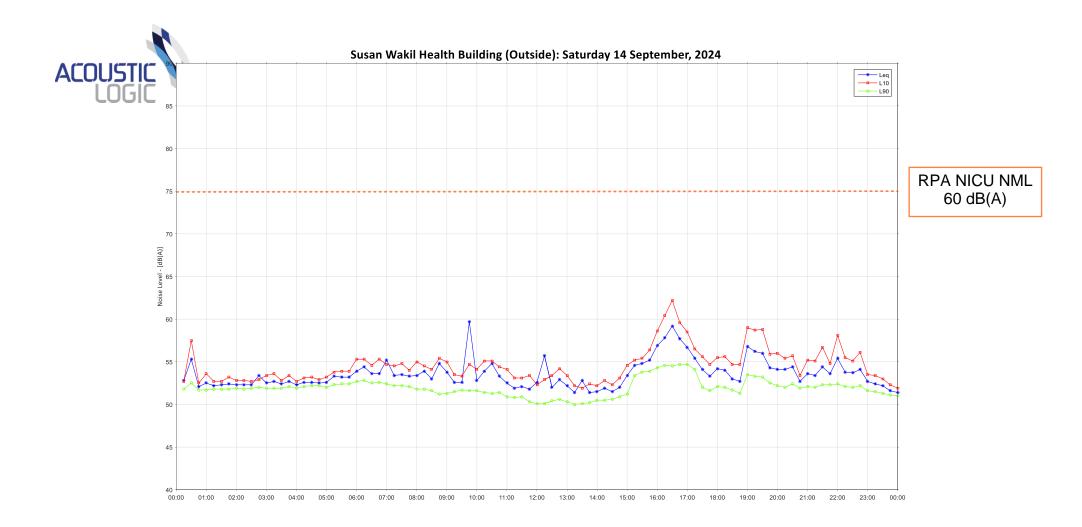
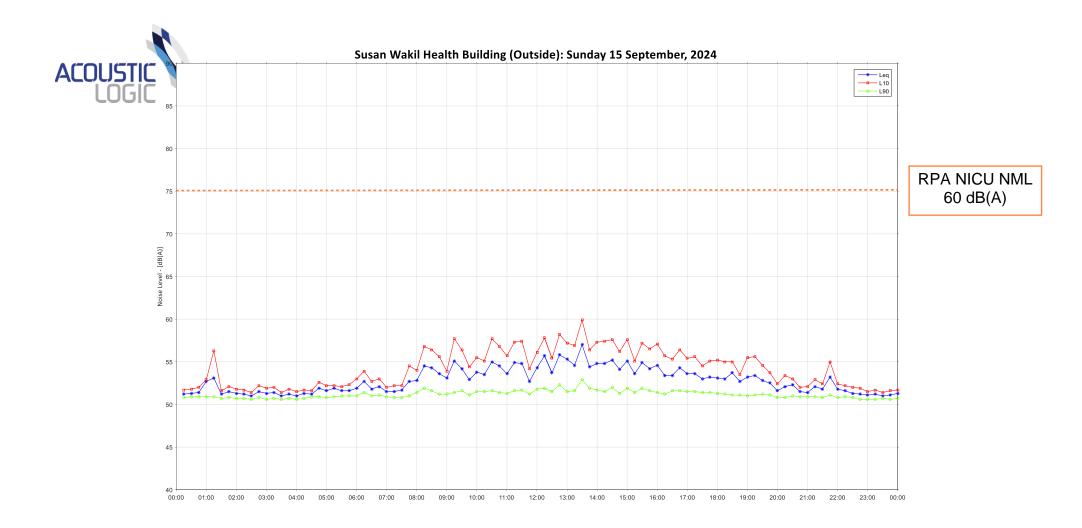
OUTSIDE SUSAN WAKIL HEALTH BUILDING

- Of the data collated during the monitoring period presented within the report, noise levels measured at the monitoring station were found to be above the Susan Wakil NML on the following dates:
 - o 03/09/2024
 - o **10/09/2024**
- Noise levels on the 8th September were on a Sunday at 6:30am, and so are not associated with construction works.
- Three fifteen-minute periods were above the NML on the 10th September, however 2 of these periods were outside of typical construction hours.
- As such, noise levels within construction hours were never observed to be above the NML for longer than one 15-minute period on any given day.
- Noise levels above the NML within construction hours were within 5 dB of the NML.
- Noise levels impacting Susan Wakil will be continued to be monitored throughout the early works construction to assess the impact to this receiver.

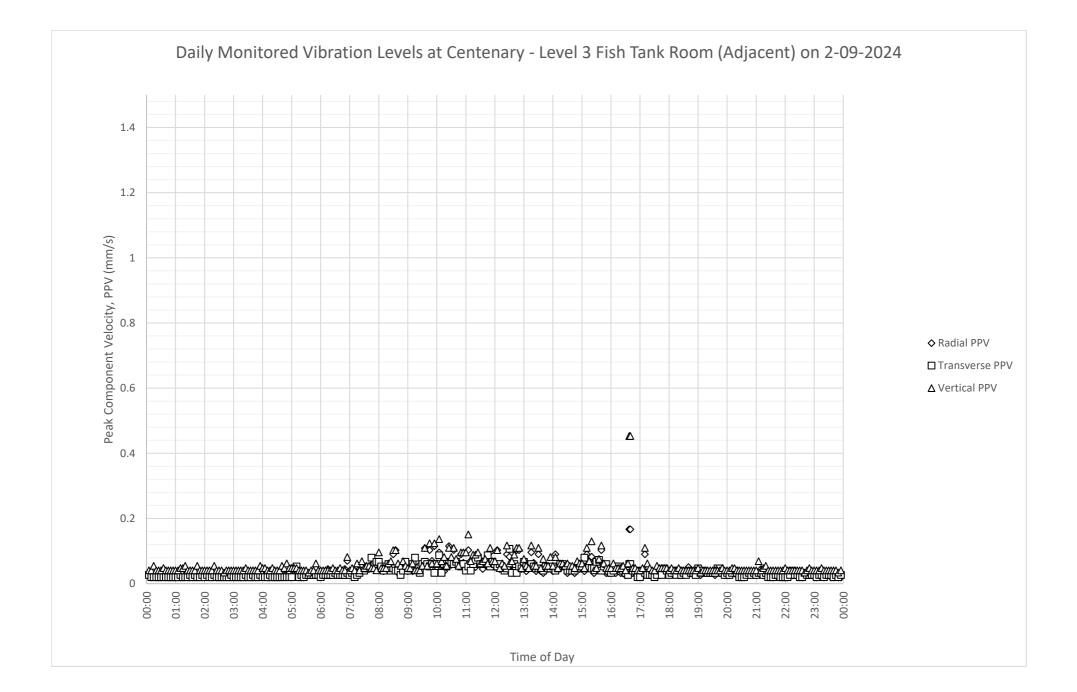
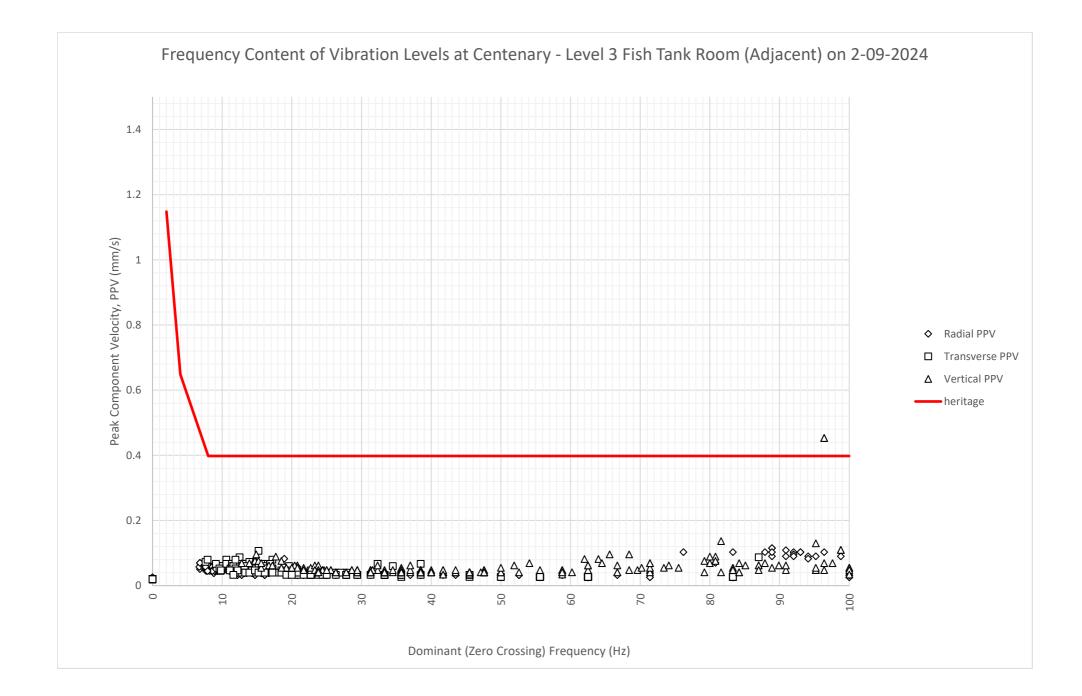
CENTENARY INSTITUTE – LEVEL 3 FISH TANKS

- Level 3 Fish Tanks:
 - One minor exceedance (<15%) on the 2nd September was measured at the Level 3 Fish Tank monitor at approximately 4:45PM. This exceedance occurred at 96.5 Hz.

- Due to the singular exceedance frequency being well above 80 Hz it is unlikely this exceedance was due to construction.
- Level 4 Surgery Room (Southern Façade), Clean Changeroom (Southern Façade) and Bathroom (Northern Façade):

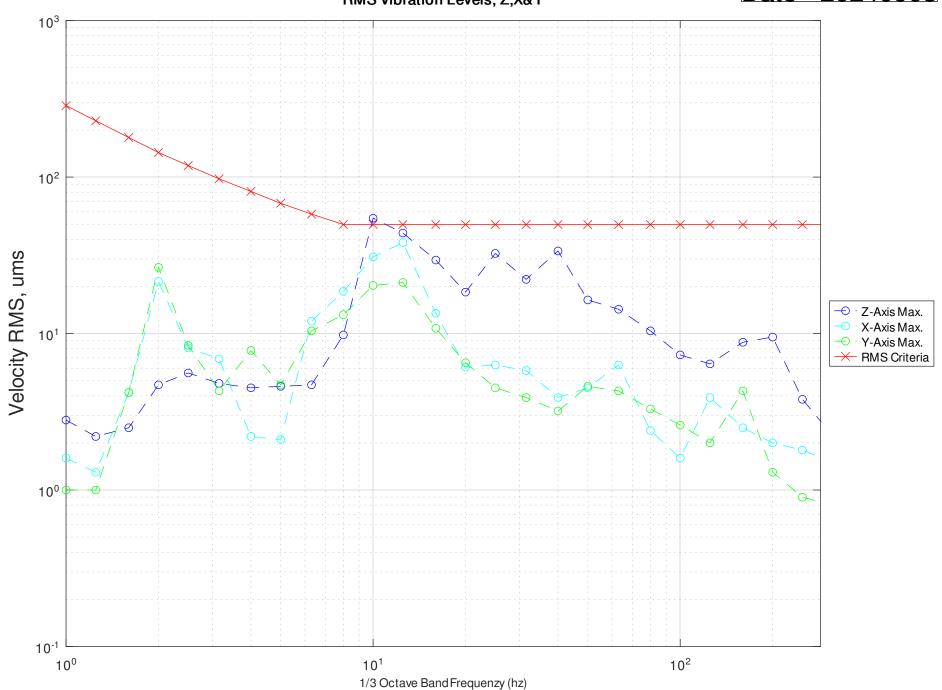
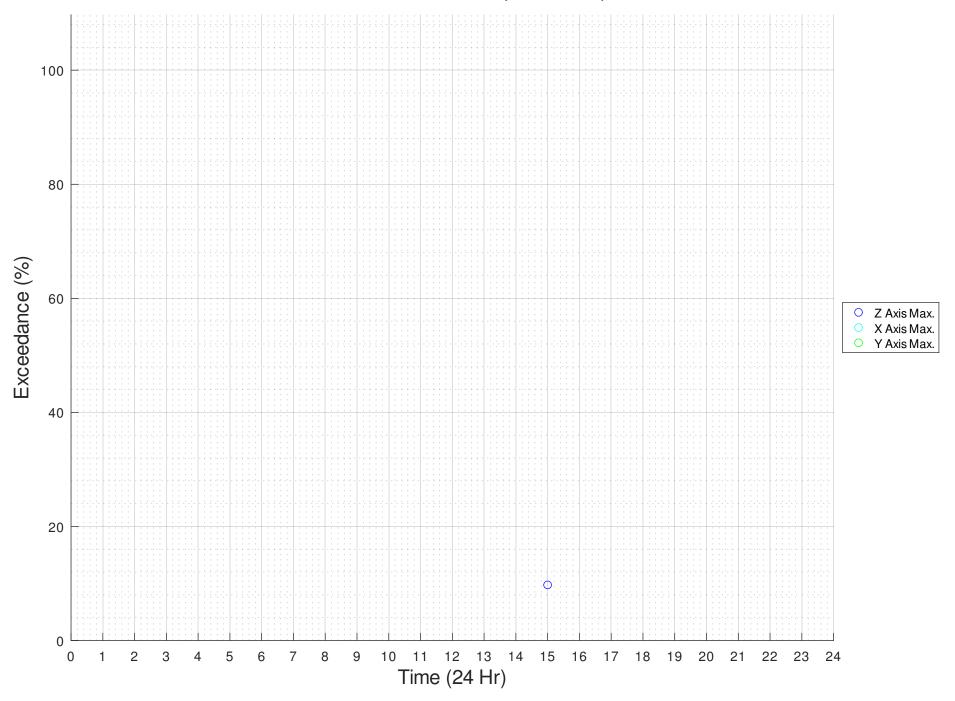
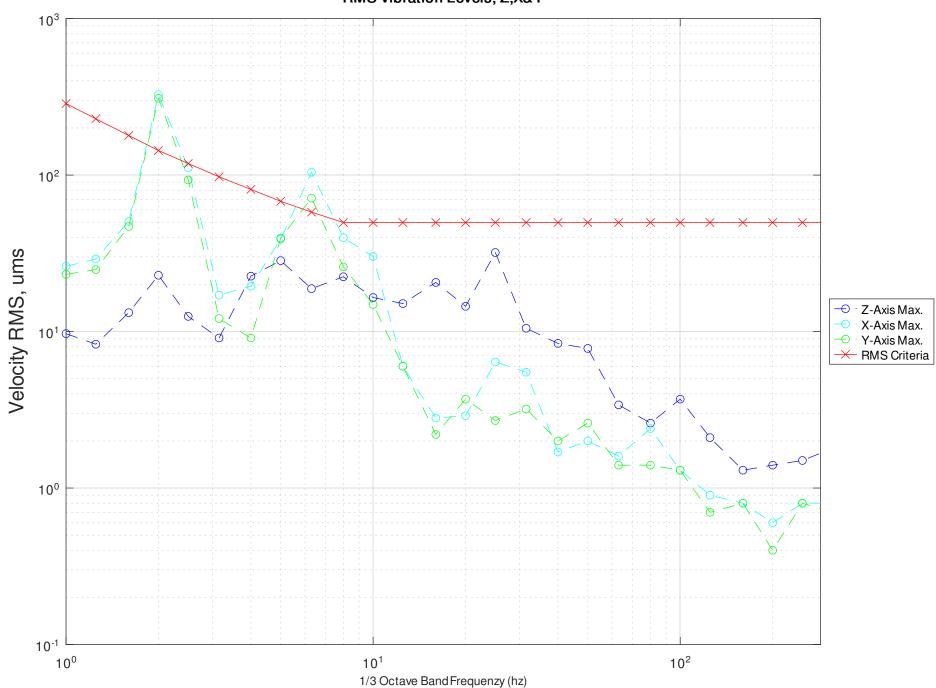
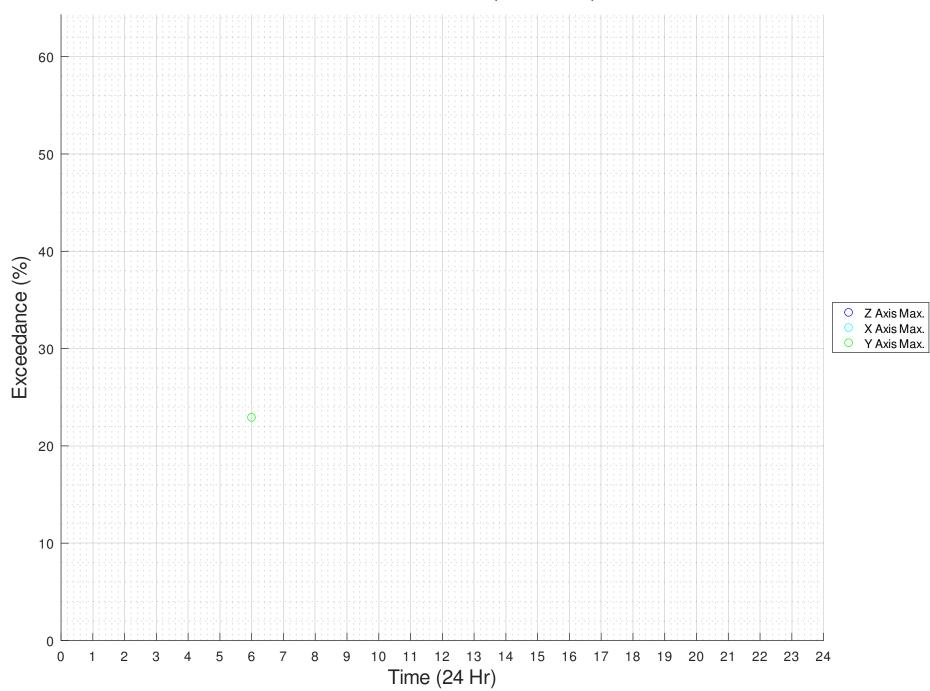
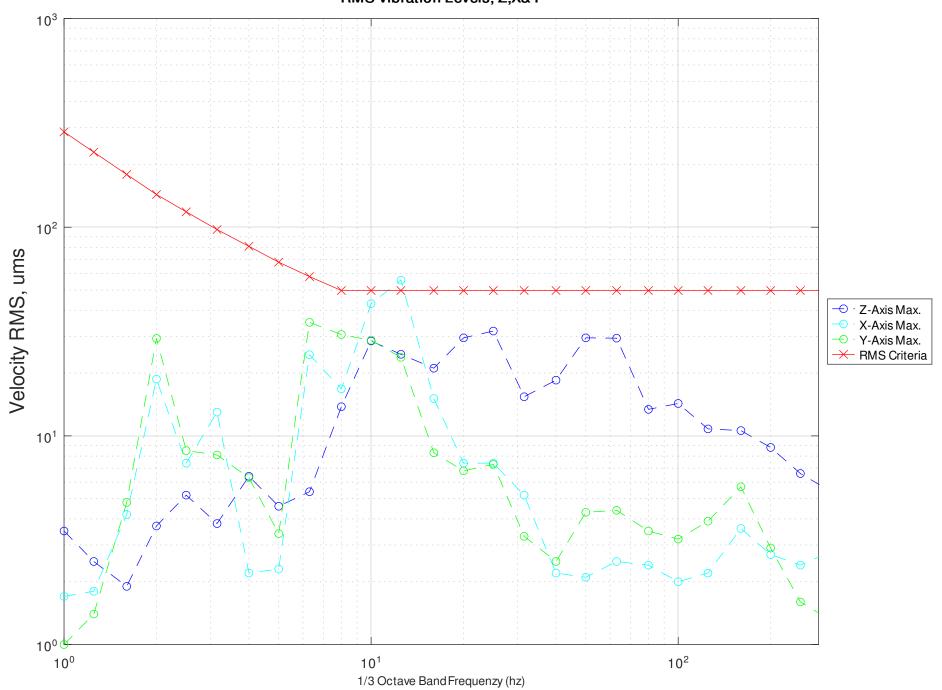
CENTENARY INSTITUTE – LEVEL 4 SURGERY ROOM (SOUTHERN FAÇADE)

- Both the Changeroom and Surgery Room monitor (Southern Façade) recorded minor exceedances on the 7th September 2024 outside of construction hours.
 - The Surgery room recorded minor maximum exceedances of the criteria of 15% or less during construction hours on the 5th and 10th September.

- Generally, of the measured exceedance events within the monitoring period from any of the monitoring stations on the L4 floorplate, many of these measured exceedances for the period would be considered marginal exceedances (<20% of applicable criteria.)
