Royal Prince Alfred Hospital Redevelopment (RPAH Redevelopment)

Construction Noise and Vibration Monitoring Report 20

Client Doc. No. RPA-ACO-ACL-RPT-MW-000023 - Rev A

Project ID	20230239.17
Document Title	Construction Noise and Vibration Monitoring Report
Attention To	CPB Contractors Pty Limited

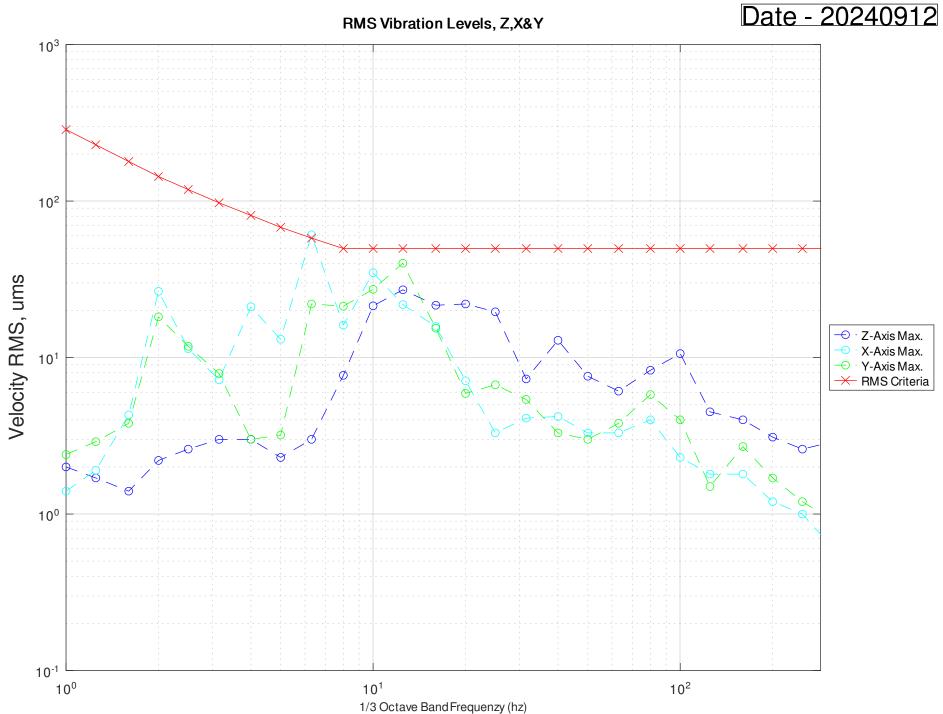
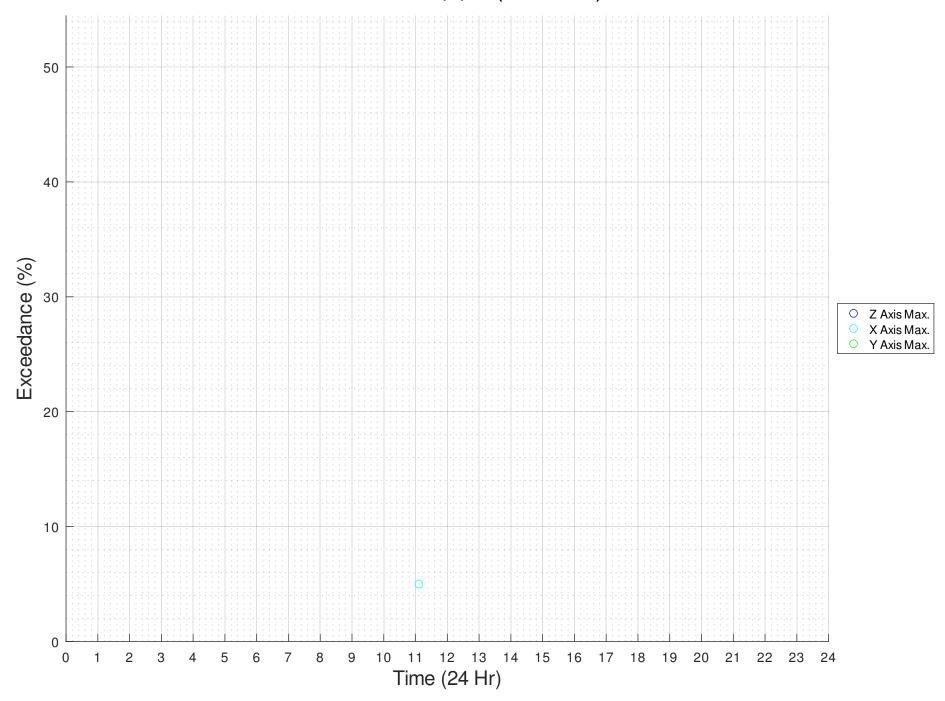
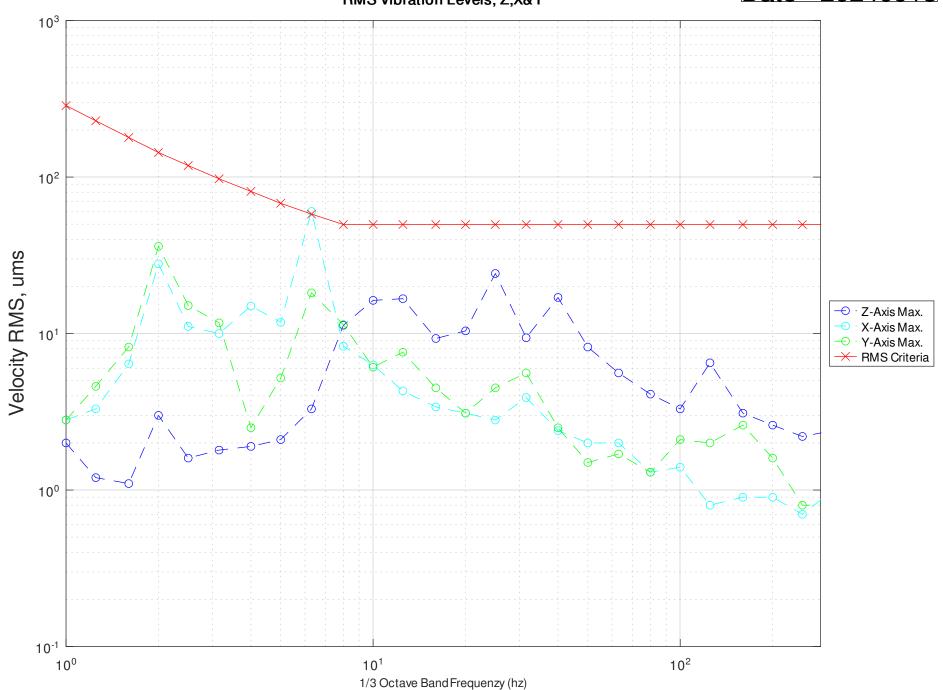
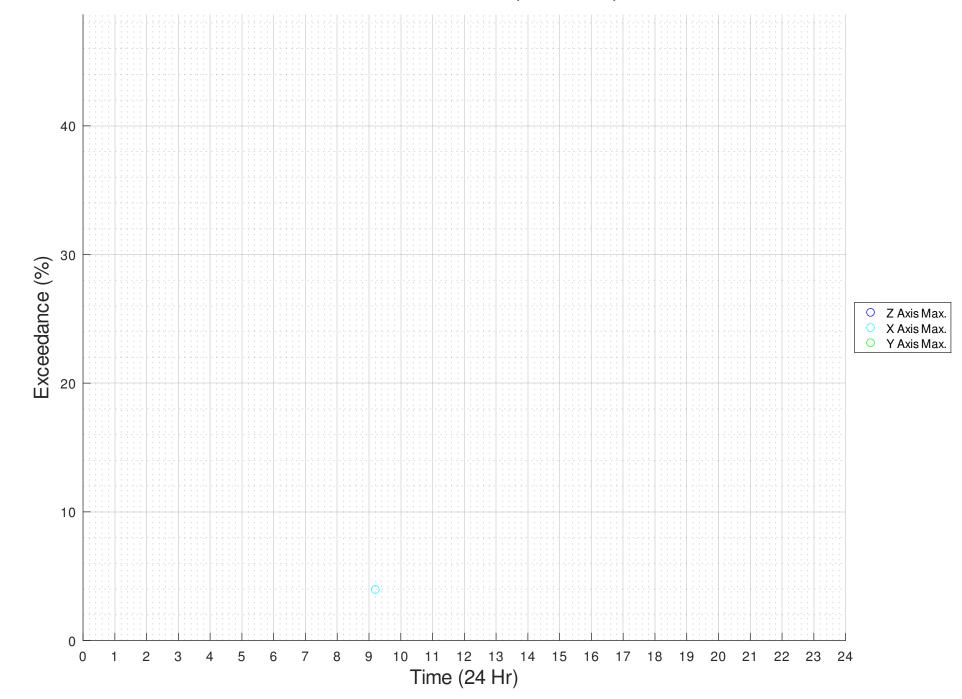
CENTENARY INSTITUTE – LEVEL 4 BATHROOM (NORTHERN FAÇADE)

- The Clean Changeroom measured a maximum exceedance of the criteria of 36% at approximately 7:50am on the 2nd September 2024.
 - The Northern Bathroom monitor recorded maximum exceedances of the criteria during construction hours of less then 10% on the 12th and 15th September.

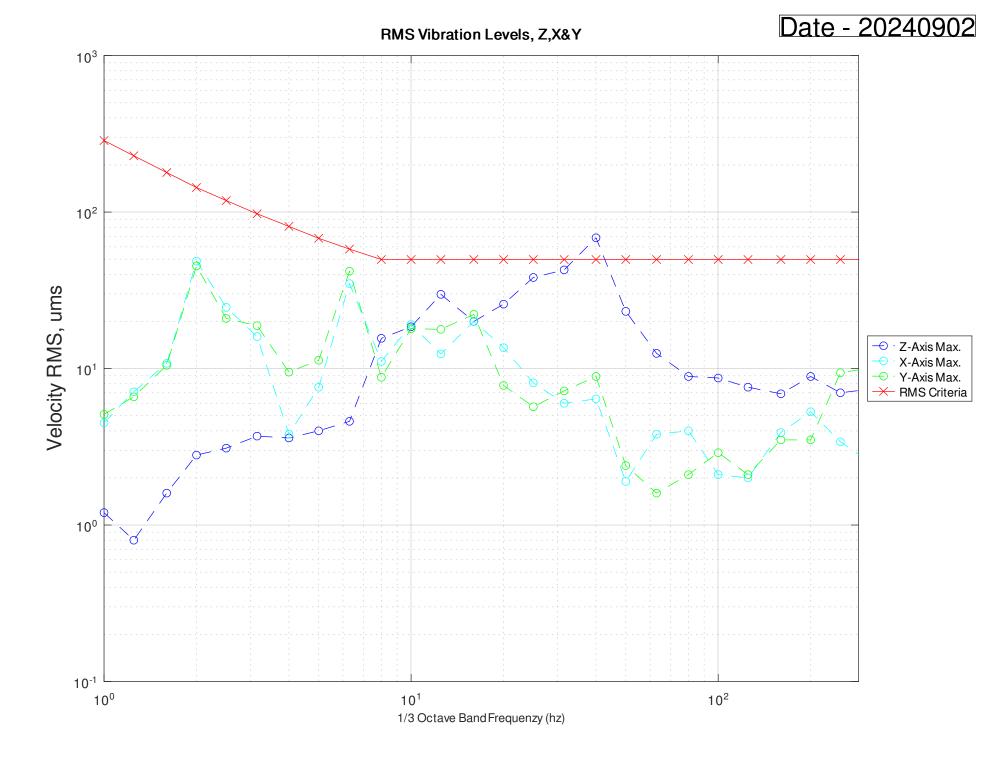
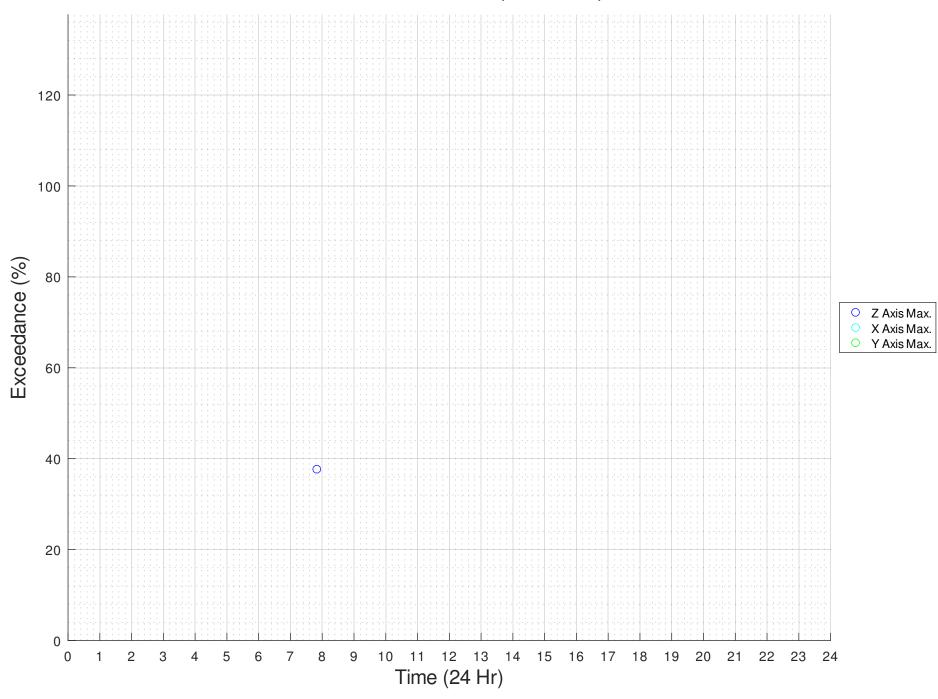
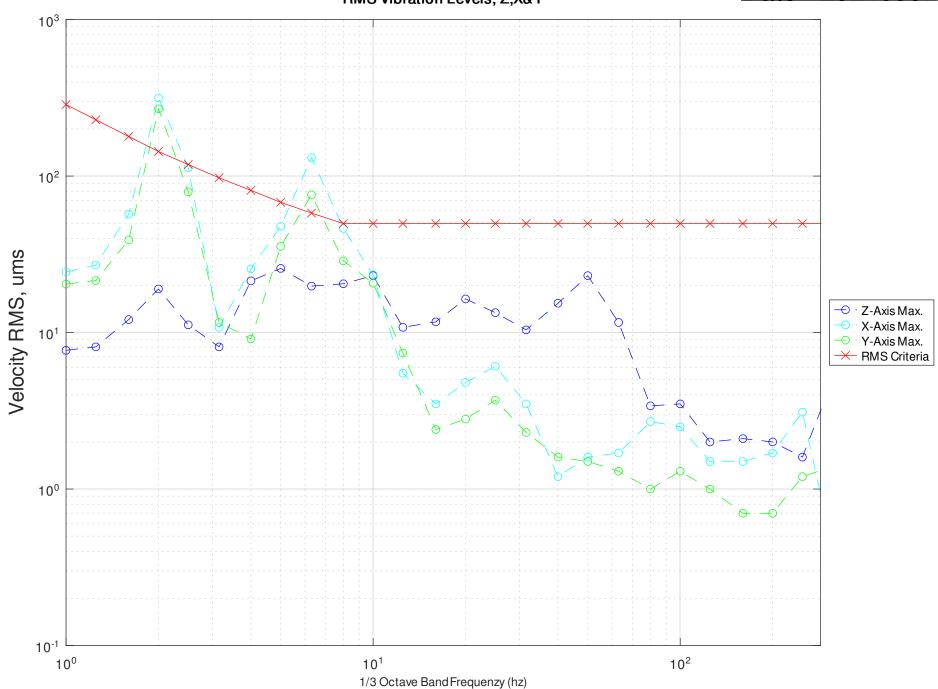
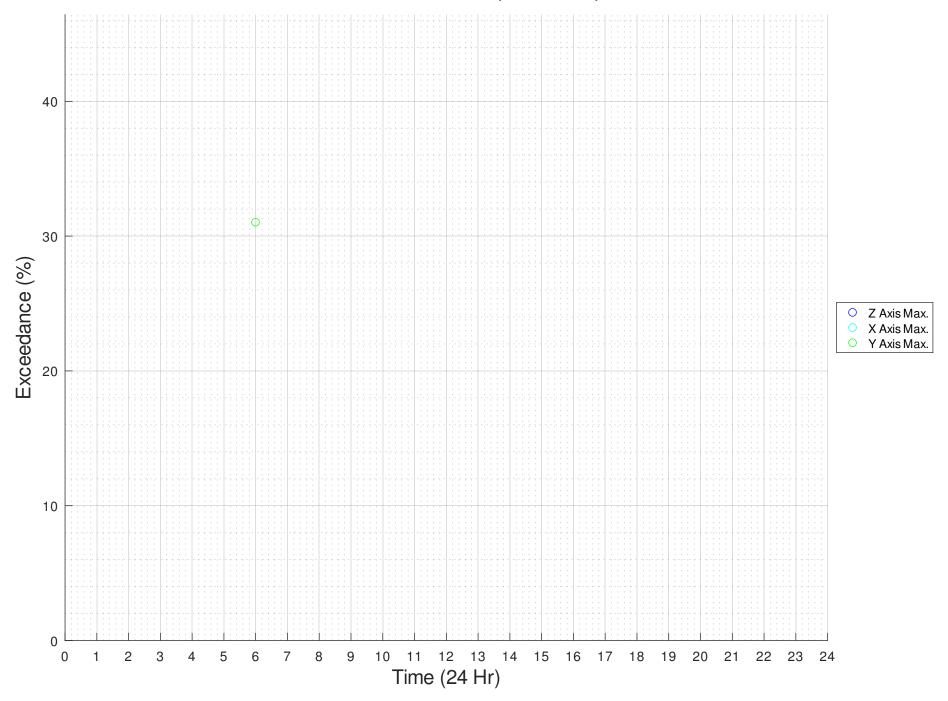
CENTENARY INSTITUTE – LEVEL 4 CLEAN CHANGEROOM (SOUTHERN FAÇADE)

- Both the Changeroom and Surgery Room monitor (Southern Façade) recorded minor exceedances on the 7th September 2024 outside of construction hours.
 - The Surgery room recorded minor maximum exceedances of the criteria of 15% or less during construction hours on the 5th and 10th September.

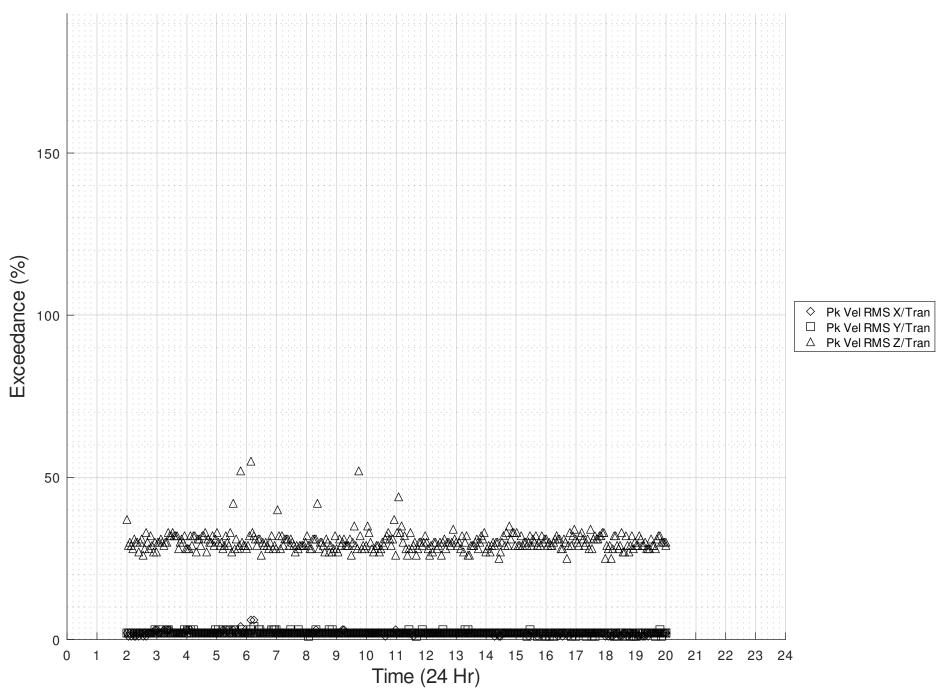
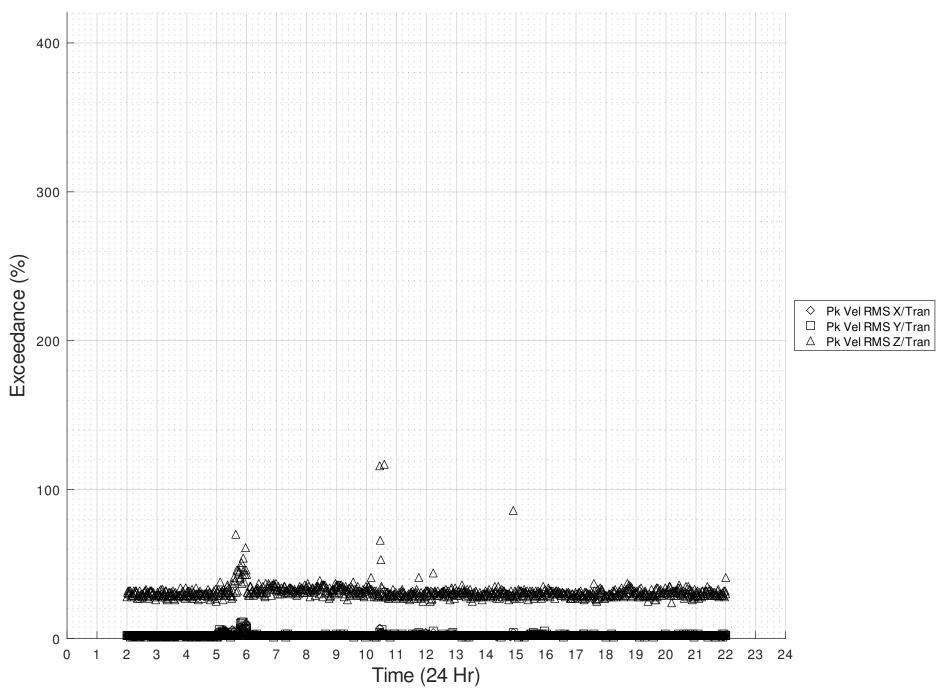
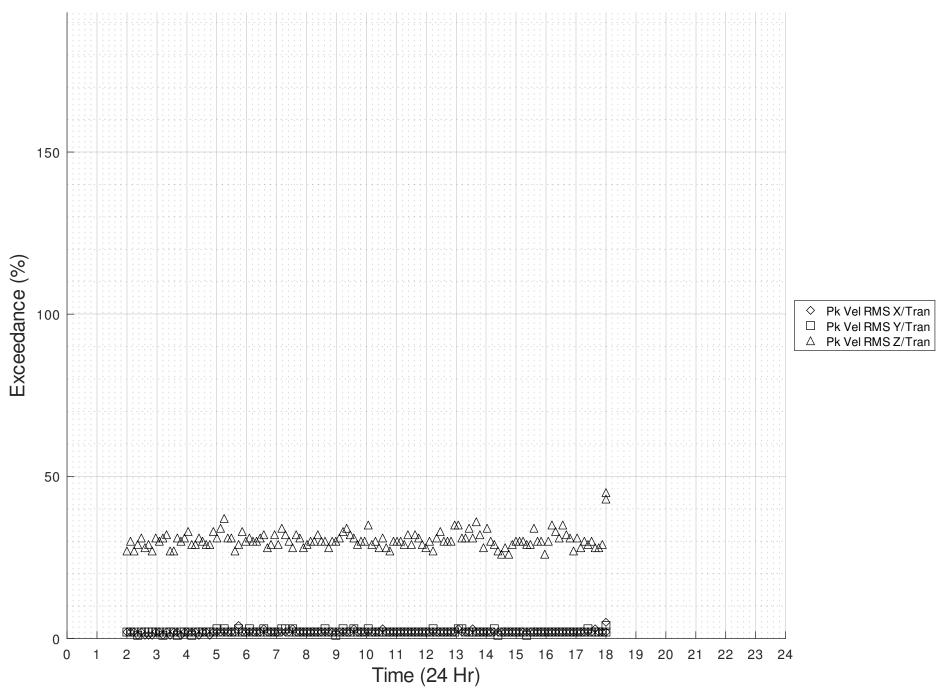
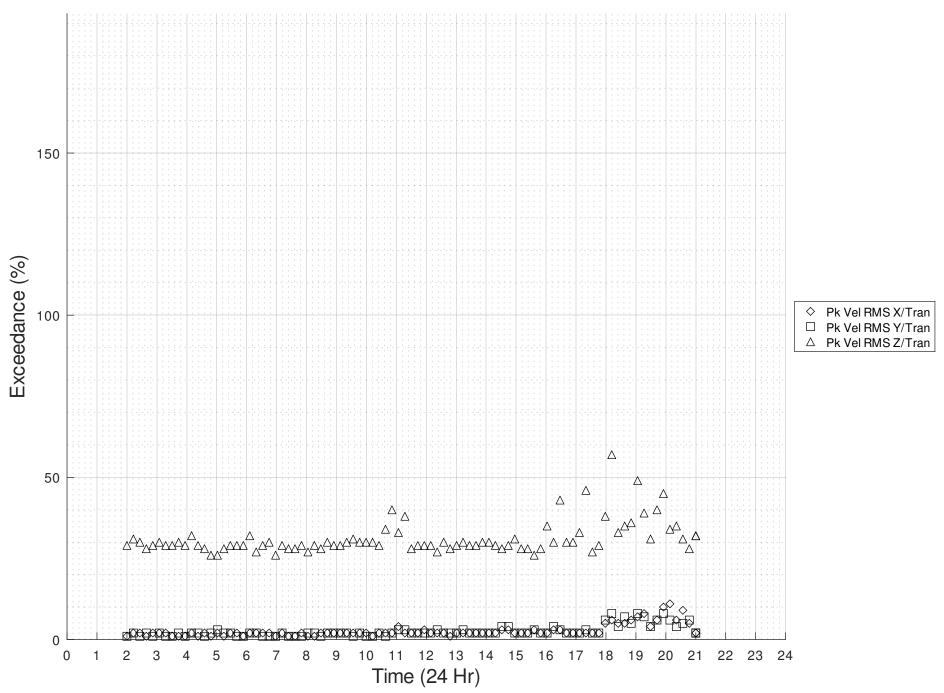
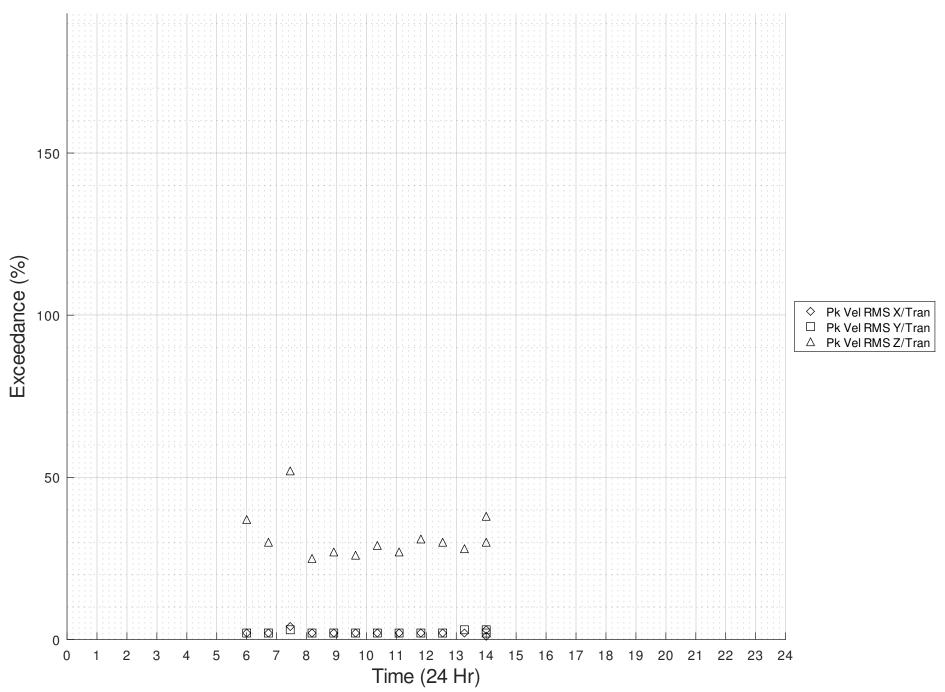
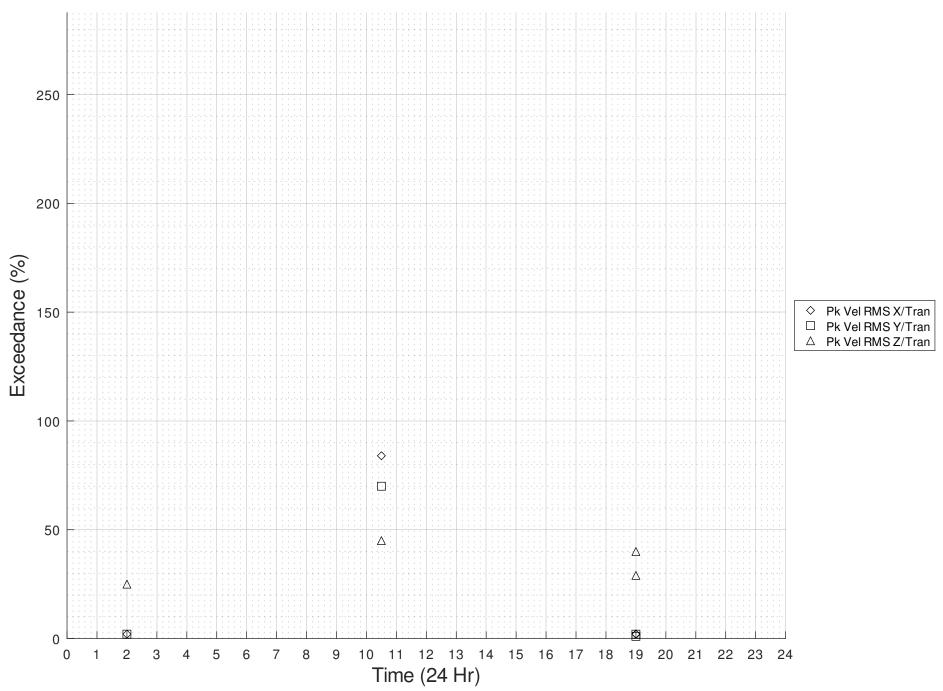
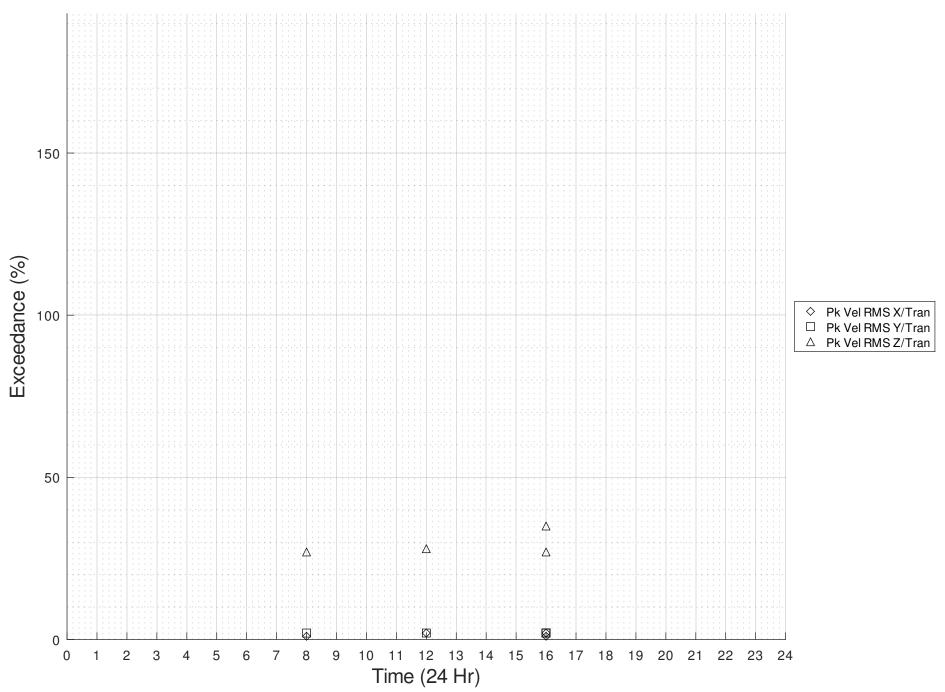
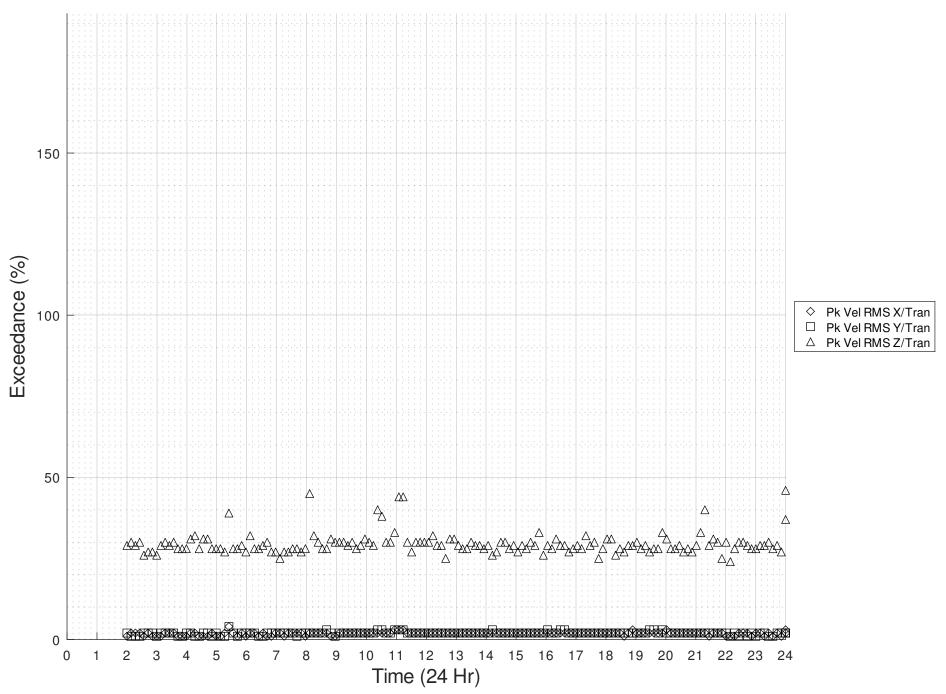
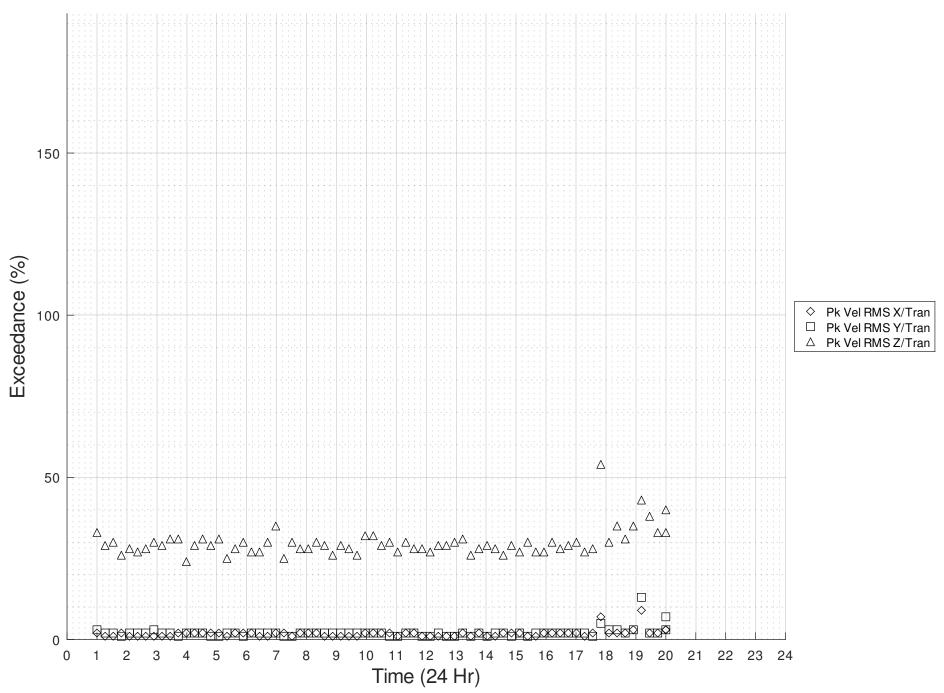
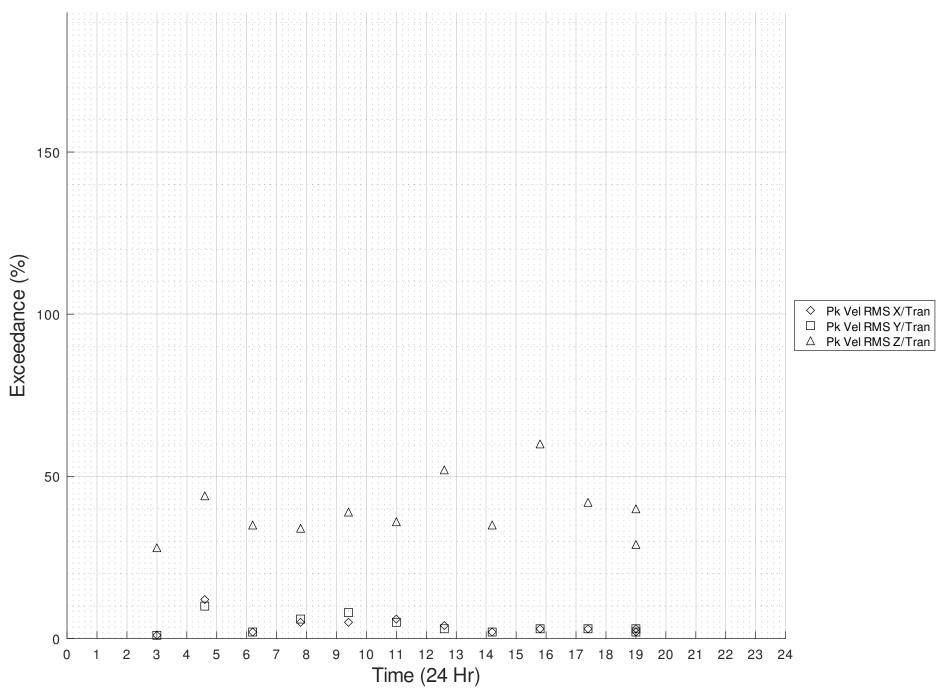
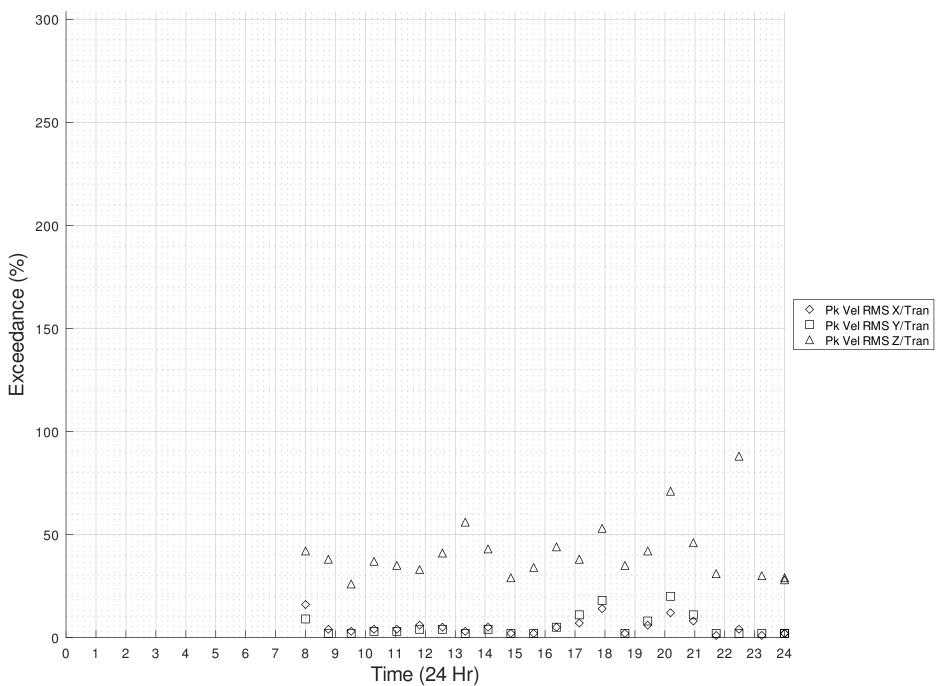
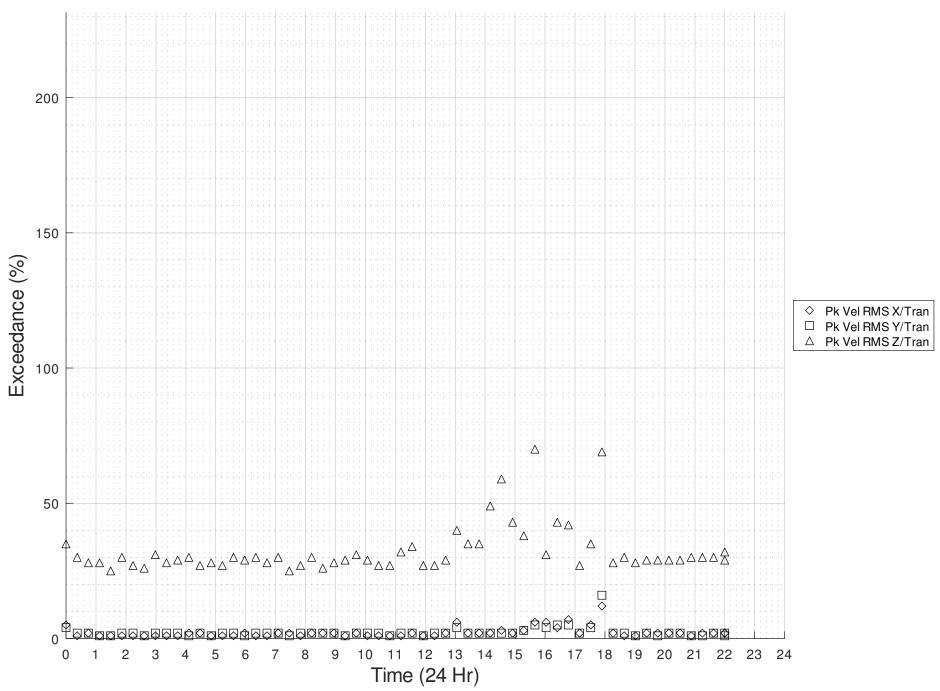
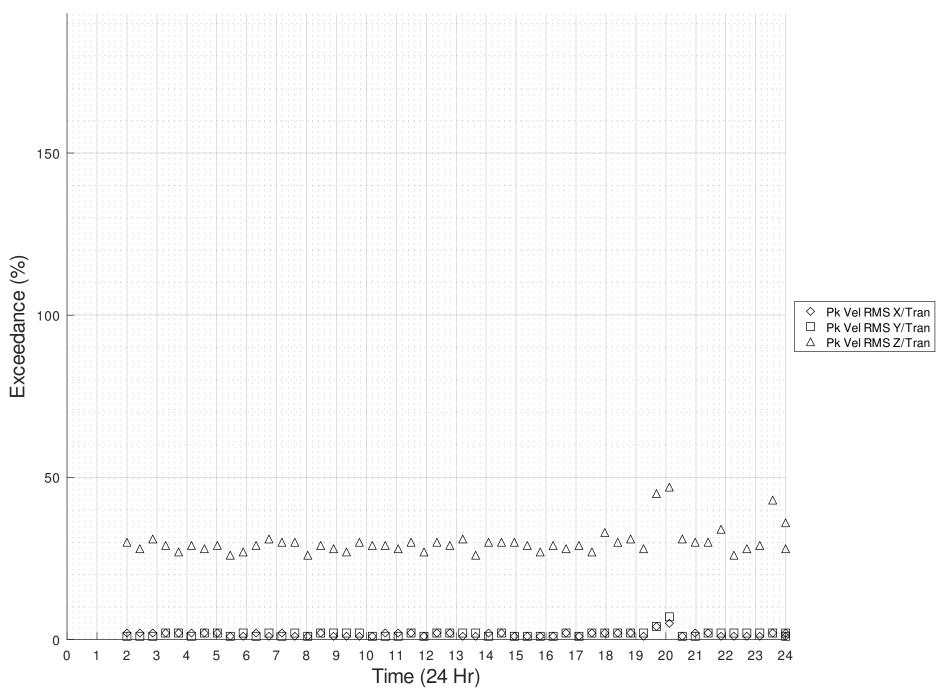
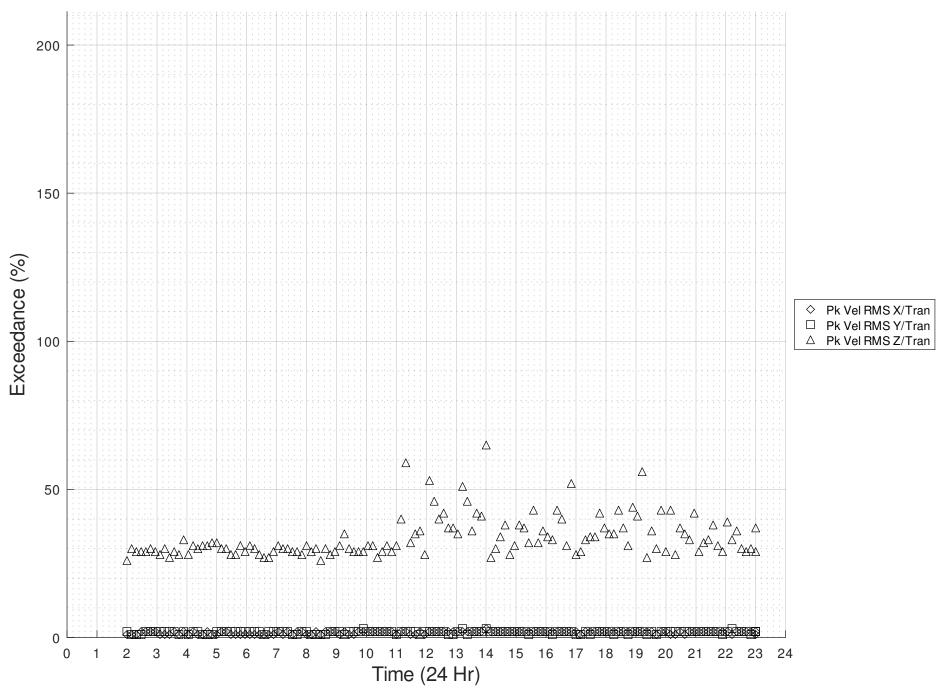
CHARLES PERKINS CENTRE – LEVEL B1 SOUTHERN CORRIDOR

- Southern Corridor (Imaging):
 - Exceedances of B2 VC-B criteria which display characteristics consistent with construction activity were observed at the monitoring station on all dates over the monitoring period.

- Exceedances are generally within 30% of the conservative VC-B criteria.
 - The maximum level measured during the monitoring period was 120µms⁻¹ on 03/09/2024.

- Exceedances are generally observed at 12.5Hz, likely to be the natural frequency of the CPC suspended slab. Exceedances at frequencies exclusive of 12.5Hz, 16Hz and 20Hz are rarely observed.

- Previous site investigation has determined that exceedances throughout the monitoring period were associated with the use of tracking excavators along Lambie Dew Drive adjacent to CPC.

- When comparing the results of the B2 monitoring location with other surrounding monitors, we note that the B2 monitor is located on a suspended slab, and hence it is possible that significant amplification of the vibration impacts from these works is occurring and resulting in exceedances at the monitoring location.

- For many of the measured exceedances there is a lack of correlation between the southern corridor monitor and the other monitoring stations surrounding the project site. Therefore, it is likely that some or most of these spikes have been caused by factors exclusive of the construction activity within the RPA Hospital project area.

- It is prudent to note that CPC is undergoing a façade refurbishment exclusive to the scope of the construction activity assessed within this report, and it is likely that these works attributed to some of the exceedances observed throughout the period.

- It is also prudent to note that there were significant exceedances observed within the monitoring period which were outside of hours of works throughout the period, noting that various repeated exceedances were observed after 5.00pm and on weekend days during the period. These events have not been attributed to the impacts of the construction.

- With respect to hammering, the attachment size of the hammer has been reduced where practical in order to reduce the overall force impact of the works, reducing the level and frequency of exceedances observed from the use of this item throughout the monitoring period.

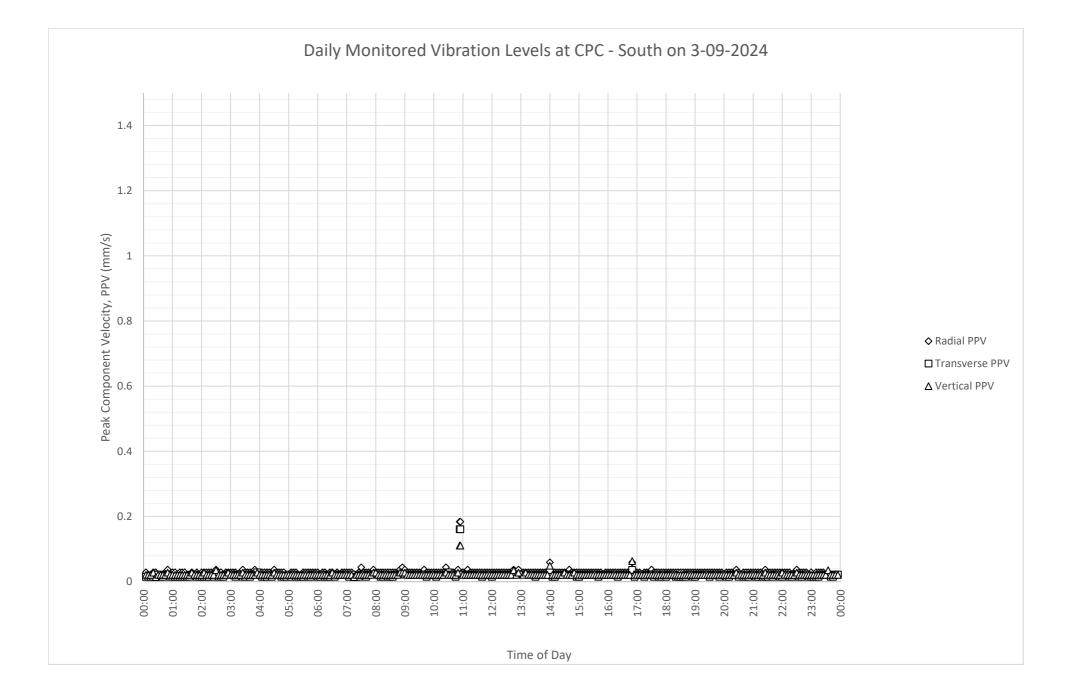
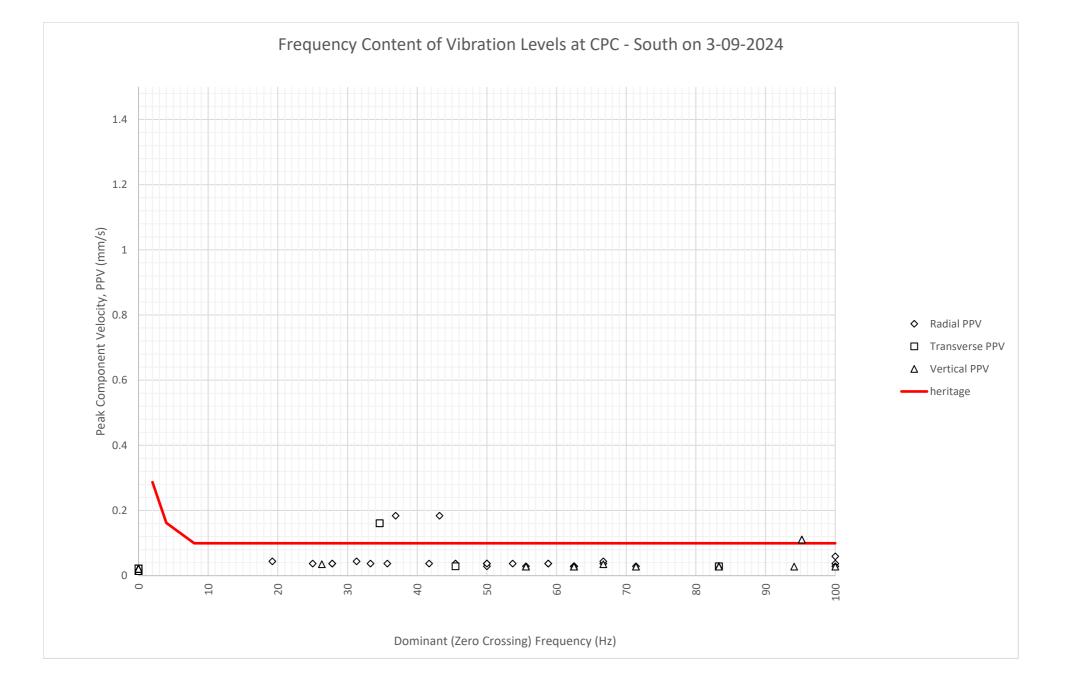
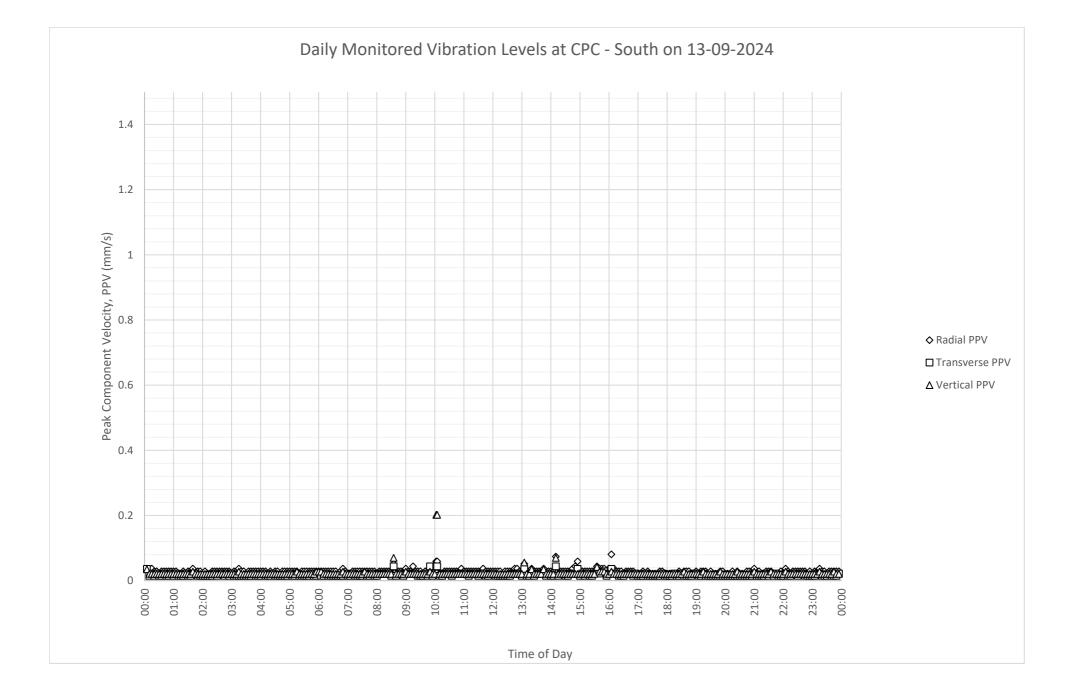
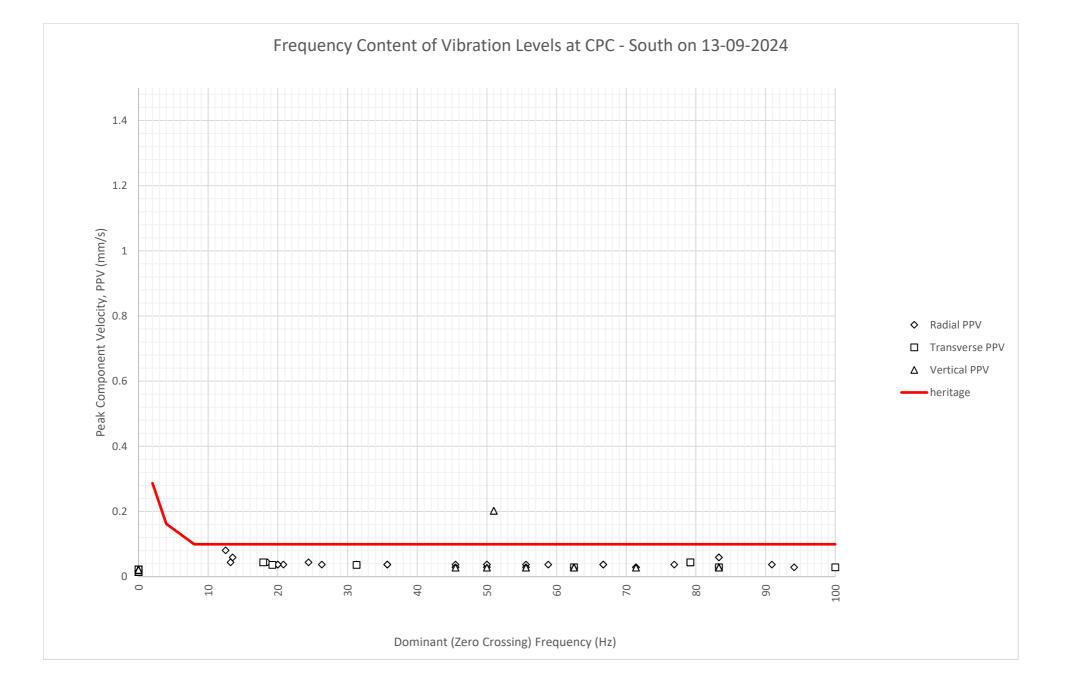
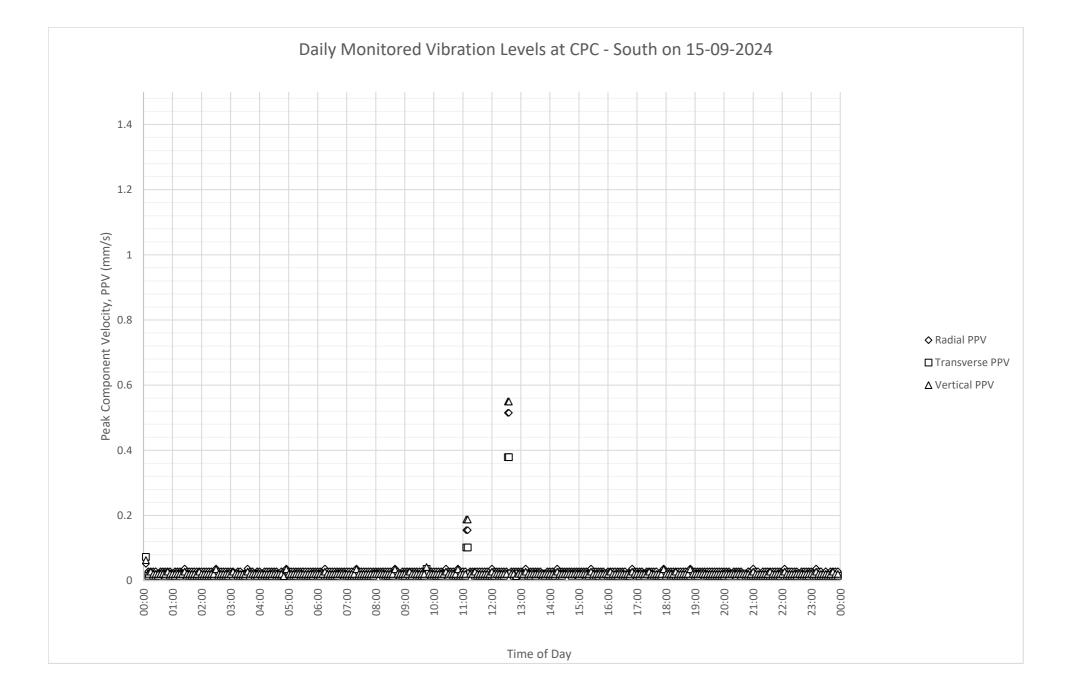
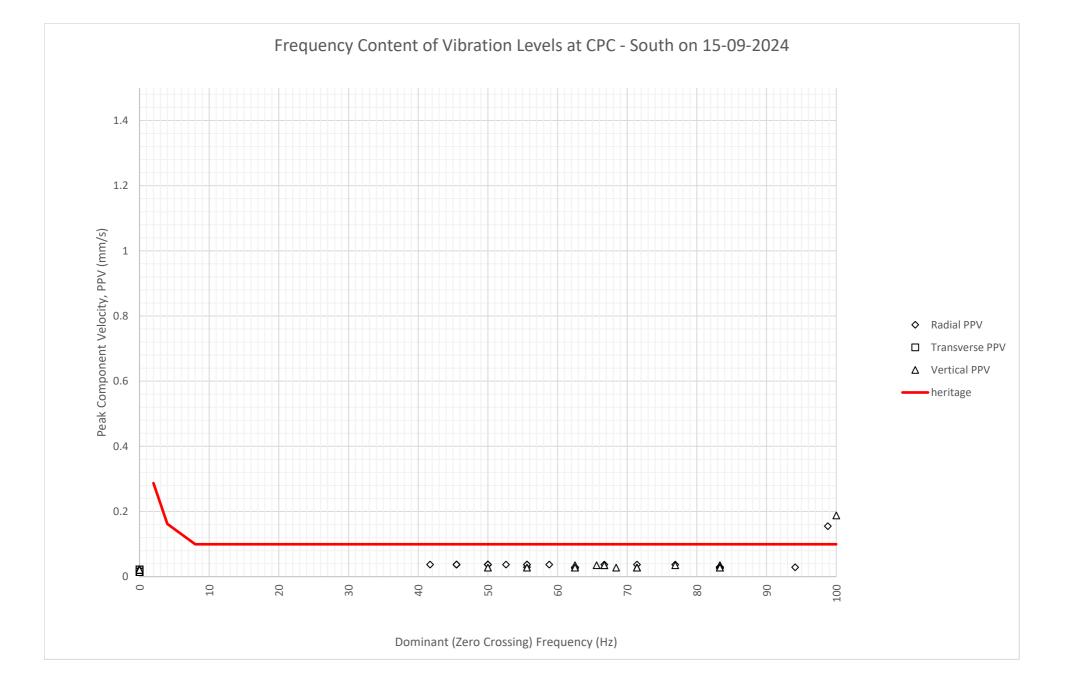
CHARLES PERKINS CENTRE – LEVEL B1 SOUTHERN WING OBSERVATION ROOM CORRIDOR

- Observation Room E (Adjoining corridor):
 - An exceedance of the PPV trigger level of the Texcel monitor within the animal testing facility was observed on the following dates:

- 03/09/2024
 - 13/09/2024
 - The more sensitive BnK monitor located within the observation room E corridor did not detect these events.
 - This is not indicative of construction vibration, noting that construction-borne vibration would be expected to impact the monitors equally and similar results would be measured.

- As the Texcel monitor is operating at it's floor of measurement, it is possible that a small
 perturbation measured by both of the monitors was artificially inflated by the Texcel
 monitor due to it's relatively lower accuracy and the relatively low vibration levels
 measured.

- Alternatively, this may have been caused by operational activity within the facility such as a step or a trolley movement, which occurred closer to the texcel monitor however did not register an exceedance at the B & K monitor.

- Also, the measured exceedances were recorded at frequencies which do not align with the resonant frequency response frequency for the animal's abdomen (27-29Hz), and hence the impacts of these measured values would be less perceivable to the animals than compared with measured values at frequencies closer to those listed above.
