Royal Prince Alfred Hospital Redevelopment (RPAH Redevelopment)

Construction Noise and Vibration Monitoring Report 20

Client Doc. No. RPA-ACO-ACL-RPT-MW-000023 - Rev A

Project ID	20230239.17
Document Title	Construction Noise and Vibration Monitoring Report
Attention To	CPB Contractors Pty Limited

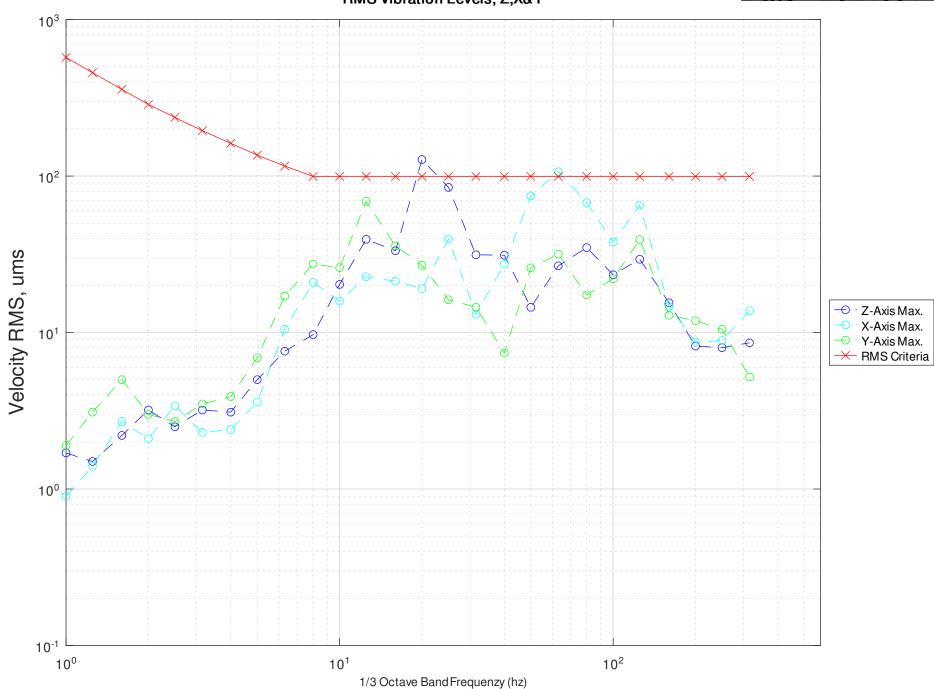
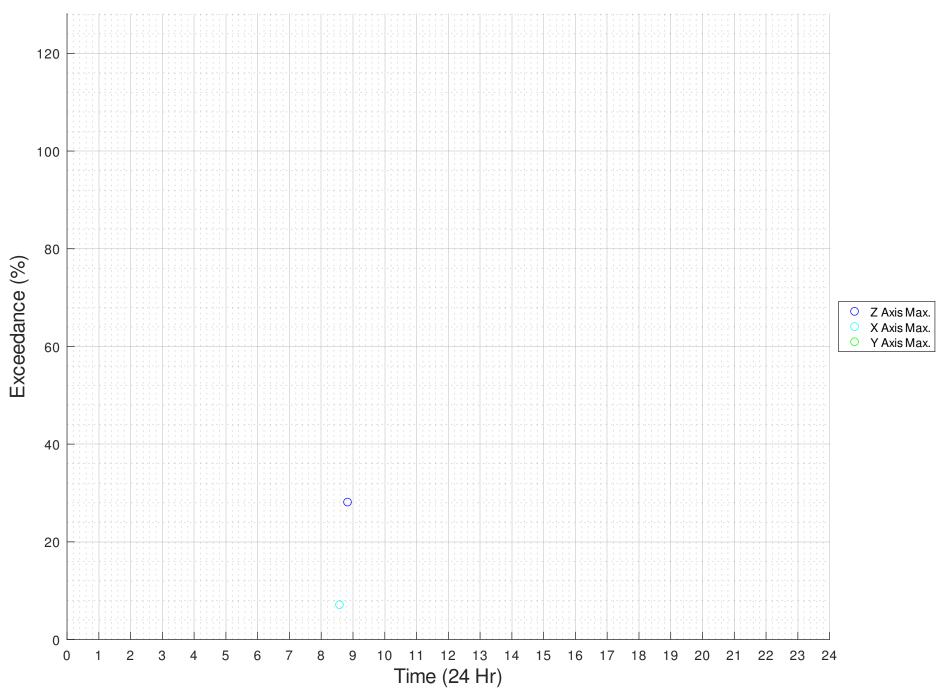
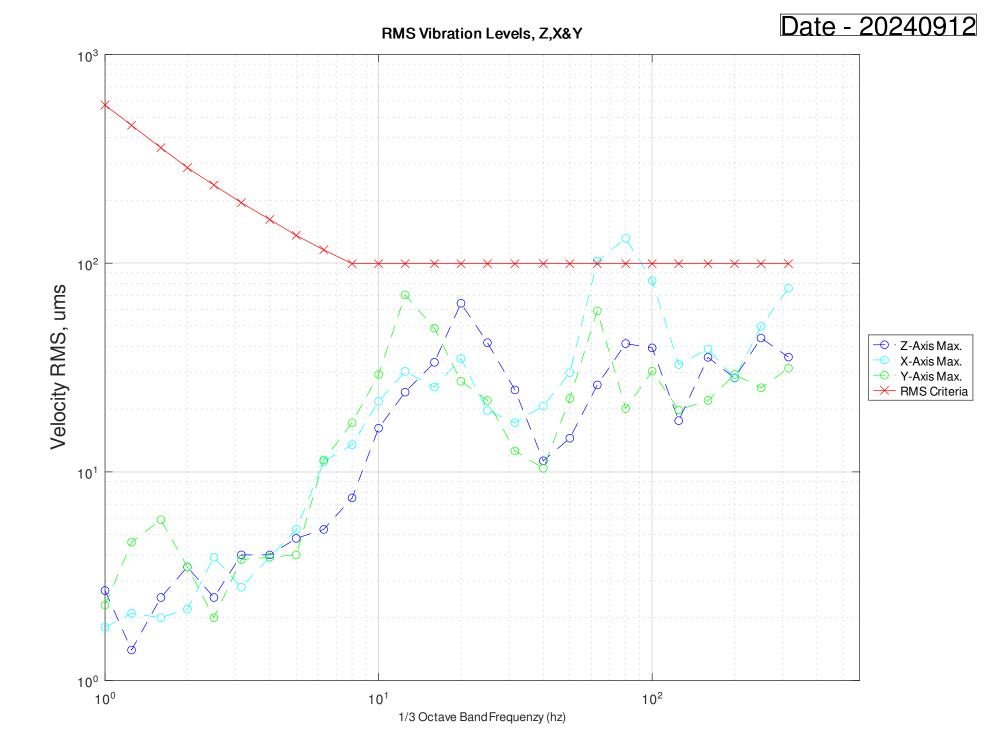
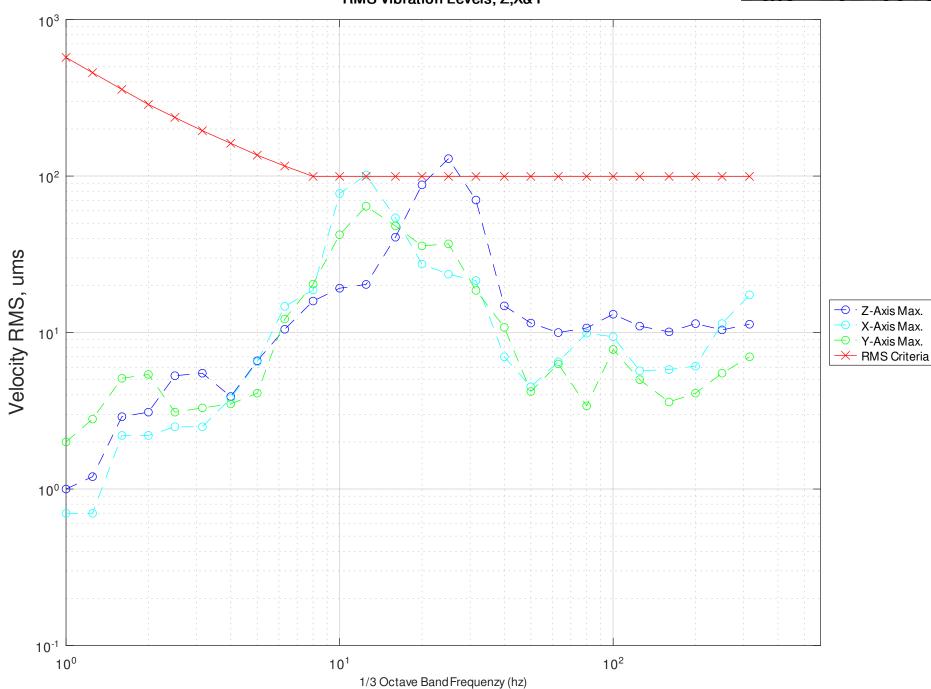
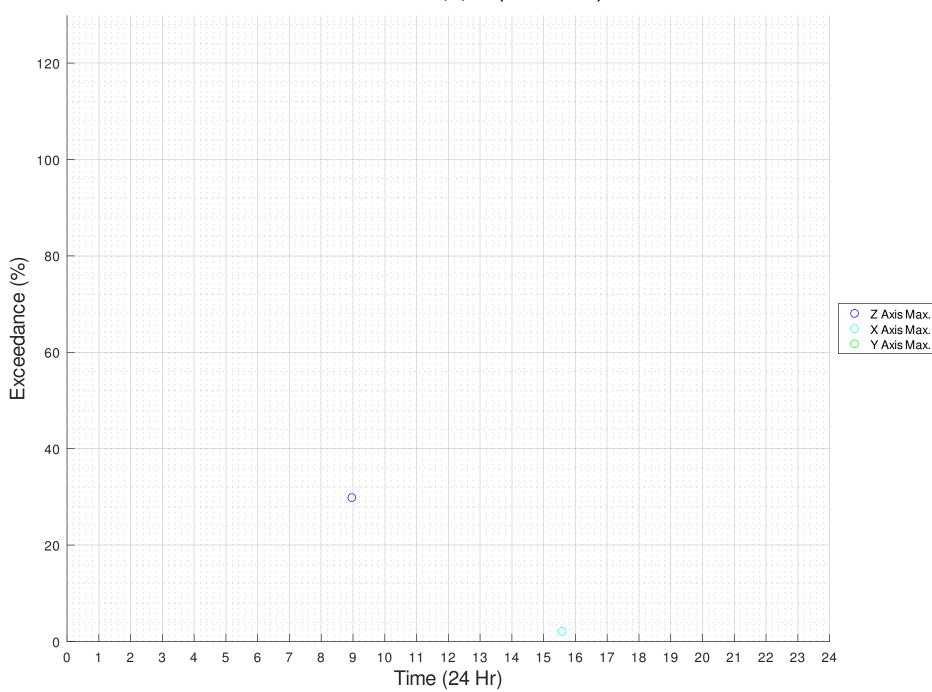
RPA HOSPITAL MAIN BUILDING – LEVEL 03 NICU

- Level 03 NICU:
 - Minor exceedances (35% or less) over the NICU 100µms⁻¹ criteria were measured on the 11/09/2024, 12/09/2024 and 13/09/2024.
 - No further exceedances were measured throughout the monitoring period.
 - Impacts of vibration will continue to be monitored within the L3 NICU floorplate to ensure vibration levels are within satisfactory limits.
