Preliminary Asbestos Clearance Certificate

Report Number: 40-15650-02-CL

Site Address: Ryde Hospital, Denistone Rd, Eastwood NSW 2122

Removal of asbestos containing-material (ACM) in the form of fibre cement sheeting from nominated locations to building 18 of the site located at Ryde Hospital, Denistone Rd, Eastwood NSW 2122

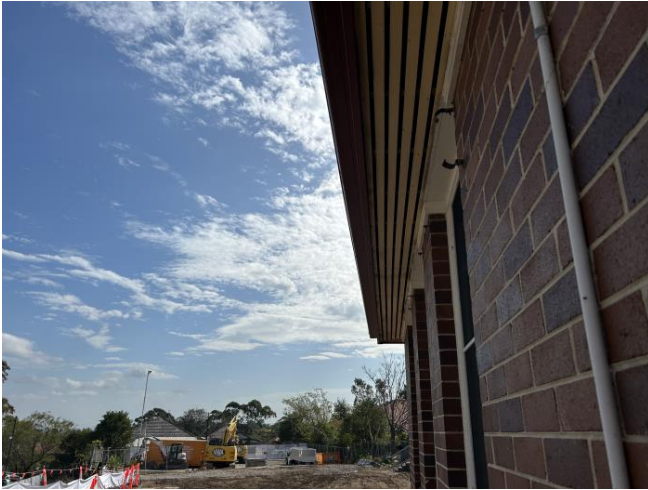
Photograph 1:

Representative photo of the footprint of former southern eaves of eastern corner of building 18 after completion of the current scope of works.

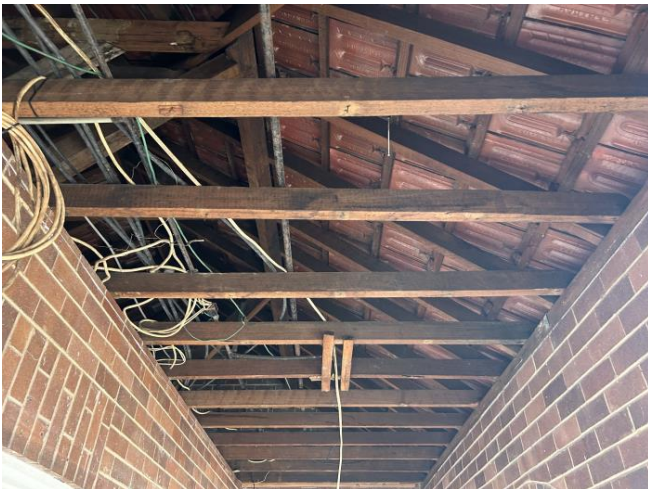
Photograph 2:

Representative photo of the footprint of former northern eaves of eastern corner of building 18 after completion of the current scope of works.
