Ecological Statement – Targeted Yangochiroptera inspection, Building 19, Ryde Hospital

Attachment 1. Photographic record of the building inspected
(photographs taken 06/09/2024)

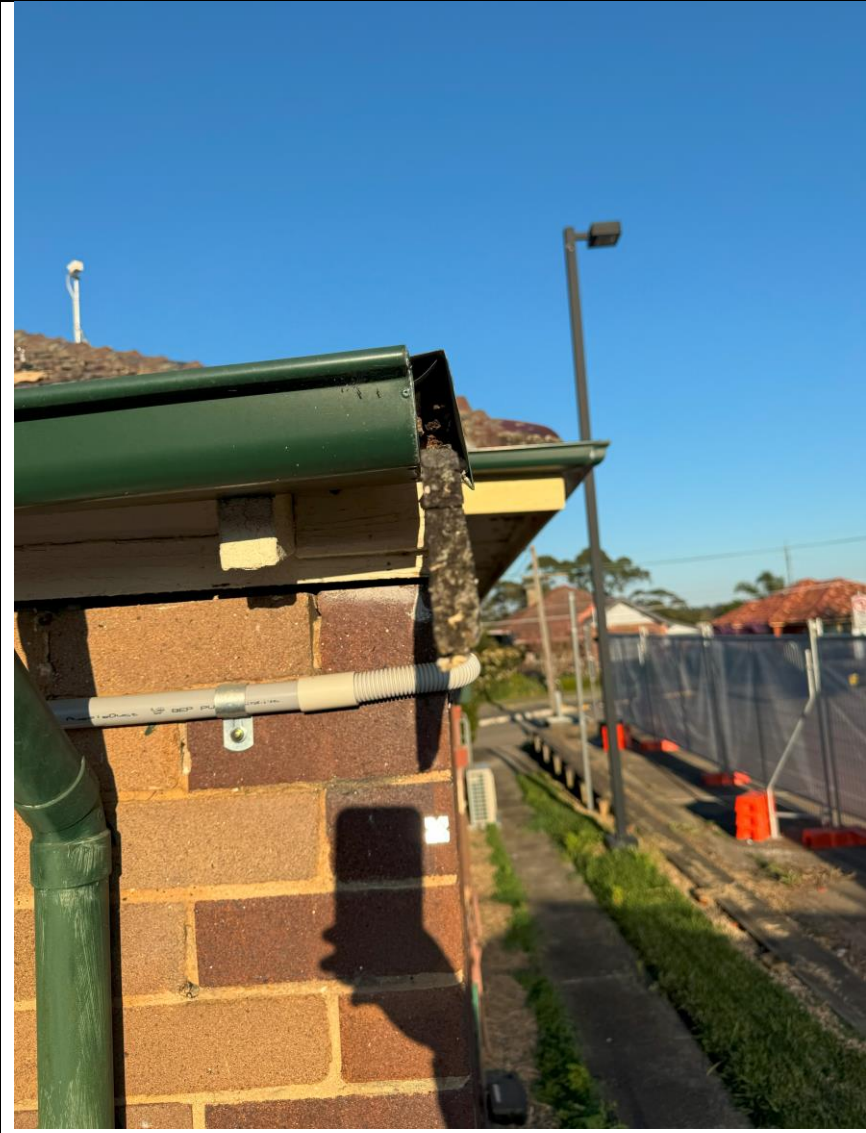
Plate 1: Example of a potential microbat roosting cavity observed in the external roof overhang of the building surveyed.

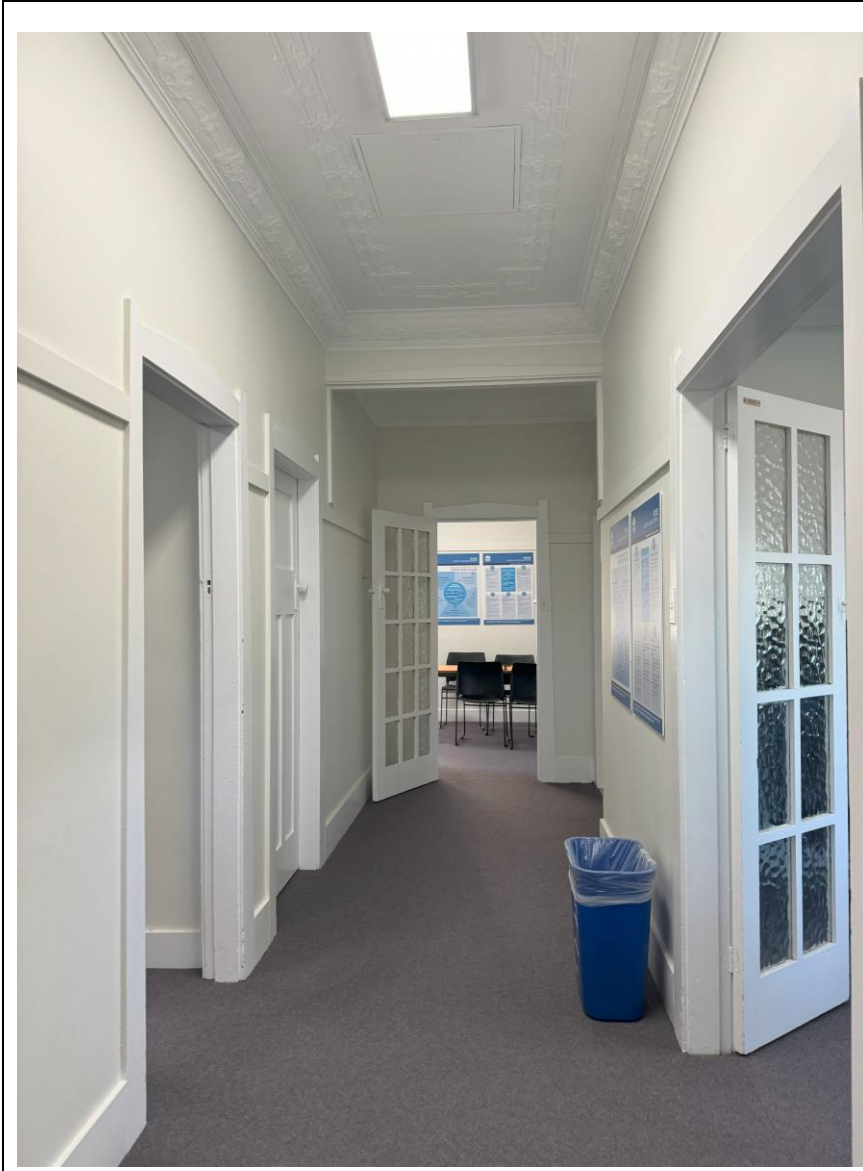
Plate 2: General character of this inside of the building inspected.

Note the access point to the roof cavity used for the inspection (centre of photograph, next to light).

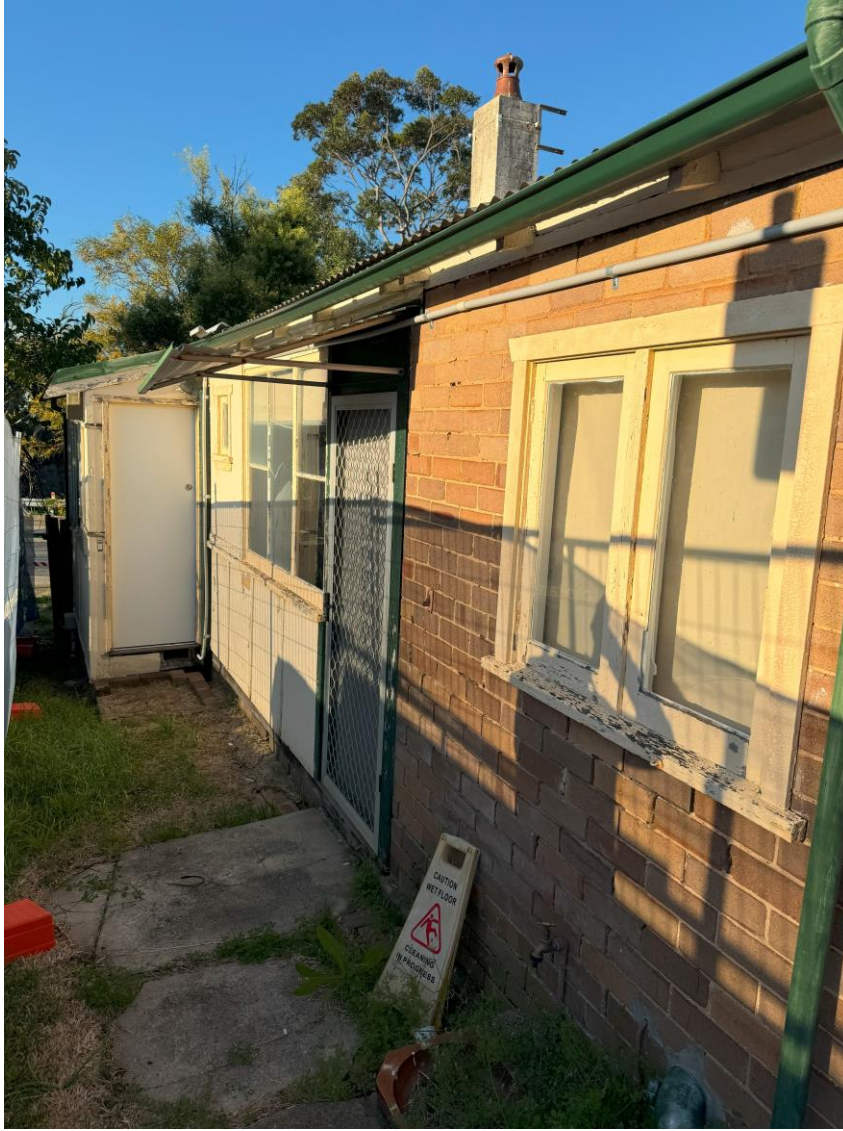
Plate 3: General character of the external composition of the rear of the building.

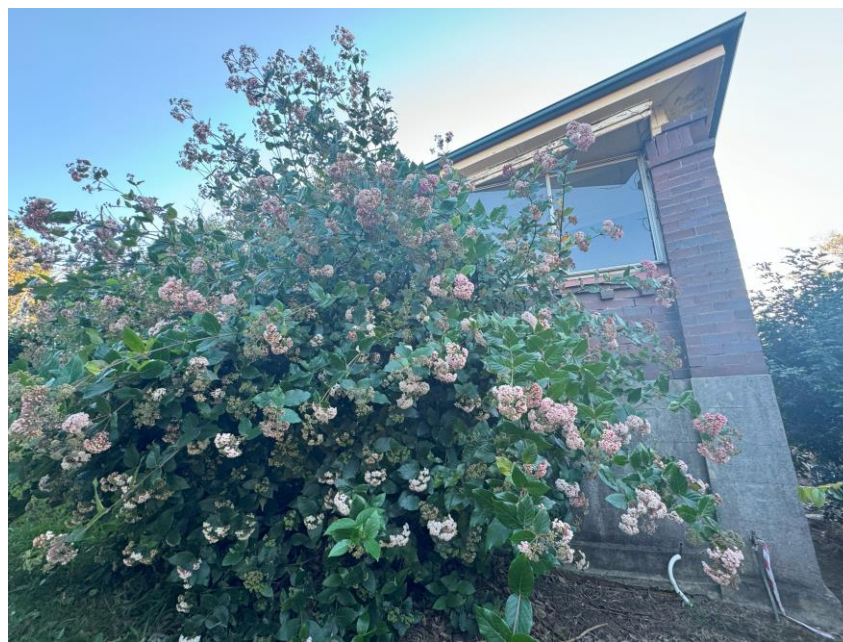
Plate 4: Example of exotic vegetation present near, and the brick composure of, the building's exterior (front of the building).

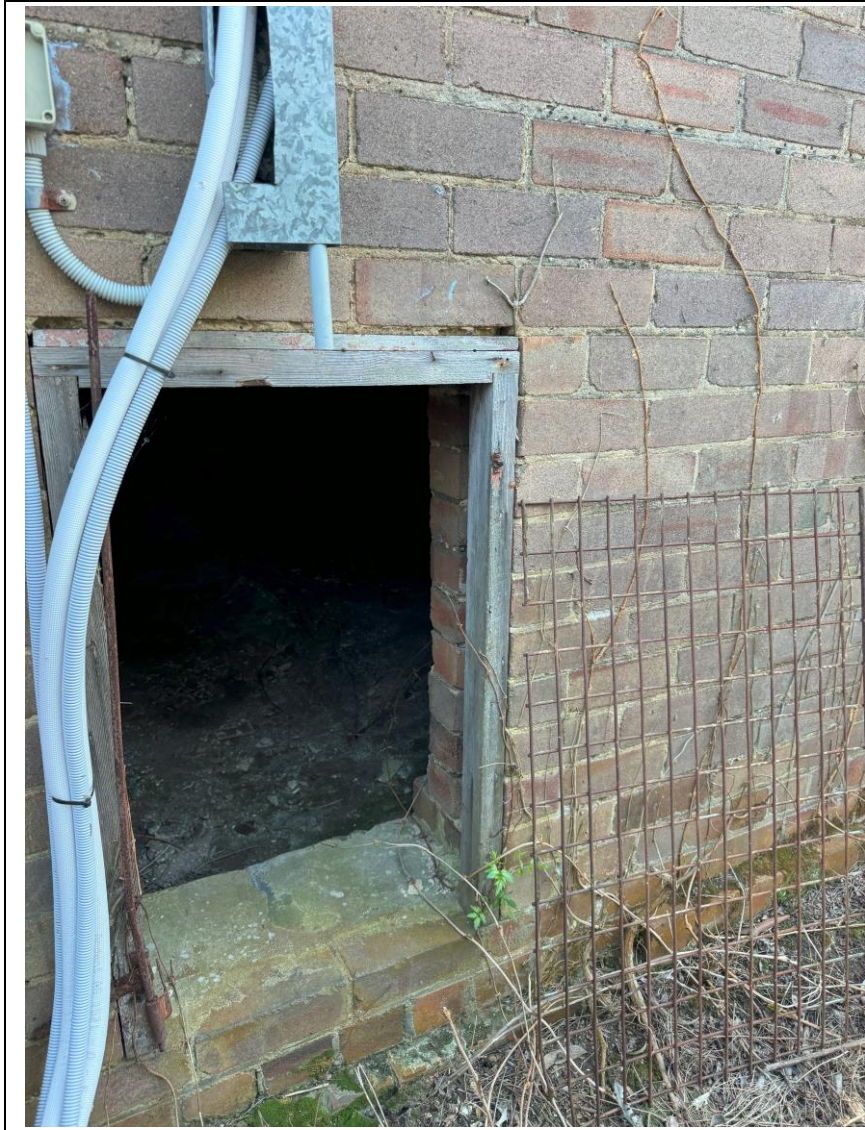
Plate 5: Example of an opening into the crawl space under the building inspected.

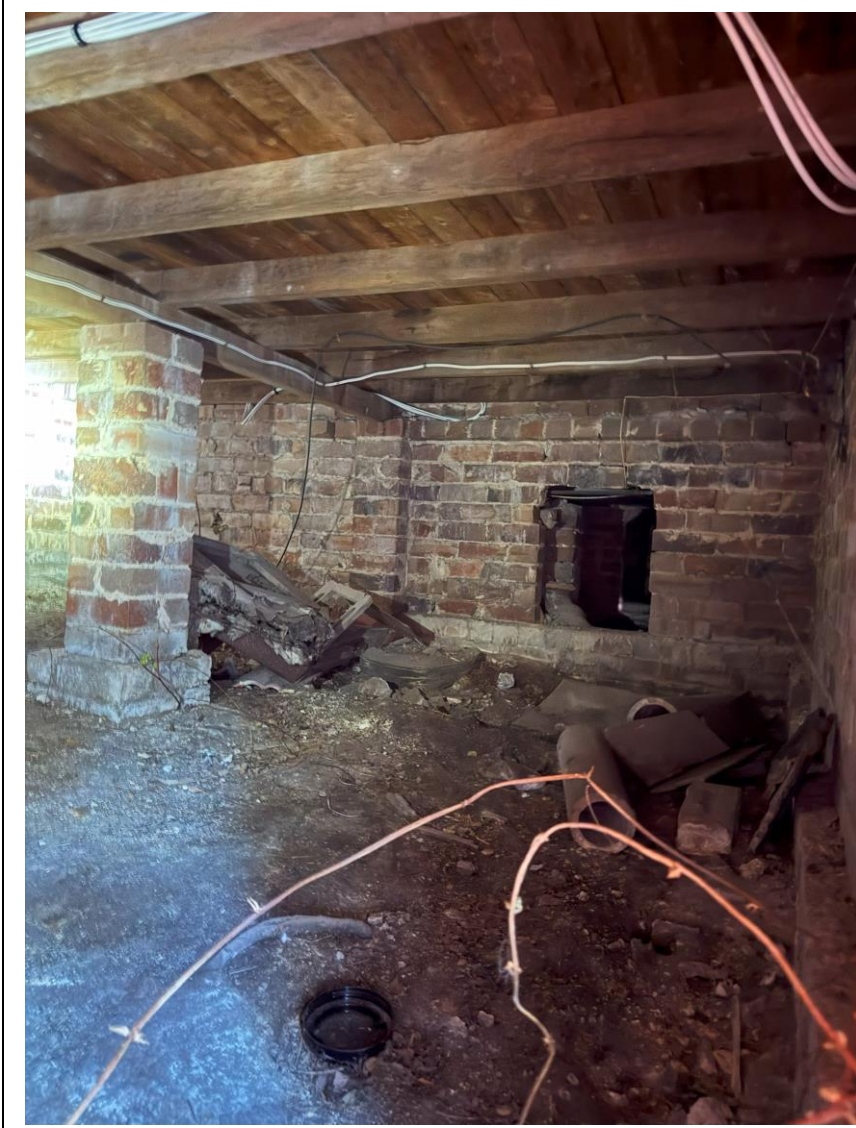
Plate 6: General character of the interior of the crawl space under the building inspected.

Note some visible spider webs, however, generally clean. No guano or signs of microbat roosting visible.
