Manning Base Hospital Redevelopment - Stage 2

Final Heritage Report - REF/Part 5 Assessment

Prepared for Mace Australia Pty Ltd on behalf of Health Infrastructure NSW
July 2023

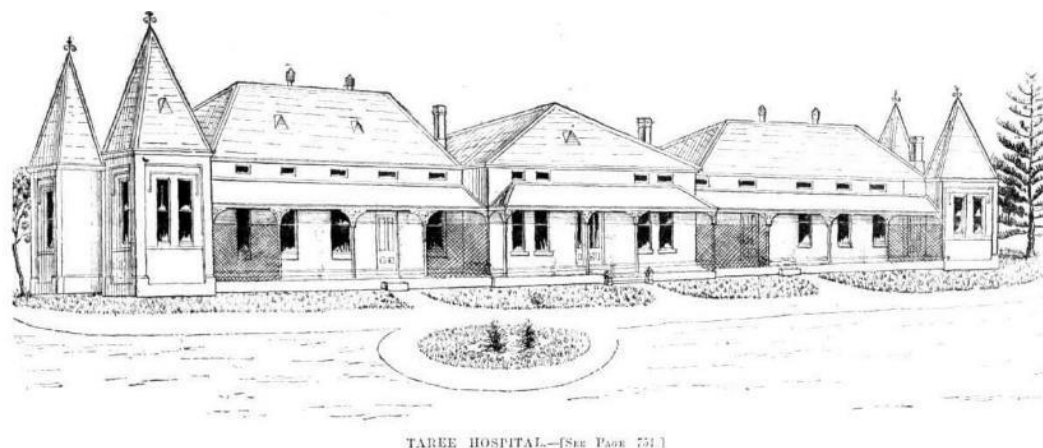
Plate 3.5 Original sketch of the Manning River Hospital main building, as proposed. Source: *Sydney Mail and New South Wales Advertiser*, 9 April 1887, pg. 758.

In April 1887, a design for the hospital building produced by the architects Messrs, Bolster and Hutson of Sydney was made public (Plate 3.5) and construction works were commenced. A news article in *Sydney Mail and New South Wales Advertiser* describes the proposed hospital building and site as containing all the modern amenities and spaces required for health care in the town and includes an indicative sketch design ('Taree (Manning River) Hospital' *Sydney Mail and New South Wales Advertiser*, Saturday 9 April 1887, pg. 751).

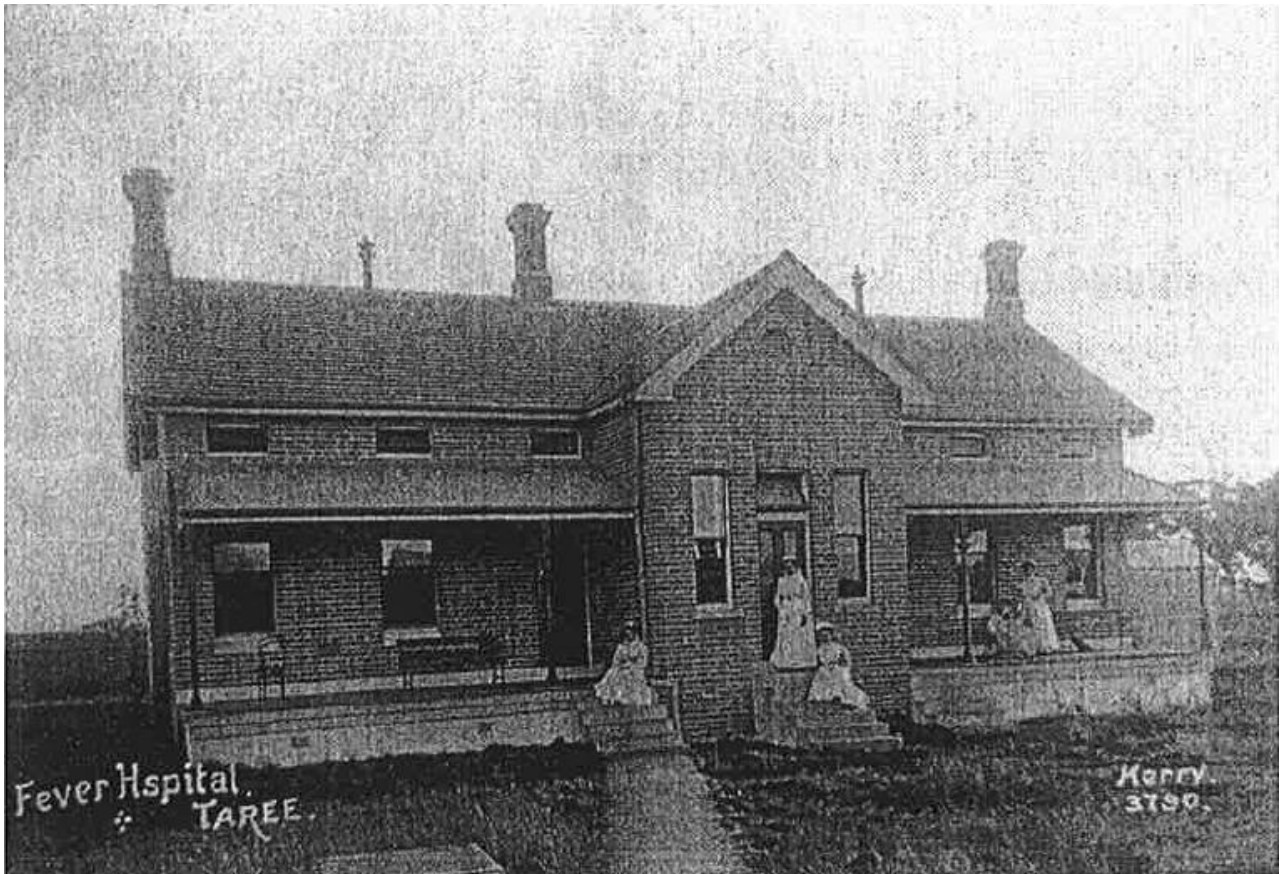
Plate 3.10 The Fever (Isolation) Ward building c.1897. Source: DPWS CMP 1999. Photograph taken by Darrel Newell.

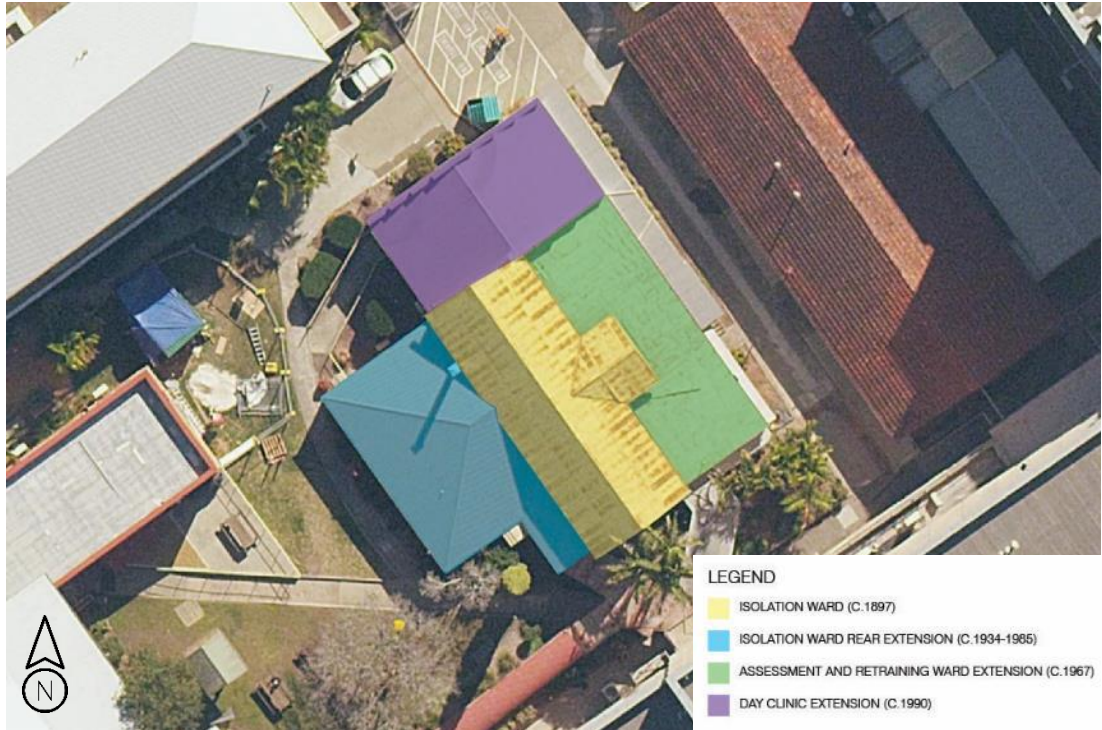
Plate 3.15 Indicative diagram illustrating various, likely phases of development to the Victoria Fever Ward. Source: base map by Metro Maps 2021, diagram by EMM.

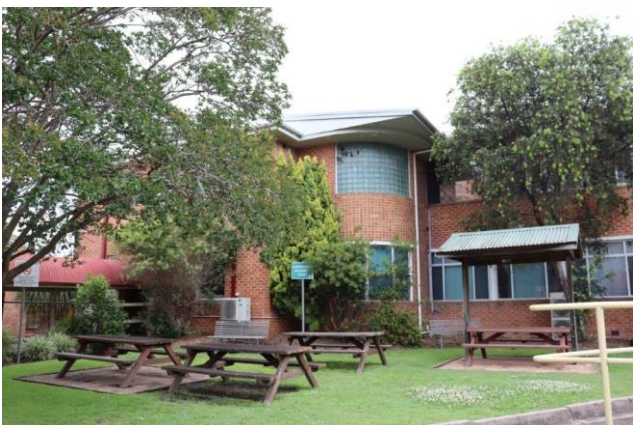
Plate 4.2 North-east elevation to Building 09 c.1941 structure.

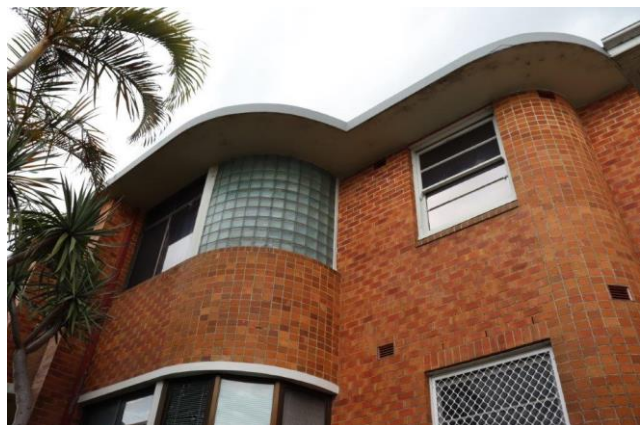
Plate 4.3 External window and roof detailing to Building 09 c.1941 structure.

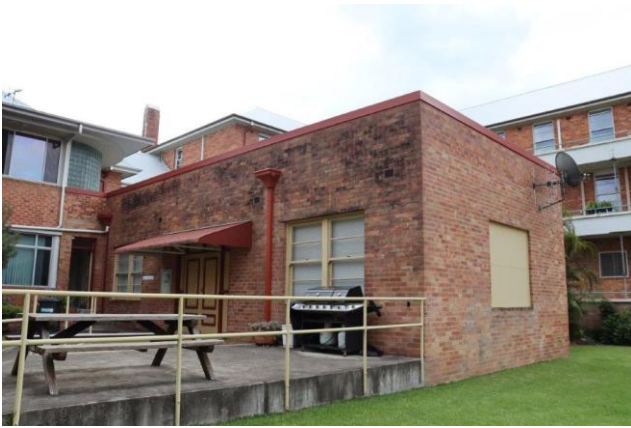
Plate 4.4 Single storey c.1954 extension to south-east elevation of Building 09.

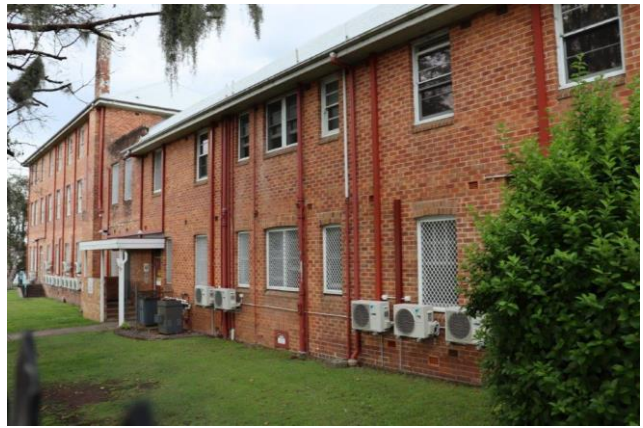
Plate 4.5 Transition from c.1941 to c.1954 structure to south-west elevation of Building 09.

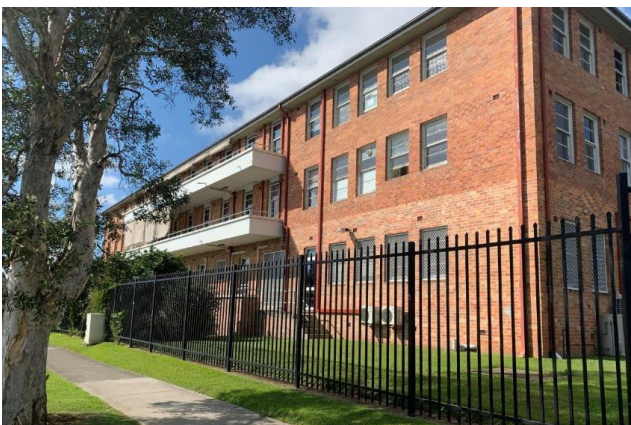
Plate 4.6 South-west elevation of Building 09 incl. concrete balconies.

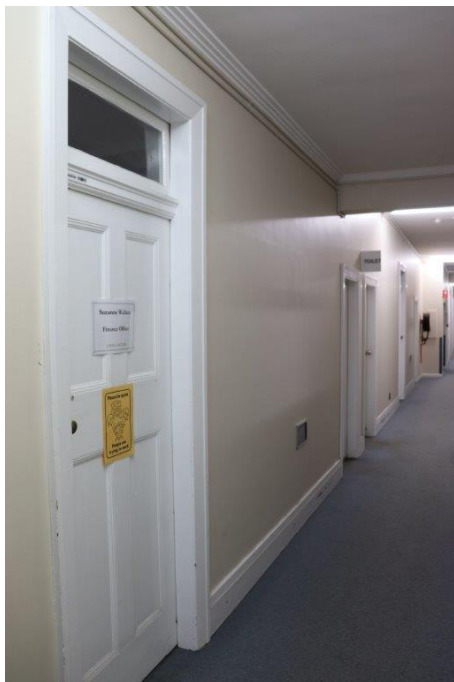
Plate 4.8 Remaining c.1921 walls and door openings to Building 09.

- a number of the internal walls were noted as dating from the 1920s located in the circulation corridor to the southern section of the c.1941 of the building. This is consistent with the history of the building and although internal spaces related to the c.1921 building have been maintained; the remaining fabric constitutes a small percentage of the overall building. The remaining c.1921 fabric includes:
 - undecorated, rendered walls with selected wall edges that are chamfered. Skirting boards and stepped cornices appear to be of a later date;
 - timber framed doors with original door panels, early or original hardware and operable fanlights;
 - timber framed windows to the south most rooms that were made internal;
 - some original door openings have been boarded.

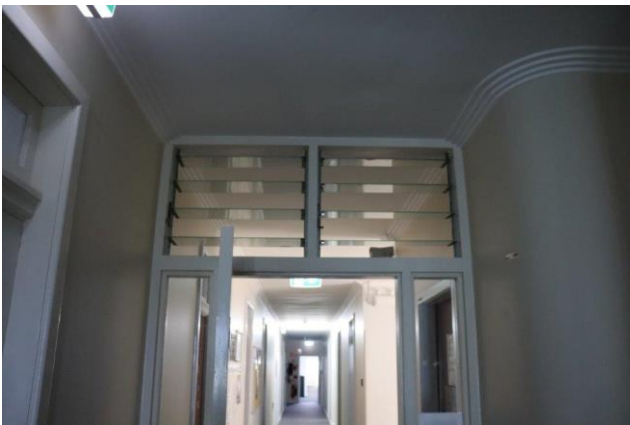
Plate 4.10 Curved wall section and glazed doorway with louvred fanlight, to Building 09 upper level.

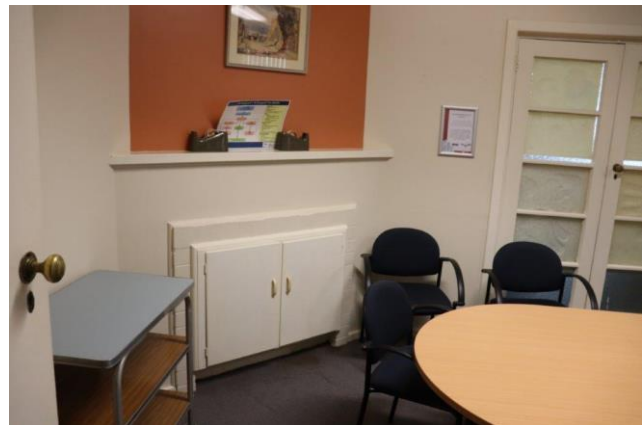
Plate 4.11 Fireplace and double doors to balcony area, to Building 09 upper level.

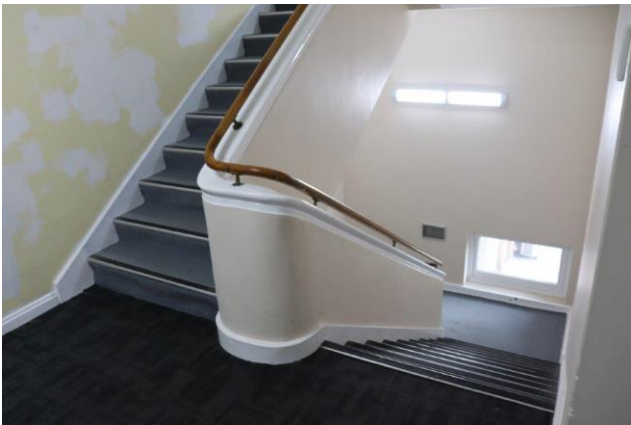
Plate 4.12 Stairway to c.1954 section of Building 09.

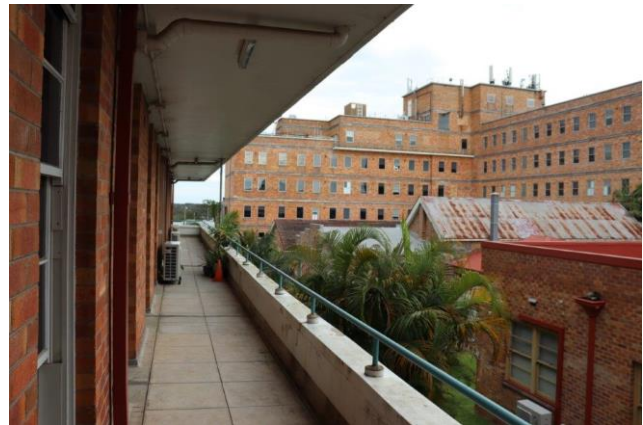
Plate 4.13 Concrete balconies to c.1954 section of Building 09.

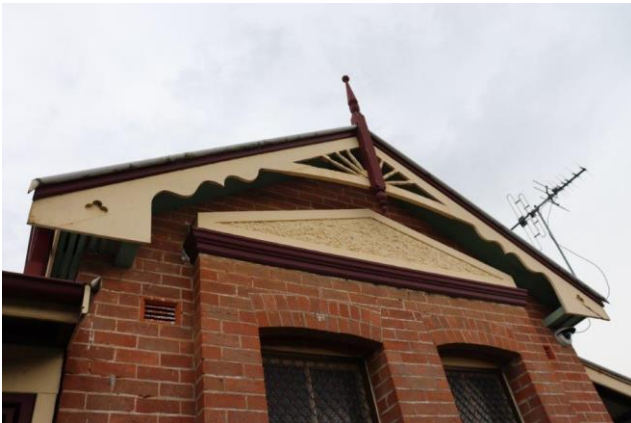
Plate 4.14 Roof structure, gable and upper section to south-east elevation of Building 11.
