# Proposed Redevelopment of Cessnock Hospital 24 View St, Cessnock NSW 2325

## Remediation Action Plan

**Reference: 754-NTLEN347071-2**

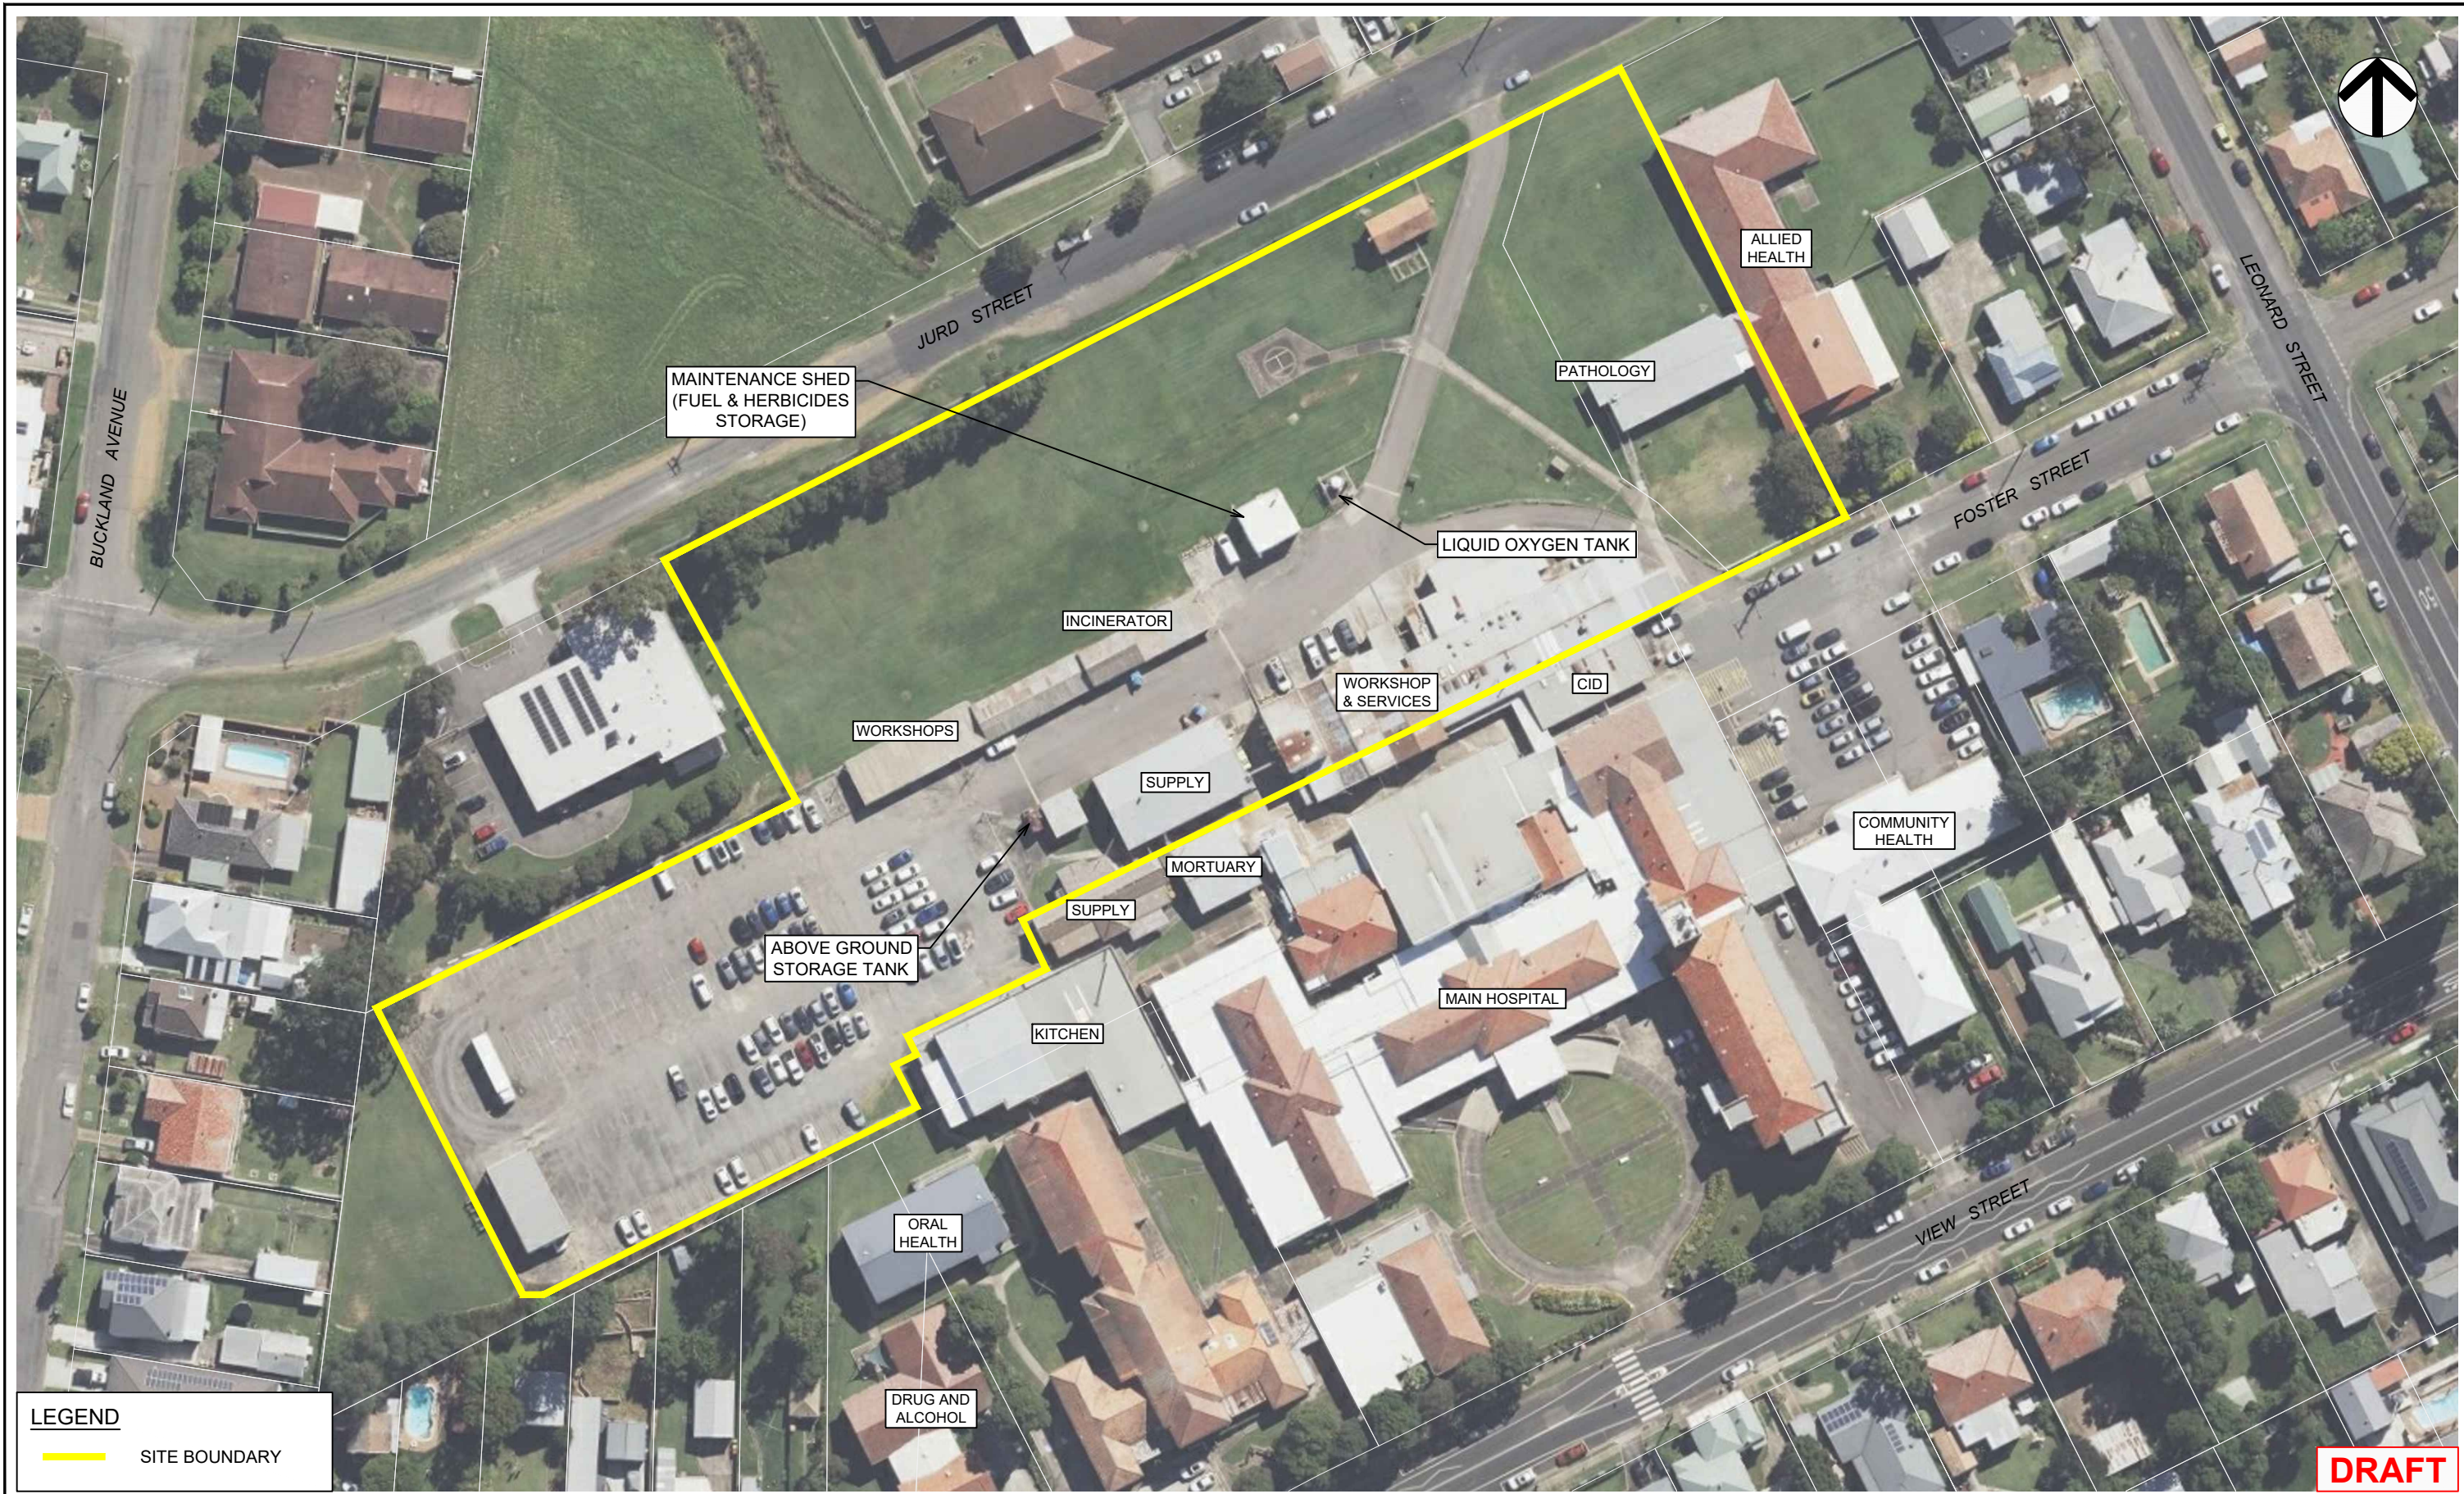
| project no: | 754-NTLEN347071-R03 | figure no: | FIGURE 2 |

During the site walkover and assessment works as part of the PSI and DSI the Site was observed to be an operational hospital. A site plan is presented in Figure 2 of Appendix A.

The Site consists of a grassed area with helicopter pad and old mortuary building in the northern portion of site. To the immediate south of the grassed area were old workshop buildings, a building which formerly housed an incinerator is now used for waste storage (in lined waste bins) and a yard maintenance shed. The yard maintenance shed contained a hoist for maintenance of ride on mowers and small amounts of chemicals (fuel, herbicides). The yard maintenance shed had only moderate staining on the concrete slab and not deterioration of the surface (cracks etc) was evident.

To the east is the pathology clinic building and in the central southern portion of the Site a workshop and services building and adjacent supply building, dangerous goods store and old bunded fuel above ground storage tank (AST). The old buildings were noted to contain hazardous materials including asbestos fibre sheeting and lead paint.

A fill mound was present in the grassed area behind the workshops, which sloped downward to the north, and the depth of the fill mound was observed to decrease to the west. A fill mound was also observed behind the pathology building and also sloped downward to the north.
