## **CESSNOCK HOSPITAL REDEVELOPMENT**

Statement of Heritage Impact

**REF SUBMISSION**

Prepared by  
Umwelt (Australia) Pty Limited  
on behalf of  
Health Infrastructure NSW

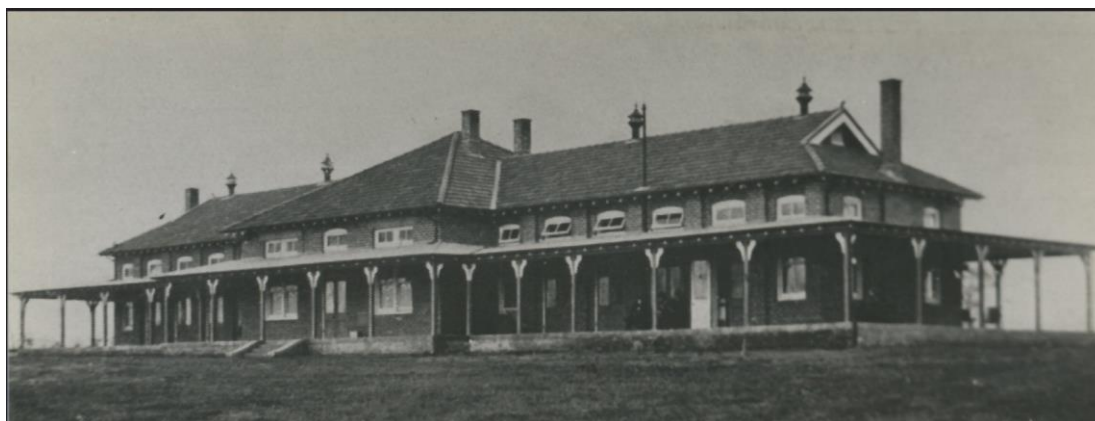
**Figure 2.1** Cessnock Hospital, Cessnock, between 1914 and 1920.

The main hospital building, consisting of the central building (see **Figure 2.1**) was completed in 1914, with the Minister for Health, Mr F. Flowers performing the opening ceremony on Sunday June 14<sup>th</sup>. Although the main building was completed, residents wishing to admit themselves for treatment were restricted to general medical care due to the lack of a suitable operating theatre (*The Cessnock Eagle and South Maitland Recorder* 1914, p. 3). Upon opening, the hospital lacked hot water, a sterilisation room and no suitable accommodation for nurses or other employees (Mattocks X). The grounds of the hospital were fenced shortly following its opening, being described as ‘substantial’ and of an ‘ornamental design’. At this time, there was no formal gardens or lawn areas and the building’s construction was heavily criticised for poor workmanship (*The Maitland Daily Mercury* 1914, p. 2).

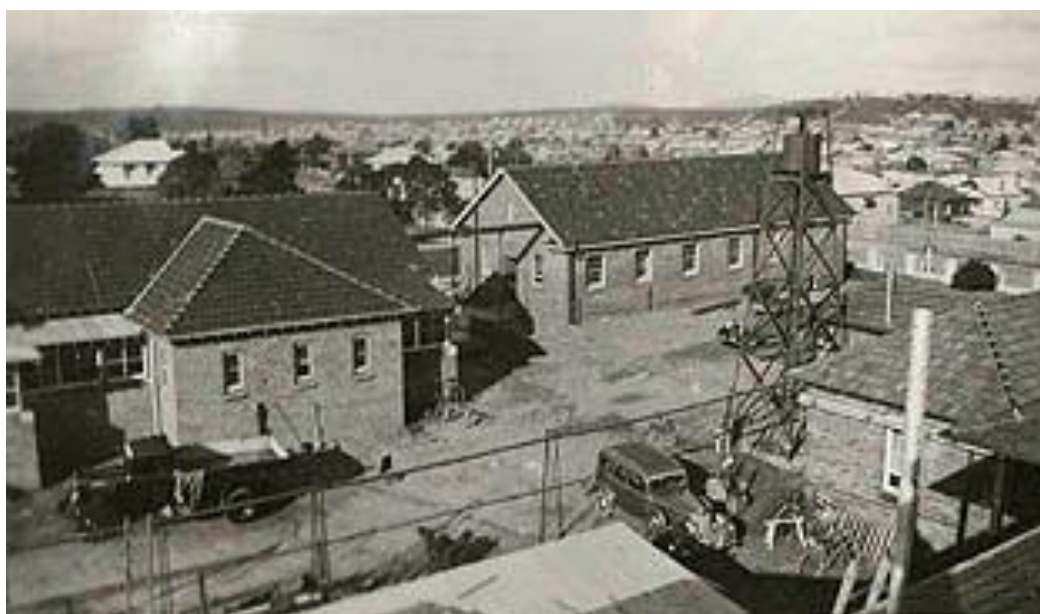
**Figure 2.2** c1930 view from the first floor of the Drinkwater Building (5) looking east, showing Building 4 mid-right in the distance, the single storey east wing of Building 5 on the right, and the inter-war building south-west of Building 2 on the left.

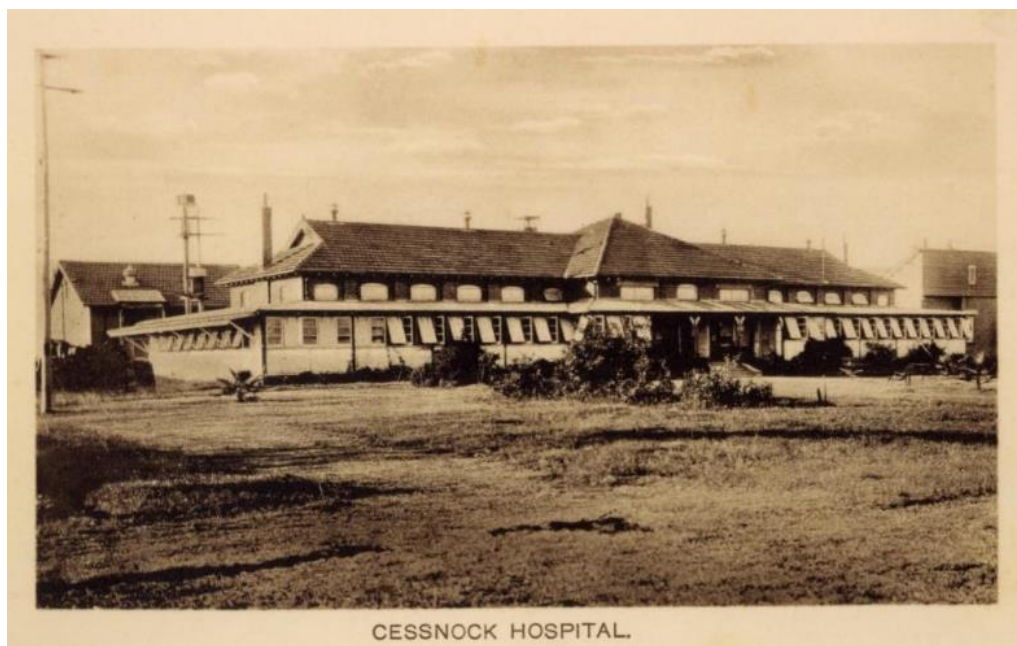
**Figure 2.3 Cessnock Hospital c1930, looking north-east, showing verandah infilled and the operating theatre on the far left**

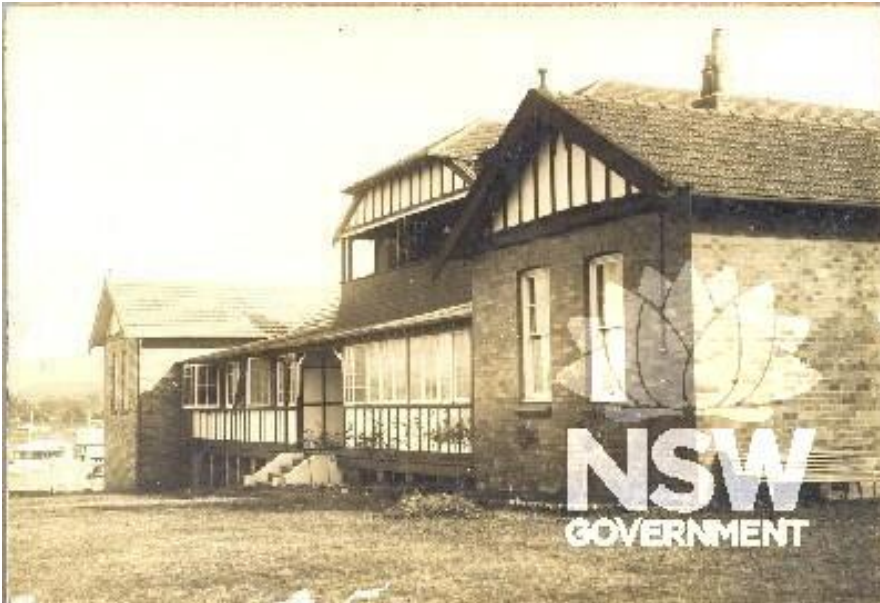
**Figure 2.4** The front of the Drinkwater Building (Building 5), facing View Street, in the inter-war period

The front was modernised and extended forwards to View Street in the 1960s to its present form. The gables were replaced with hips, the verandah was replaced with aluminium-framed glazing under Klip-lok steel roofing, and the central pavilion was enlarged. The whole building has been abandoned for many years and is boarded up. The building contains a large amount of asbestos and is in poor condition.

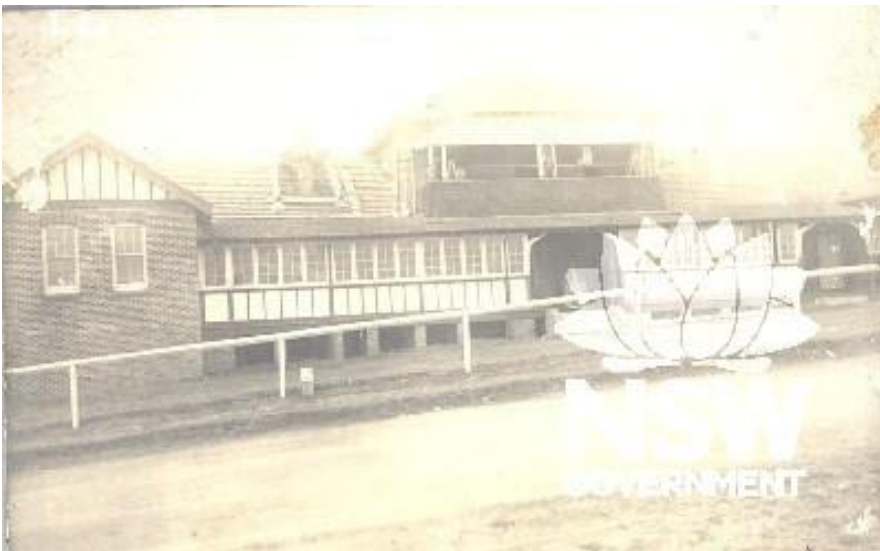
**Figure 2.5** The front of the Drinkwater Building (Building 5), facing View Street, in the late inter-war period

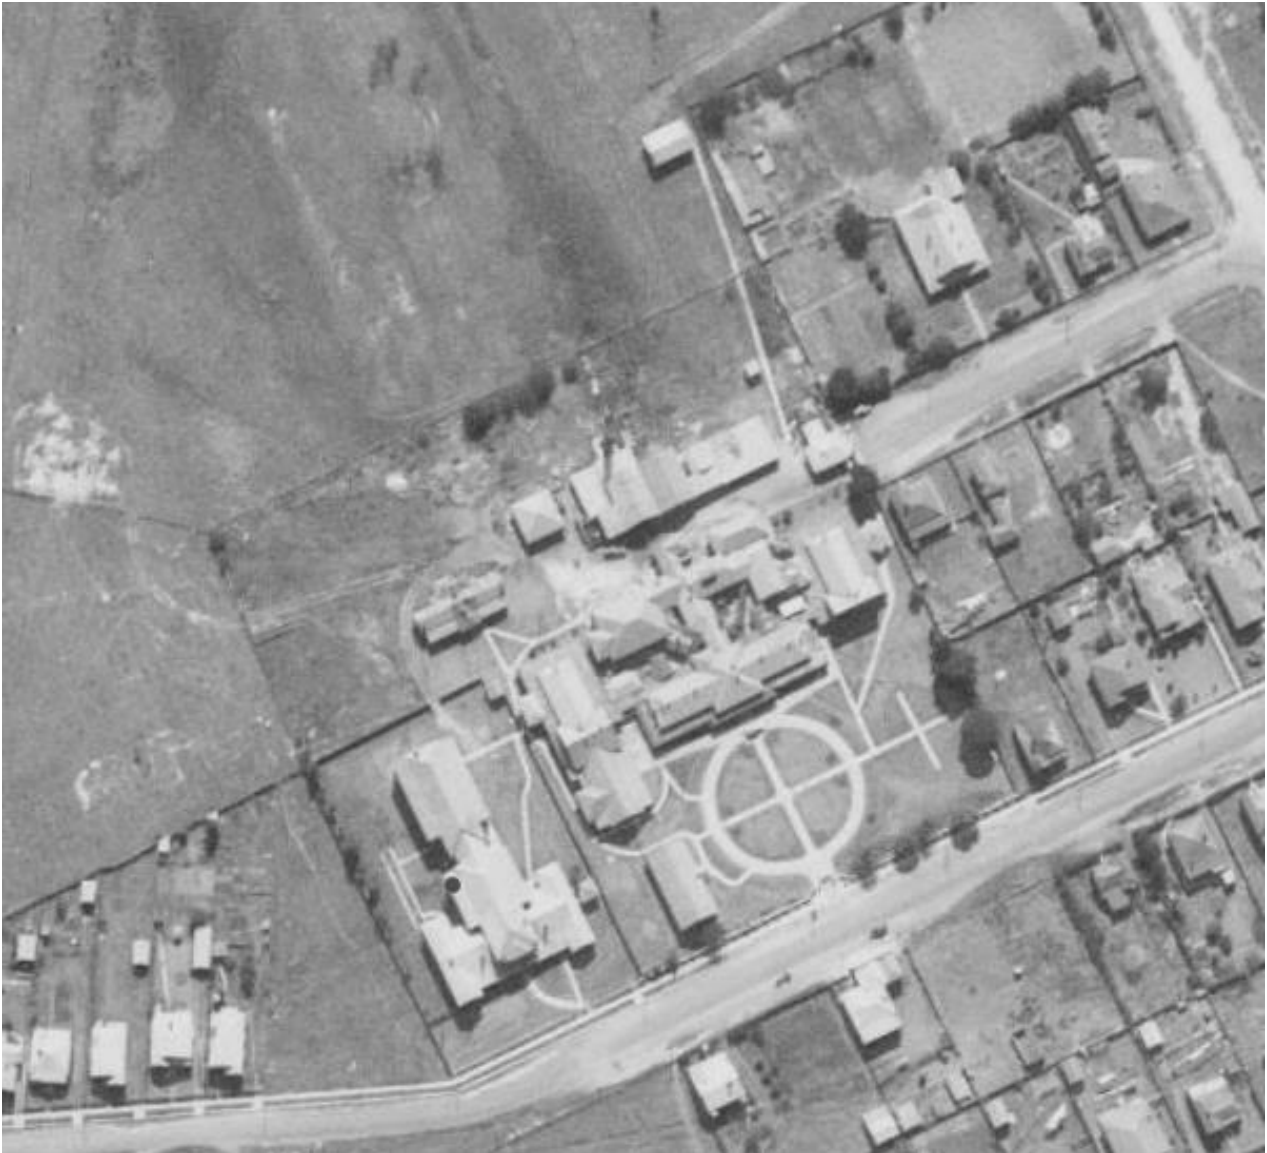
**Figure 2.6** 1944 aerial photograph of the Cessnock Hospital.

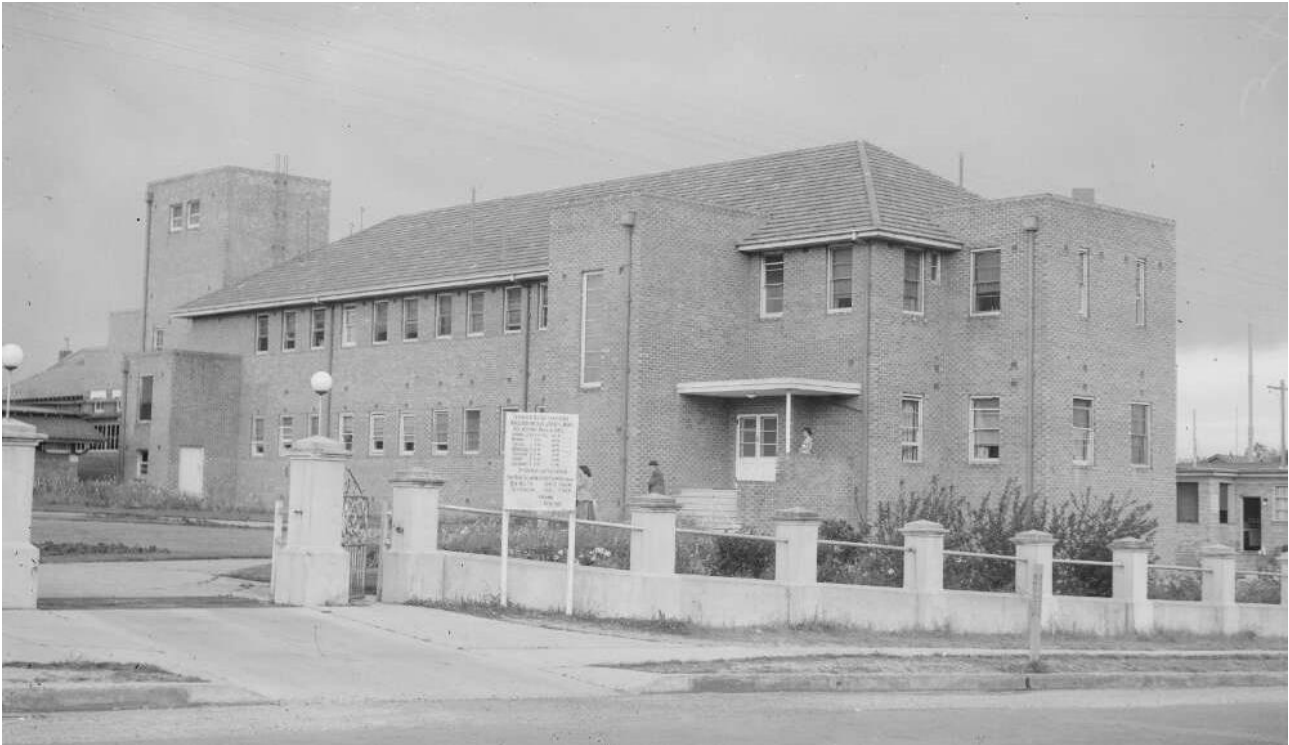
**Figure 2.7** New maternity wing of the hospital, Cessnock, 20 October 1949. Note original steel gate.

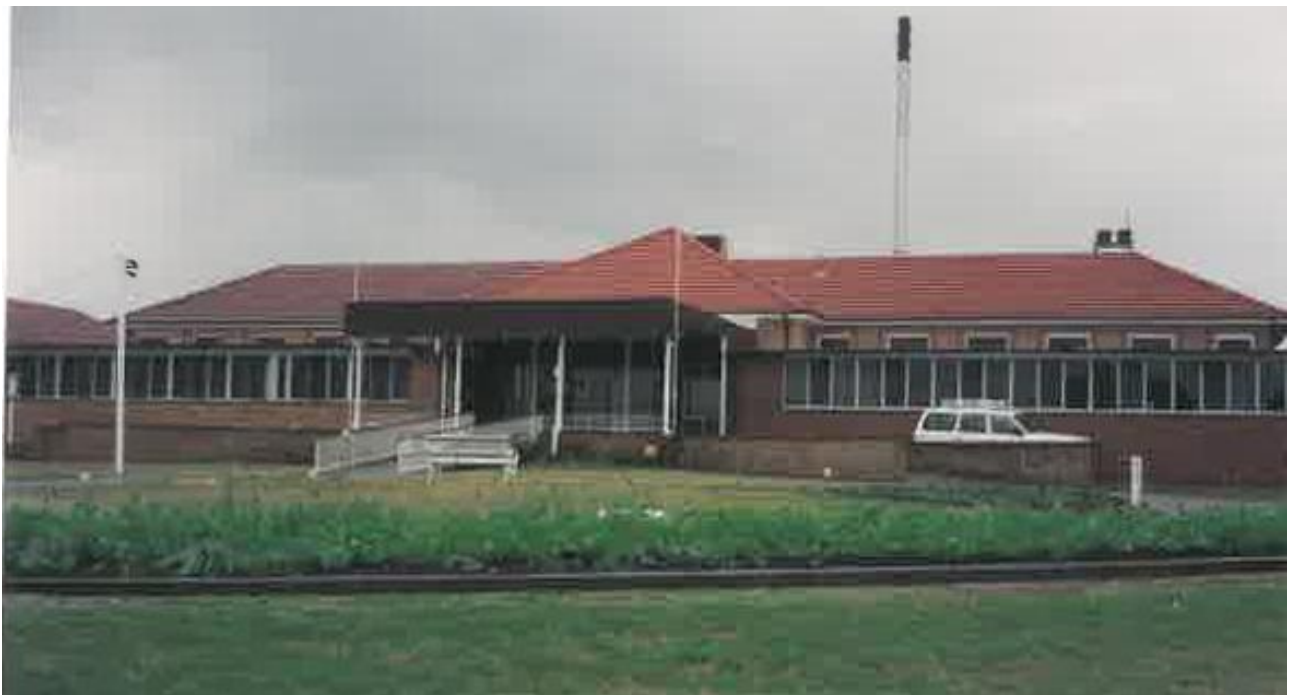
**Figure 2.8** The south front of the hospital in 1992

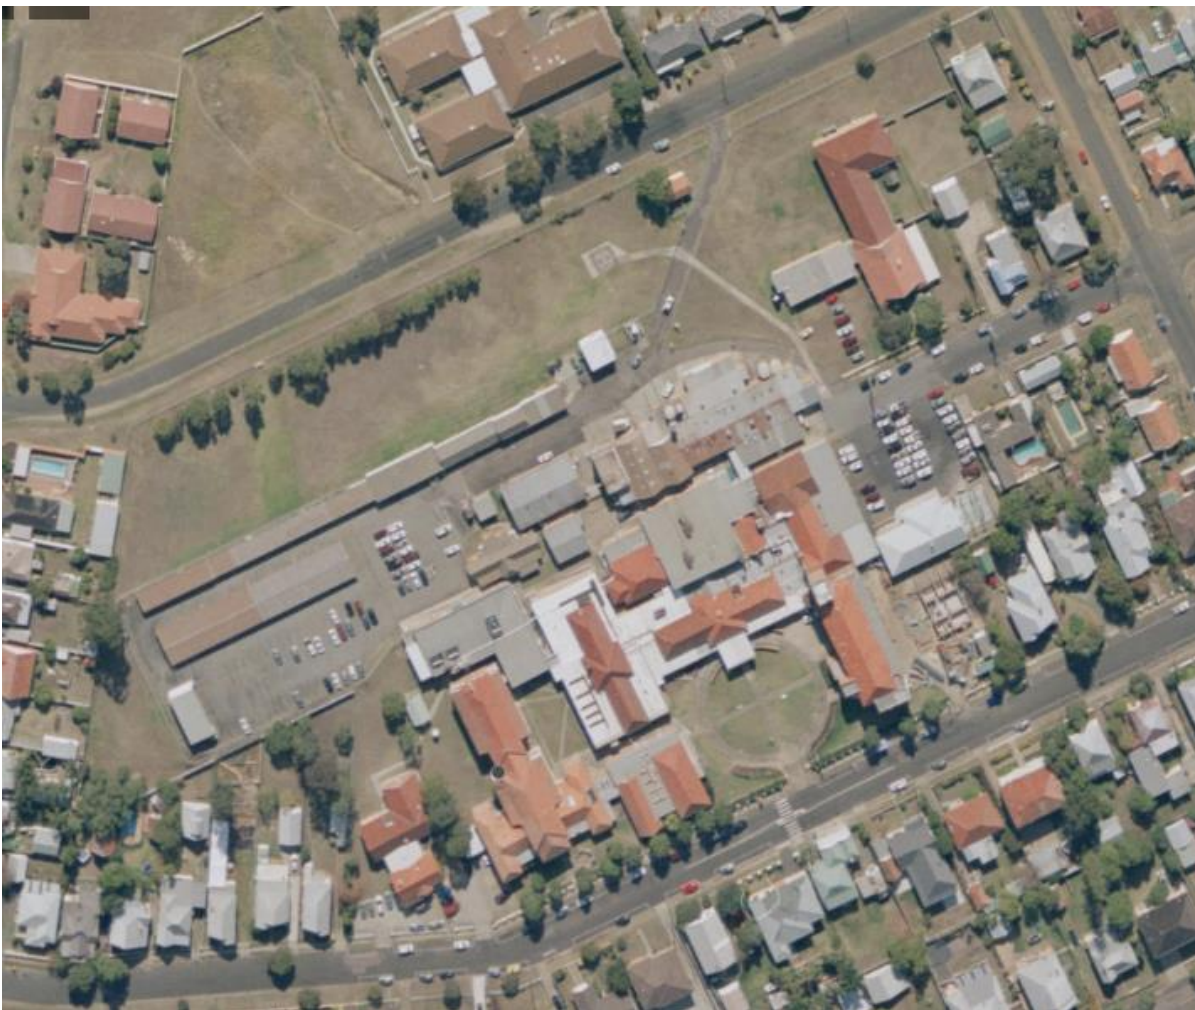
**Figure 2.10 2006 aerial photograph of the Cessnock Hospital**

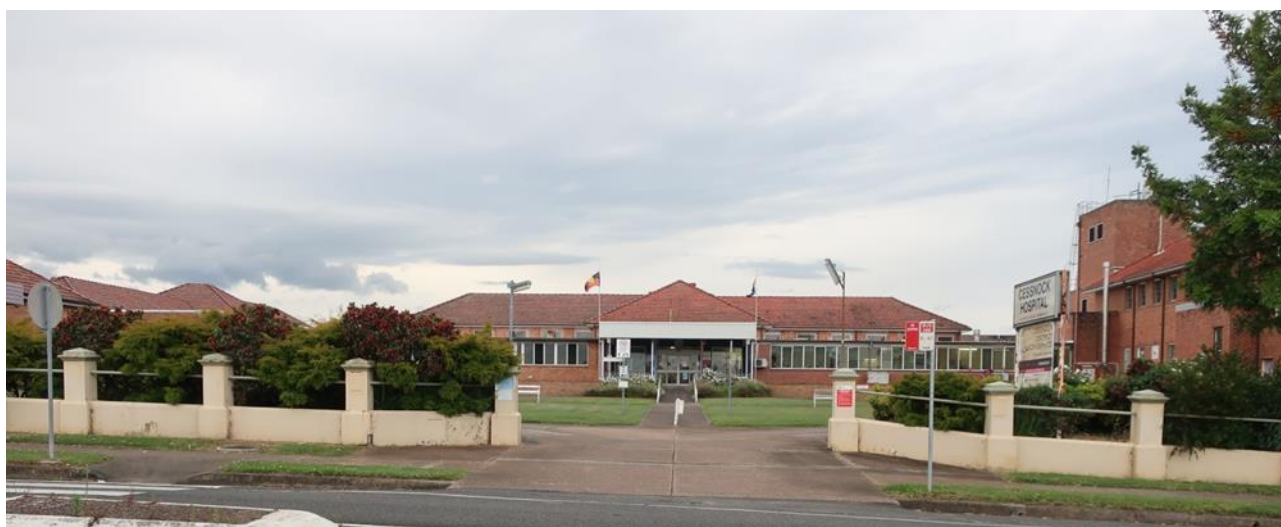
**Photo 3.5** Building 2 seen from View Street. This central building is the focus of the heritage listing

The original 1914 hospital building is a single-storey symmetrical brick building constructed with brick walls and a tiled roof. The central pavilion under a pyramid hipped roof contains the entry and a short rear corridor to buildings behind. The long, slightly lower hip roof extends from both sides of the central pavilion and covers the long corridor from which most wards and other spaces in the building are accessed.

While the original footprint of brick walls is apparent, all the original openings in the brickwork have been changed with new aluminium-framed windows fitting into altered openings that have removed large areas of the original articulation of the building. All the visible brickwork is in running bond, so there is no visible evidence of earlier complex bonding techniques or slim lime mortar joints.

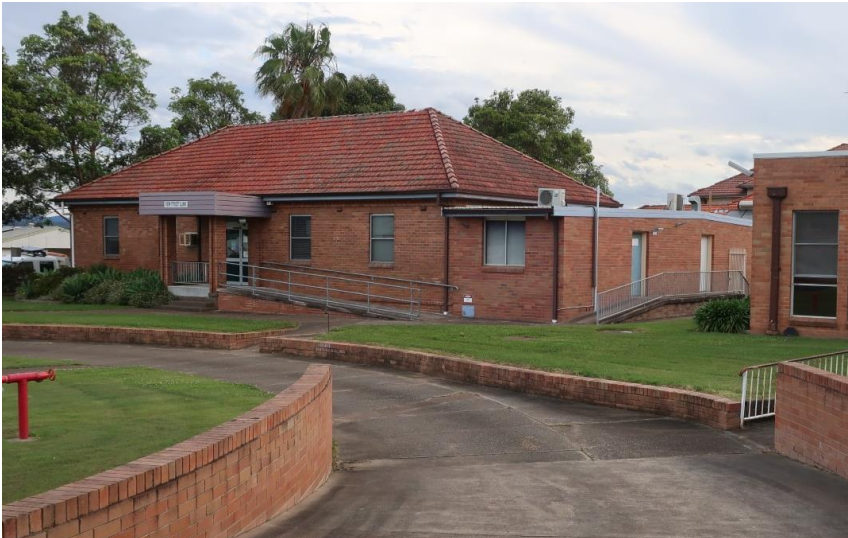
**Photo 3.6** Building 4 was built in the 1930s

This is a single-storey inter-war building with plain brick walls, a tiled roof and aluminium-framed windows. The 1944 aerial photograph shows it with a gable roof. The hip roof is likely an early post-war renovation. It has been altered and extended to the north and to the east to join Building 5.

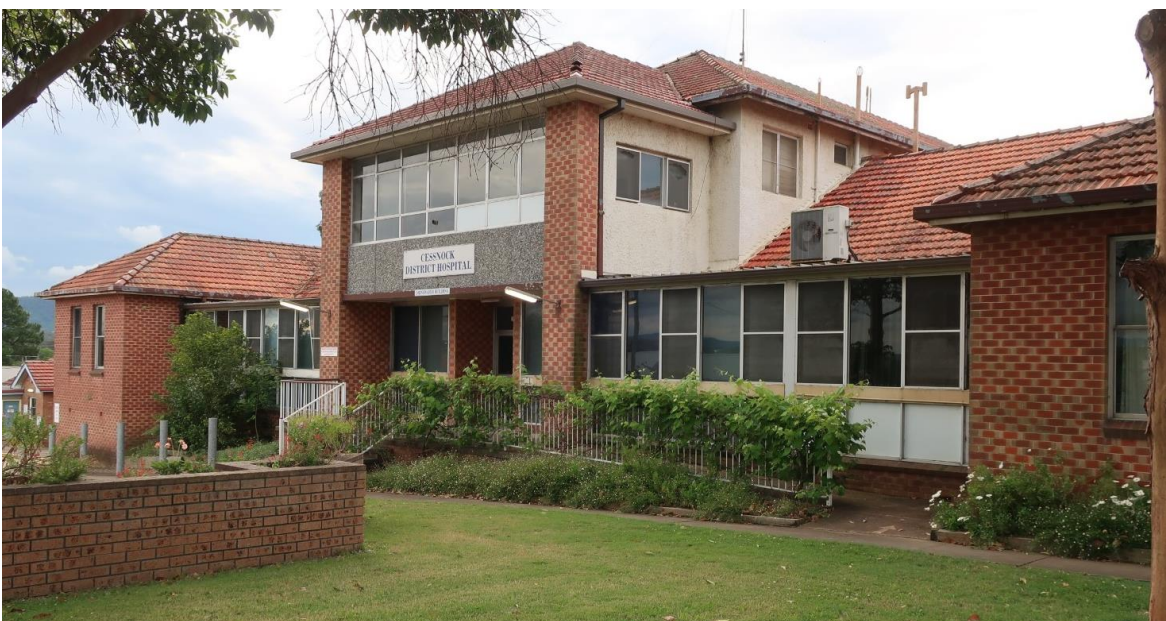
**Photo 3.7** The altered front section of the Drinkwater Building (Building 5) facing View Street

The Drinkwater Building is a one and two-storey brick building built for wards. A central two-storey section extends northwards from View Street, comes to a narrower section, and then enlarges again with another large ward building. A single-storey wing extends from either side of the central pavilion parallel to View Street at the front, and hipped wings extend forward and to the rear.

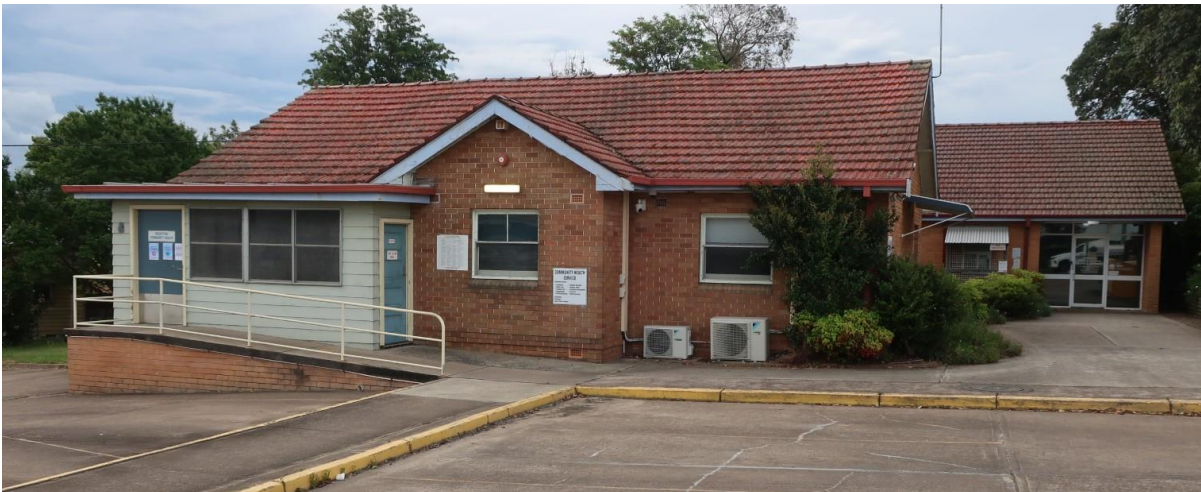
**Photo 3.8** Building 7 Community Health was built c 1948

Building 7 is single-storey complex of attached buildings with a domestic character. The building makes a transition between the institutional scale of the main hospital and the single-storey scale of detached houses off the hospital site. It was built in c 1948 with face brick walls, timber-framed sash windows and gable tiled roofs. The architectural style can be called Mid-twentieth-century Traditional Pragmatic because it uses common domestic forms and construction detailing. It has been used for drug and alcohol counselling and community health services.

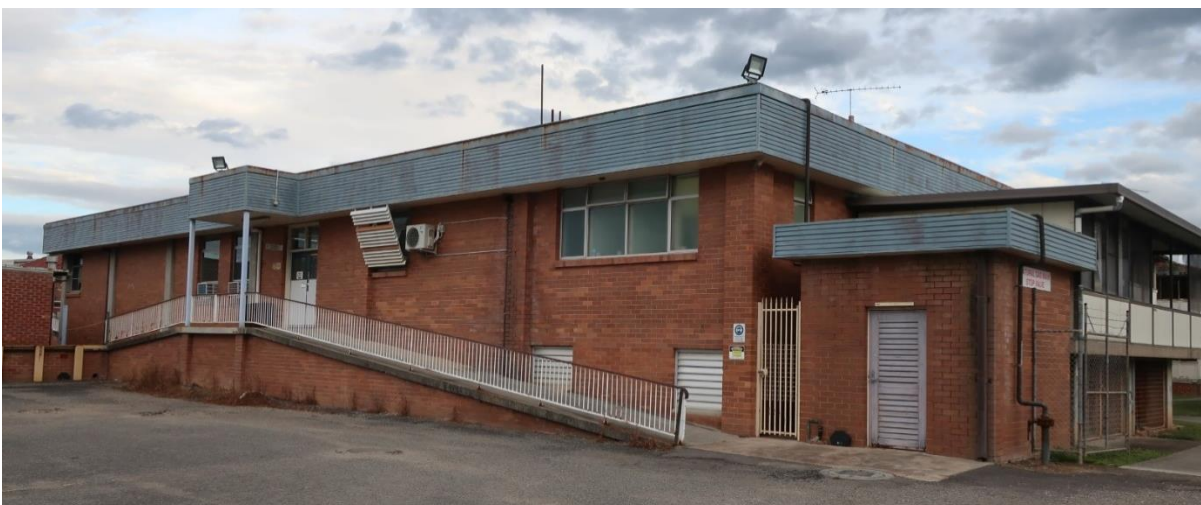
**Photo 3.9** East view towards the rear of Building 8, facing the car park

Building 8 is a kitchen complex that has a flat roof supported by a frame on reinforced concrete columns. The reinforced concrete floor slab has a recessed brick plinth. The fenestration is aluminium-framed, with fibre-cement spandrel panels. The building is typical of the second generation of modern architects in the NSW Public Works Department.

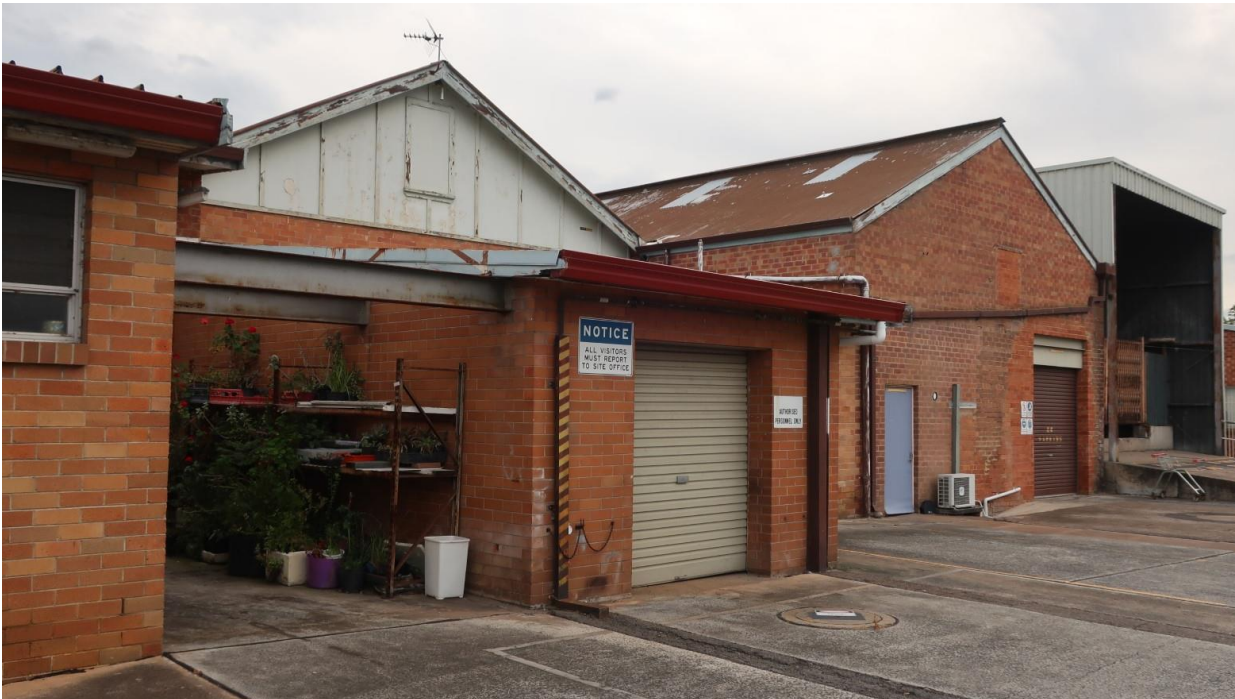
**Photo 3.10** The gable roofed sheds seen above were built in the inter-war period

The gable roofed brick sheds within the group that is Building 9 were constructed in the inter-war period and may have housing boilers, among other service functions. The eastern shed has a pediment clad in batted fibro with a boarded vent, typical of the late Arts and Crafts style. The 1944 aerial photograph shows some low-pitch roofed sheds at the eastern end of this group that were replaced with gable-roofed brick building in the early post-war era.

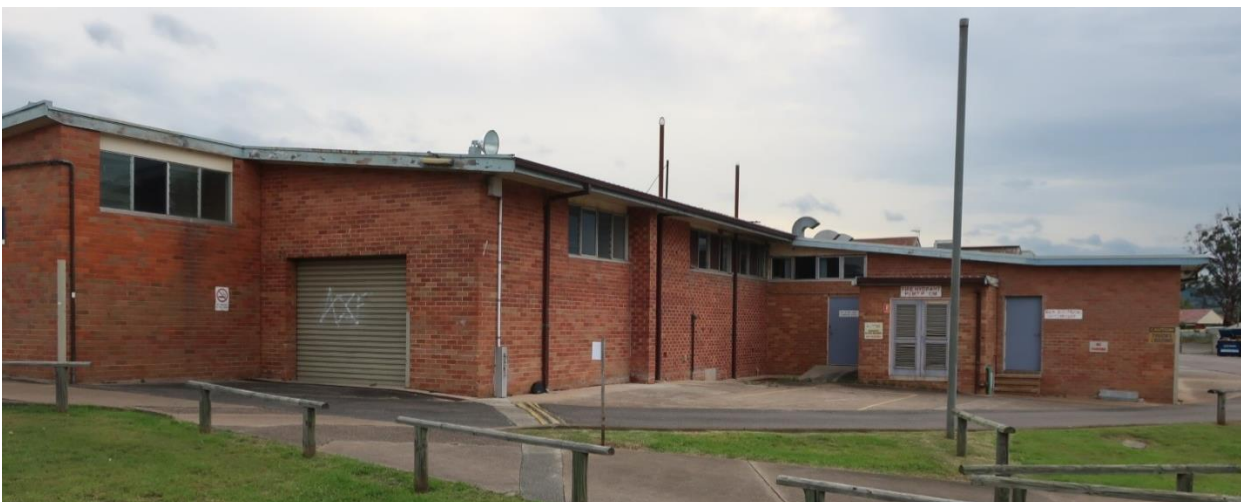
**Photo 3.11** The eastern industrial Building 9 from the c1950s would be demolished

The proposed demolition of buildings 9 (north one only), 11 (north one only) and 15 would cause the loss of minor service buildings from the post-war period that have little heritage significance. The removal of these buildings would cause little adverse impact on the heritage significance of the site.

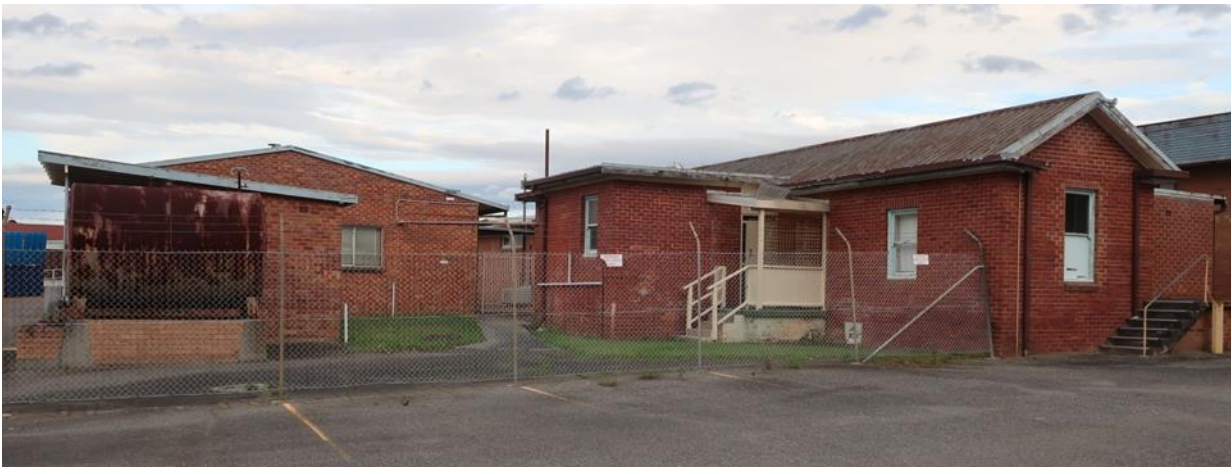
**Photo 3.12** The service buildings that are Building 11. The building on the right is likely from the 1920s. The post war building on the left would be demolished.

Several service buildings make up Building 11. An early twentieth-century domestic scale building is the older one in the group. It has mostly gabled roofs and a skillion to the rear. It is constructed of fine red bricks with some segmented arches, typical of the early inter-war period. The roof is a modern Kilp-lok profiled steel sheet. The building has been altered and extended many times.

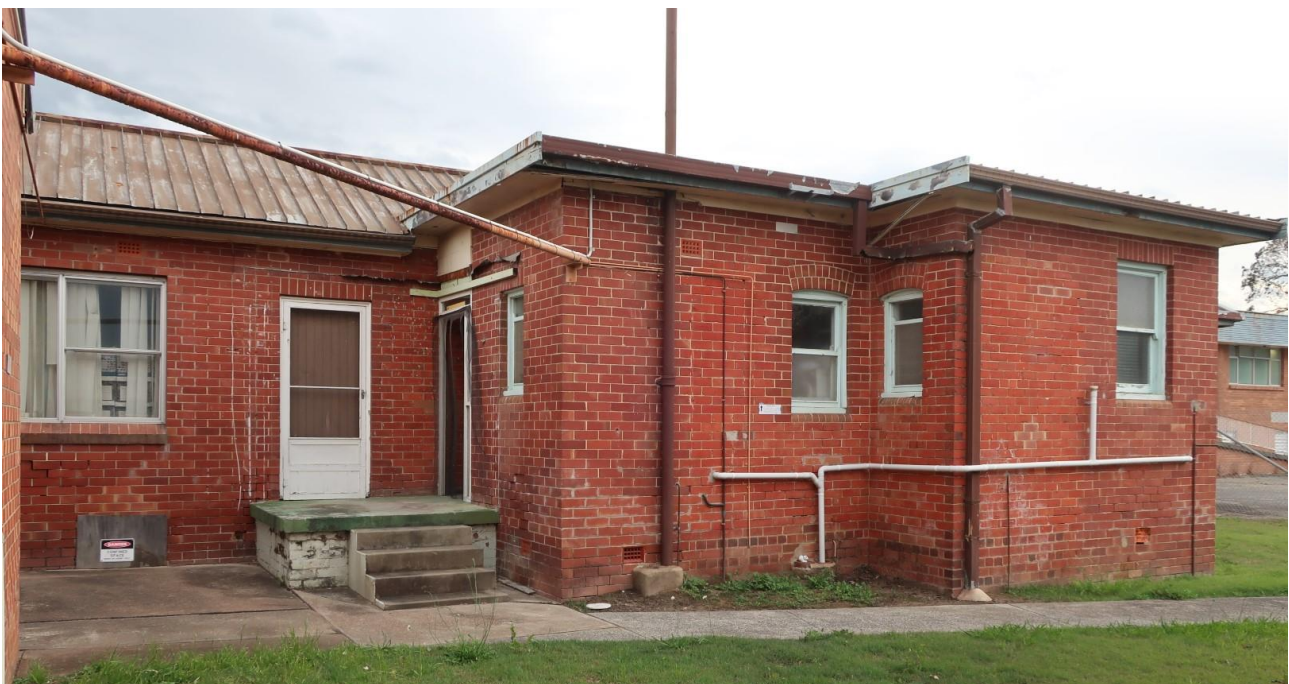
**Photo 3.13** The north-western side of the older part of Building 11 would be retained

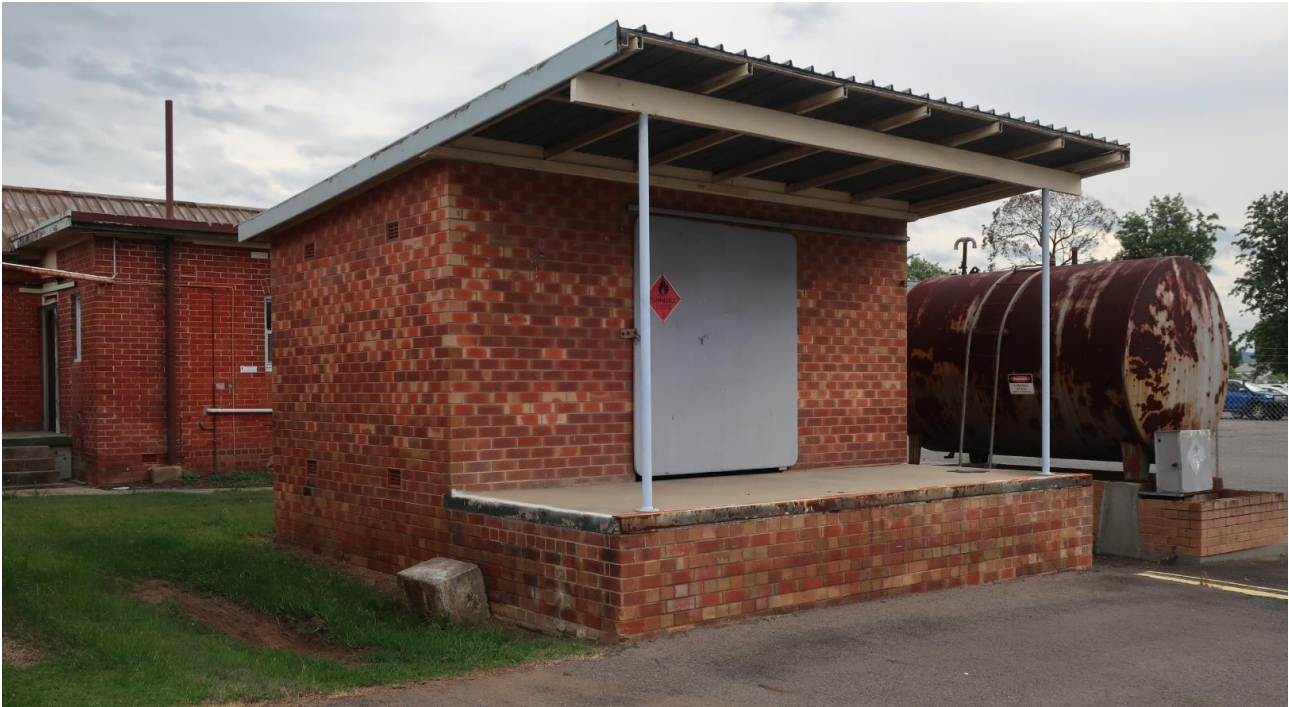
**Photo 3.14** The post-war fuel store that is part of Building 11 would be demolished

A fuel store was built in the mid-twentieth century, north of the earlier building. The fuel store is a single room with a loading dock. It is constructed of face brick walls, a reinforced concrete slab floor and a timber-framed skillion roof.

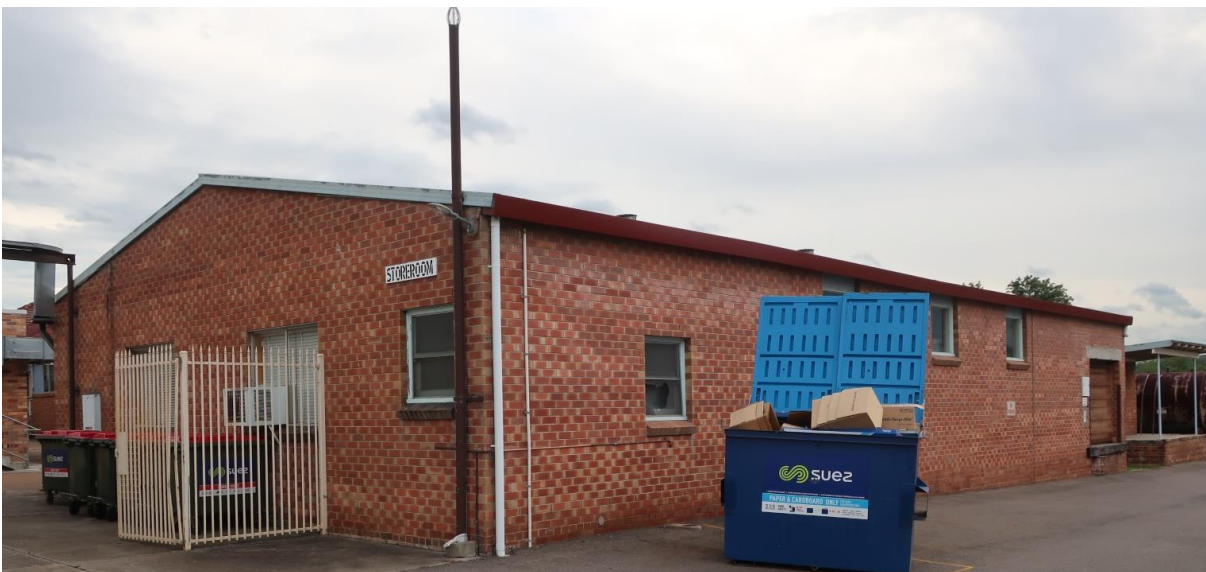
**Photo 3.15** The early post-war storeroom that is part of Building 11 would be demolished

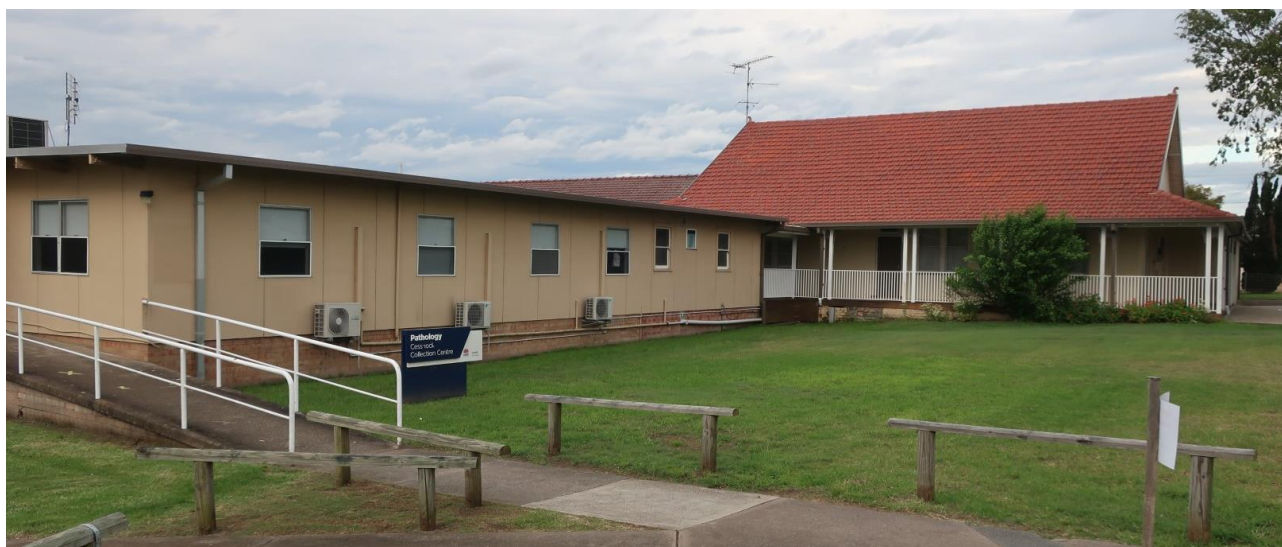
**Photo 3.16** The c1960s Building 12 on the left would be removed, and the Federation Building 13 on the right would be retained

The southern section of Building 13 is a Federation Arts and Crafts building that has been used as a nursing home and later for allied health services as a pathology collection point. It has a domestic scale and character typical of the 1910s. The brick front boundary fence was built in the inter-war period.

The northern extension of Building 13 appears to have been built c1980. The western wing that is Building 12 appears to have been built in the 1960s. These extensions are not significant buildings.

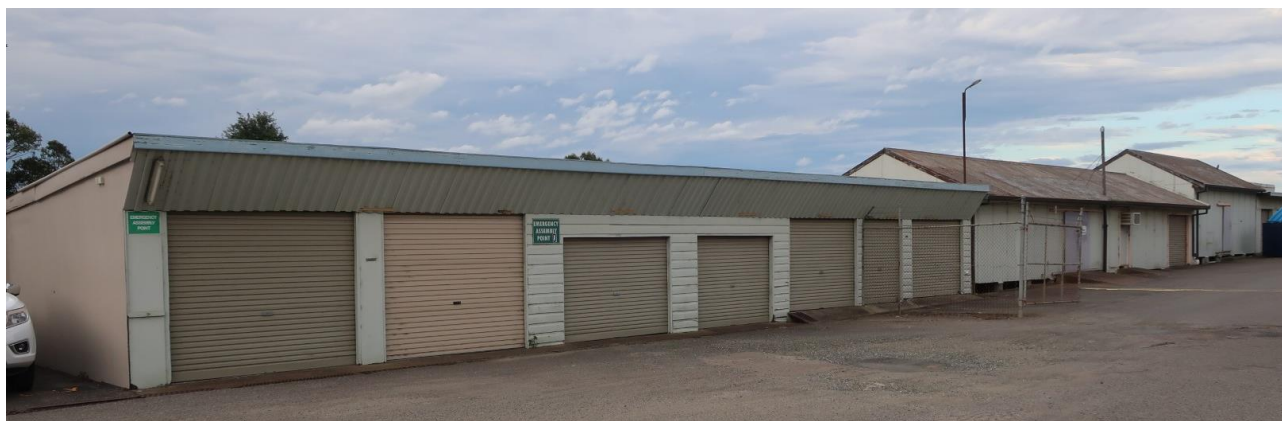
**Photo 3.17** The sheds that make up Building 15. Those on the left were built in the late twentieth century; those on the right were placed here soon after WWII. They would be demolished.

A row of sheds faces the north-western edge of the access drive in the rear of the hospital site. The 2006 aerial photograph shows the row of sheds extending the full length of the carpark, and a further row parallel and south of the outer row. Only the eastern half of the northern row remains. Of the remaining sheds, the western sheds were built in recent decades, and the two eastern buildings were placed there in the post-war period. The older eastern sheds have a timber frame, fibro wall cladding and corrugated steel sheet roofing. The earlier doors and sliding panel of ledged timber, and some later steel roller doors have been added. These timber sheds have detailing typical of the 1930s and may have been relocated here.

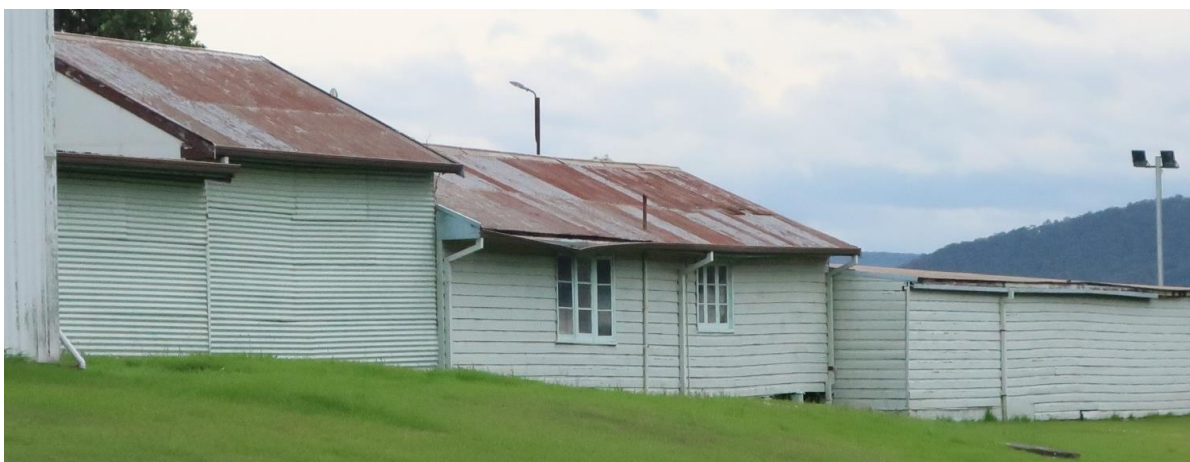
**Photo 3.18** The north-western side of the shed that are Building15. The timber windows have a 1930s character. They would be demolished.

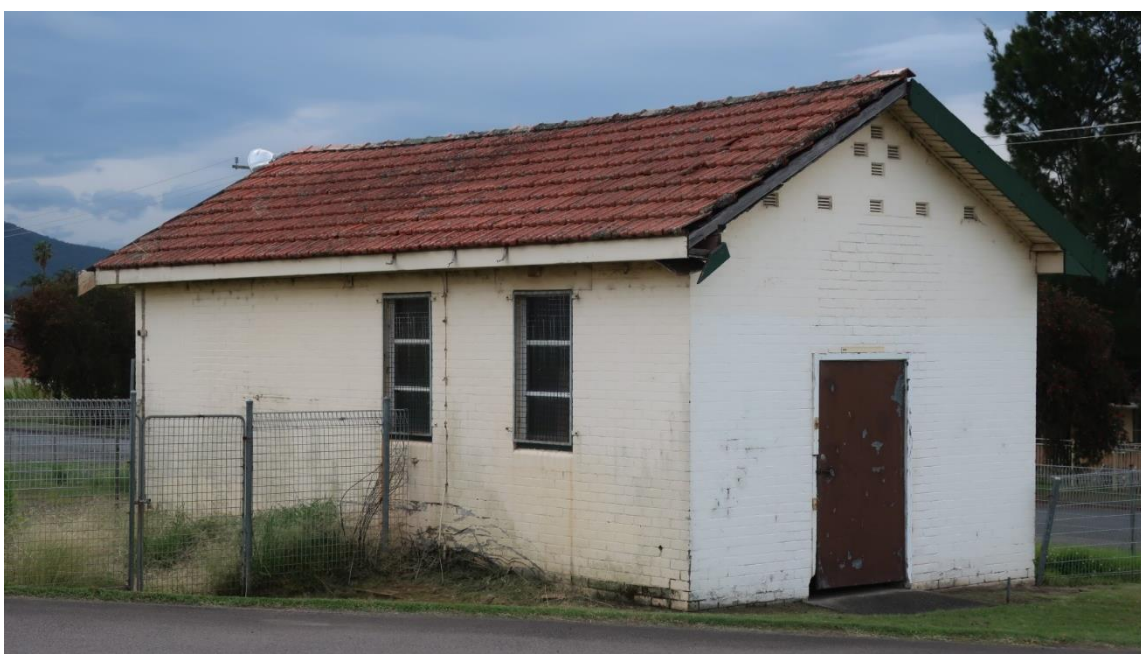
**Photo 3.19** The inter-war mortuary Building 14 would be demolished

The mortuary is a small, isolated brick building with a tiled gable roof built close to Jurd Street. It was constructed in the inter-war period. The walls are brick, now painted white. A pattern of wall vents in a cross suggests a building function meeting eternity. The cement lintels over the window openings and V-jointed timber eave soffit are typical of the 1920s. The fenestration has been replaced with modern fixtures. The floor is concrete. The Marseilles-type roof tiles are likely original, but the timber roof structure has a slight sag.

The Cessnock Hospital Redevelopment would cause the demolition of the inter-war period mortuary building (building 14), which was previously assessed by Umwelt as having Moderate heritage significance. This loss is sustainable for the heritage significance of the hospital site that is a local heritage item.

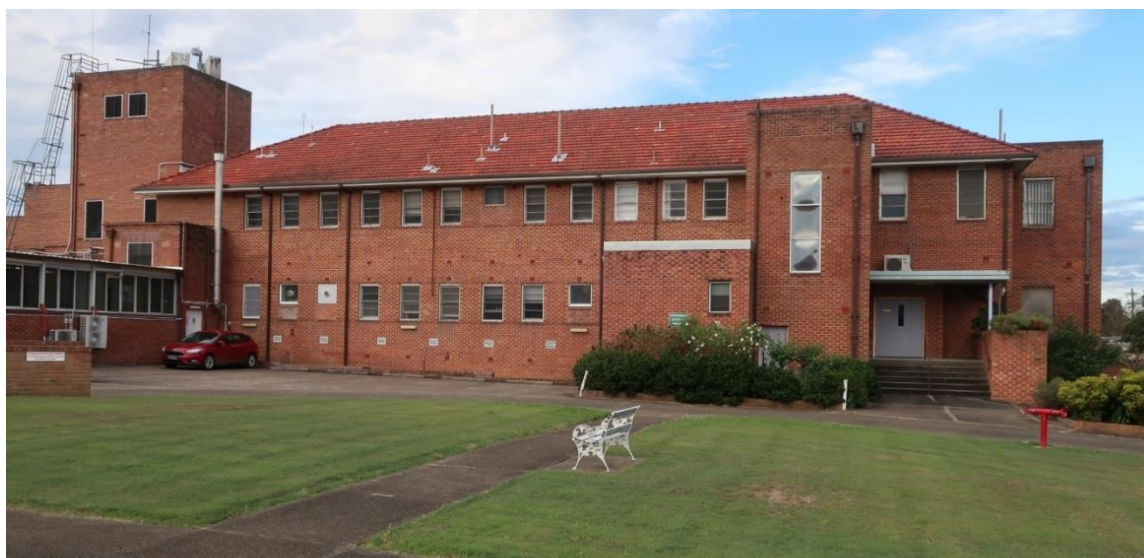
**Photo 3.20** The south-west elevation of the maternity wing, Building 17

The maternity wing was completed in 1949 in a style typical of the 1930s. It is constructed of brick walls, original windows are timber-framed and more recent ones are aluminium-framed; the hipped roof is tiled. Flat-roofed prisms contrast with the hip roof, in a manner that references early twentieth-century Continental Modernism. One curved wall return on the east side is similar to the larger Parramatta Hospital of the same period. The repeated windows give a sense of formality, appropriate on the second largest hospital building here built before 1950.

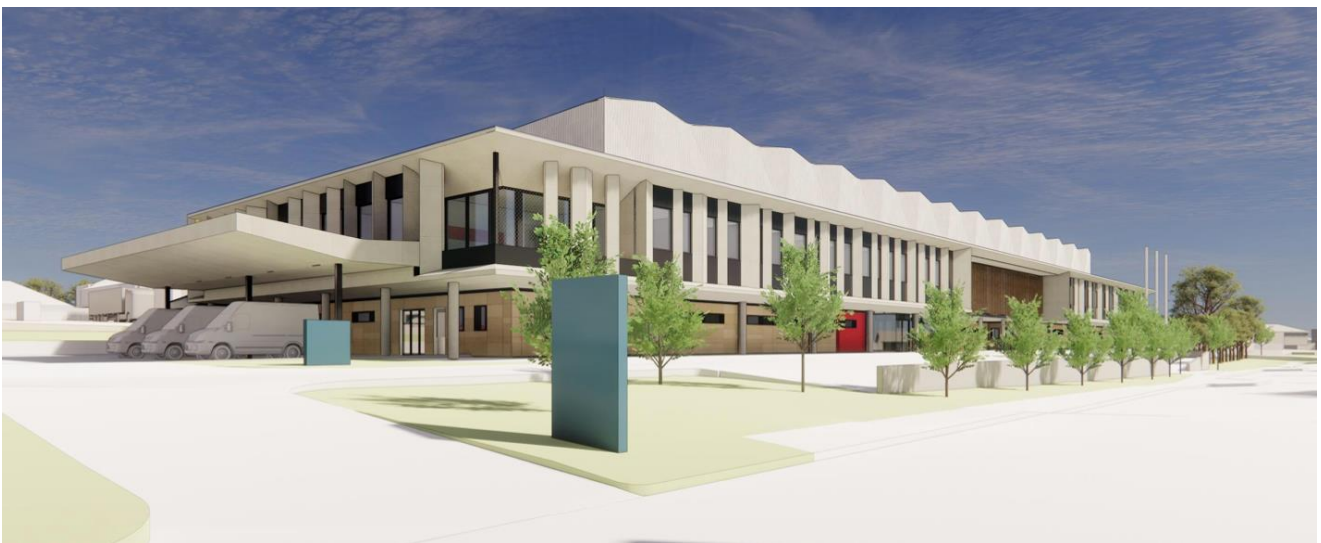
**Figure 7.1** Westerly rendering of the Cessnock Hospital Redevelopment from Jurd Street

- Demolition of the smaller buildings in the north of the site, including the mortuary building, sheds and minor service buildings, all located well north of the group of more significant buildings.
- Realignment of internal roads and a new primary vehicular and pedestrian entrance to the hospital campus from Jurd Street.
- Refurbishment of the existing at-grade car park.
- Installation and realignment of selected services.
- Installation of ancillary development including, but not limited to, lighting and signage.
- Landscaping.
- New kerb, gutter and road resurfacing on Jurd Street.
