# Manning Base Hospital Redevelopment - Stage 2

Final Heritage Report

Prepared for Mace Australia Pty Ltd on behalf of Health Infrastructure NSW  
August 2023

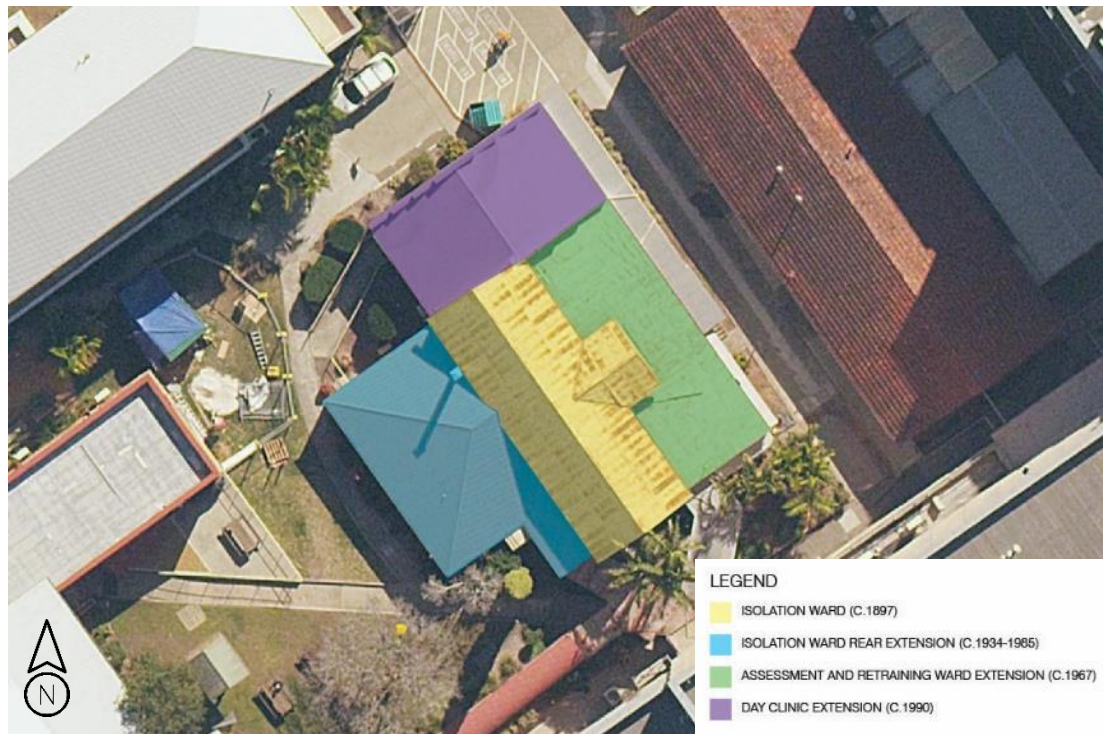
Plate 3.15 Indicative diagram illustrating various, likely phases of development to the Victoria Fever Ward. Source: base map by Metro Maps 2021, diagram by EMM.

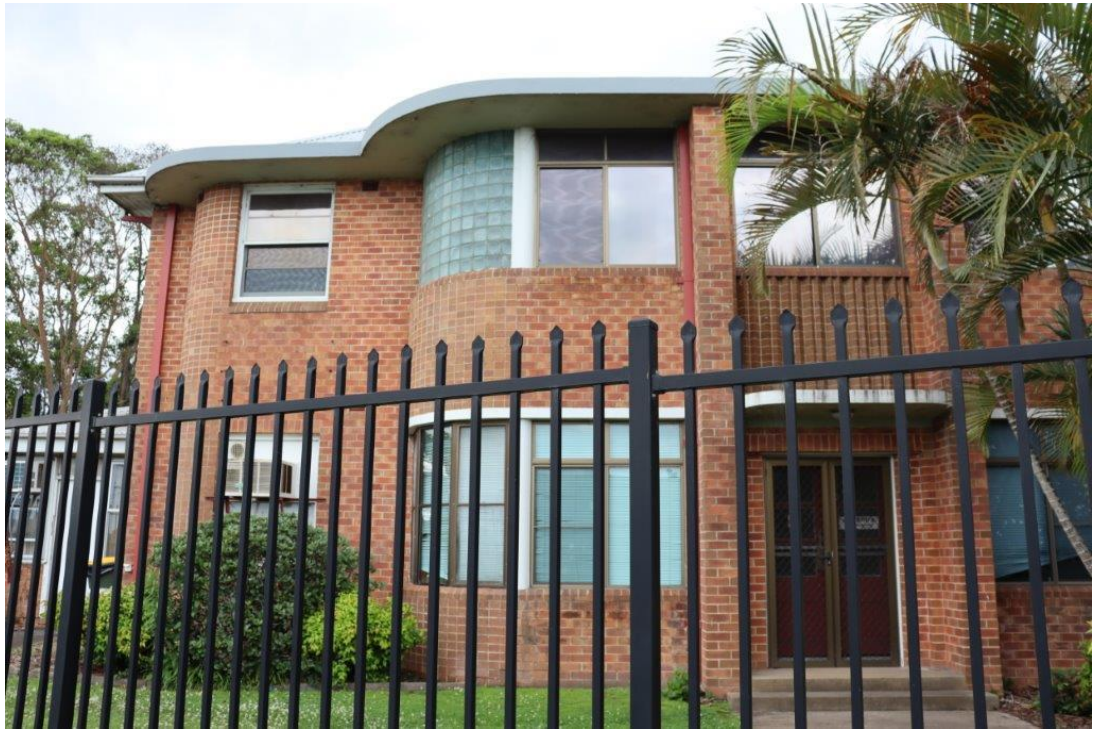
**Plate 3.17** South-east elevation to c.1941 nurse's quarters building section. Source: EMM 2021

The alterations and modifications to the second nurses' accommodation building were completed in 1941 (Plate 3.17) with the opening of the building in the same year. Within four years, the building was once again deemed inadequate accommodation for the nurses at the hospital and funds of £2,500 were raised for further structural additions. Plans for a major extension of the building were produced by Cobden Parkes in 1948 that included the construction of a double storey brick addition to the north-west of the existing nurses' accommodation building. The extension would provide over 50 new accommodation and amenities rooms.

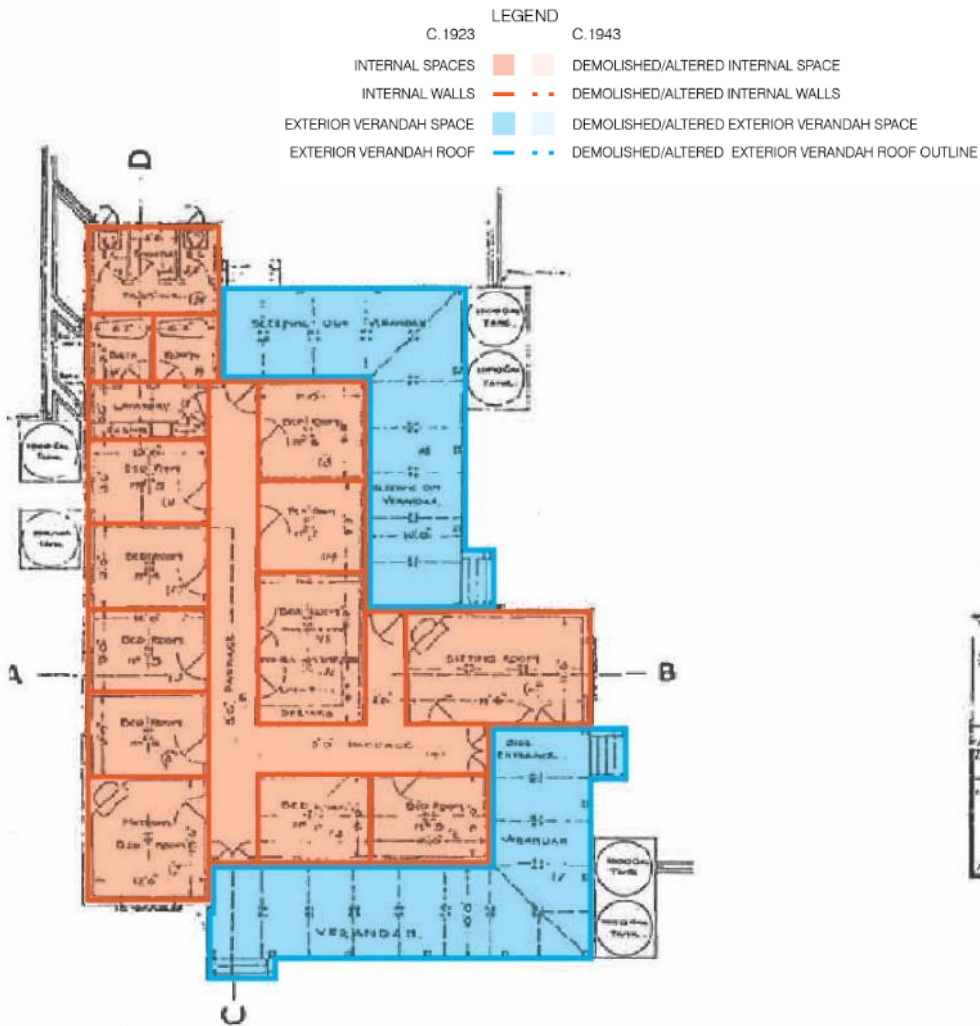
ALTERATIONS TO SECOND NURSE'S ACCOMMODATION BUILDING  
DRAWING C.1938 / BUILDING C.1941

Plate 3.20 Indicative diagram illustrating the proposed alterations, additions and modifications c.1938 (right) to the original c.1923 (left) second nurses' accommodation building. Source: EMM after DPWS 1999.

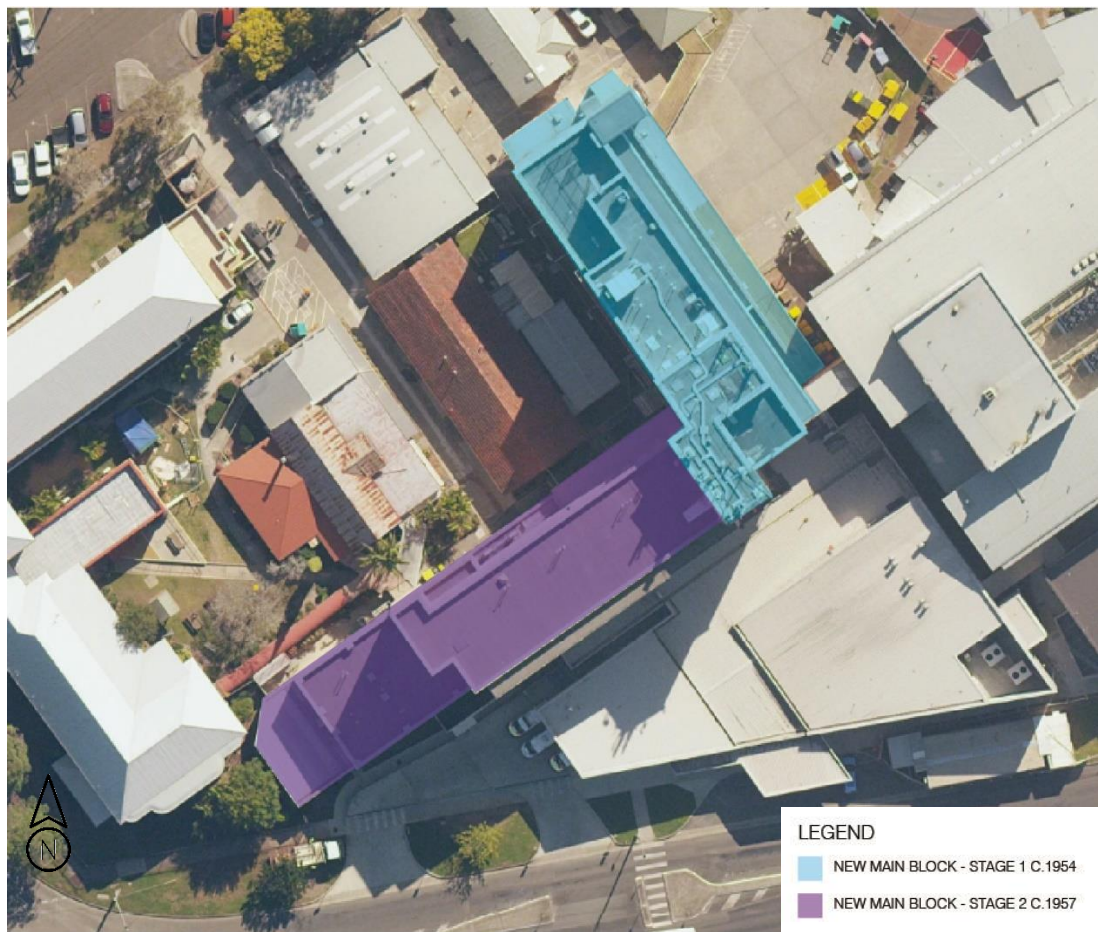
**Plate 3.24** Indicative diagram illustrating the two stages of development to the new main building (Building 01 – IPU). Source: base map by Metro Maps 2021, diagram by EMM.

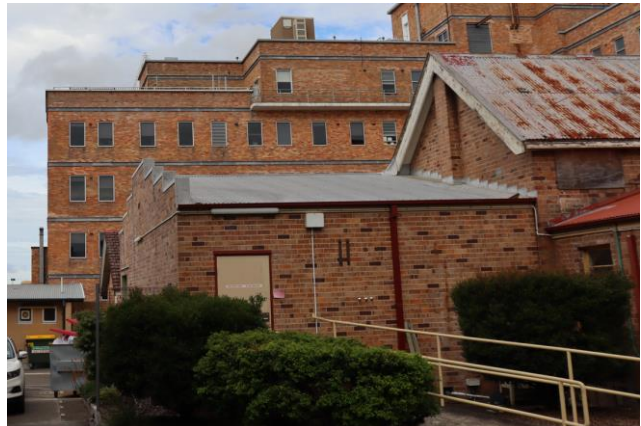
**Plate 4.7** c.1990 extension to the north-west elevation of the original building.

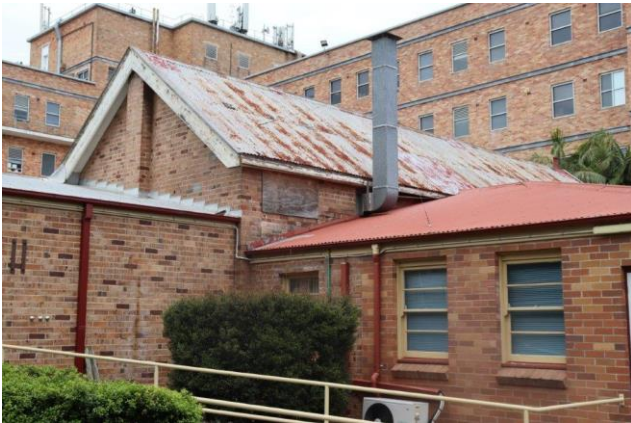
- when viewing the building to the north and south areas in close proximity to the building, a greater percentage of the original roofline and structure, gables and upper level elevation is visible. At these locations the former northern chimney stack and boarded skylight windows can be viewed (Plate 4.8 and Plate 4.9);

**Plate 4.8** Roof and upper section of original building to north-west.

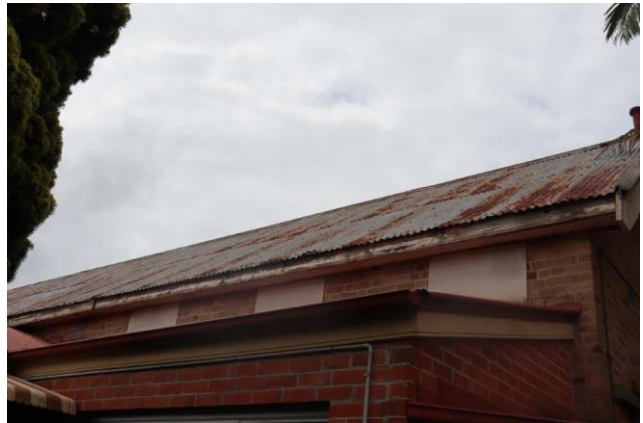
**Plate 4.9** Roof and upper section of original building to south-west.

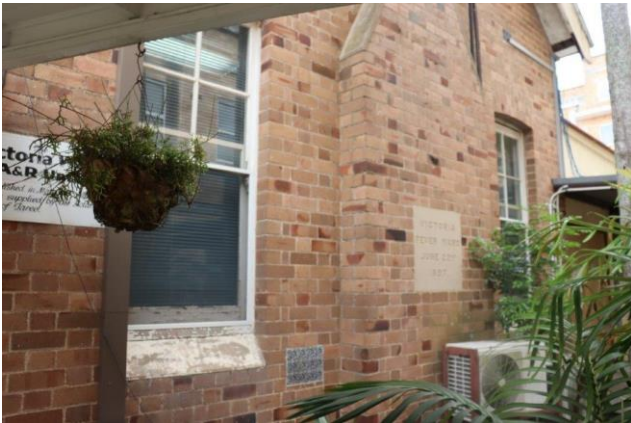
- The south-east elevation of the original Fever Ward building is fully exposed and includes the former chimney stack, original (boarded up) windows, decorative metal vents with a spiral motif (Plate 4.10) and a sandstone plaque integrated into the brickwork that includes the text 'Victoria Fever Ward June 22<sup>nd</sup> c.1897.' (Plate 4.11).

**Plate 4.10** Exposed original south-east elevation.

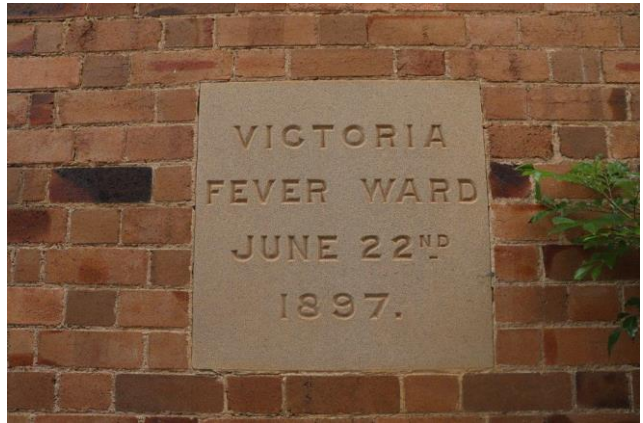
**Plate 4.11** Sandstone plaque to south-east elevation.

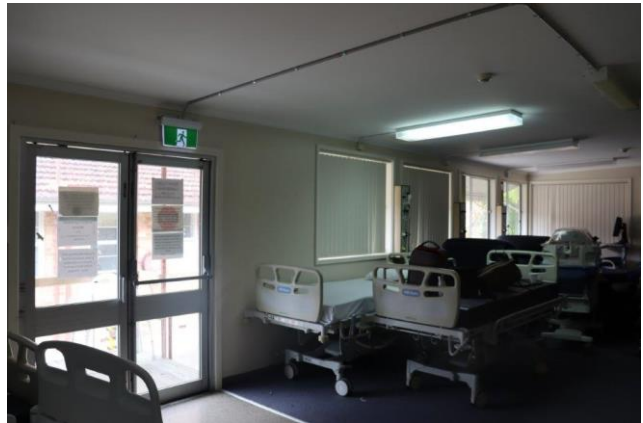
**Plate 4.13** Interior space and main entry to c.1967 extension to north east.

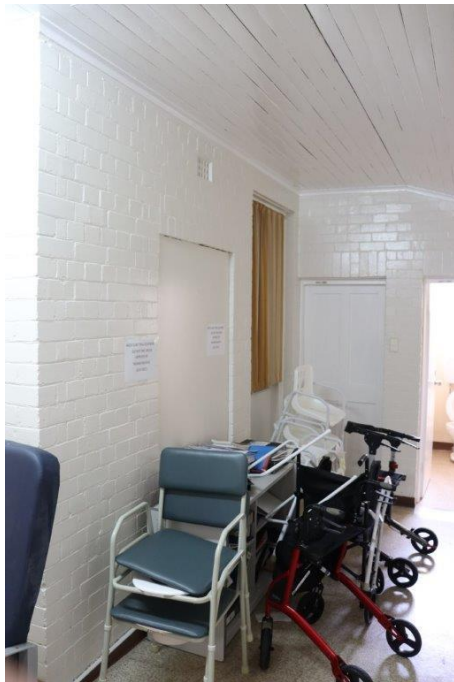
- the spaces and structures to the south-west are predominantly associated with the c.1934 extension this is characterised by white painted English bond brickwork, timber door panels, cupboards and windows that are typical of the inter-war period and a timber lined ceiling that alternates in angle throughout the interior. The extension includes several amenities spaces that appear to have been added or modified in the c.1950s in terms of fixtures, fittings, door panels and the introduction of new windows or window modifications;

**Plate 4.14** Interior space c.1932 extension to south-west.

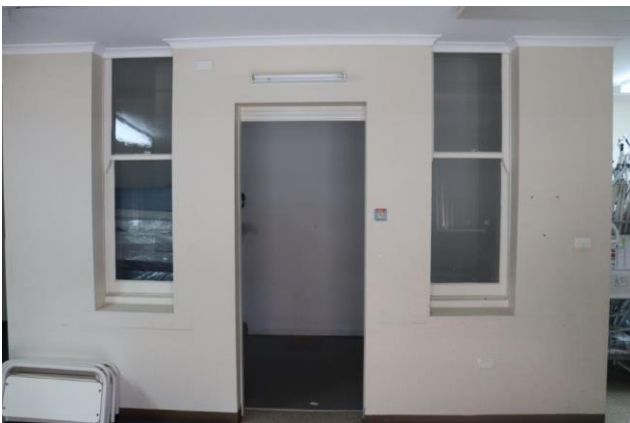
**Plate 4.16** Original Fever Ward main entry with timber framed windows.

- original double hung, timber windows;
  - decorative, circular air vents with a 'dagger' motif (Plate 4.17);
  - the original main door cavity with a missing door panel. The door fanlight is present and covered by plaster boarding that includes a lighting fixture and switchboard.

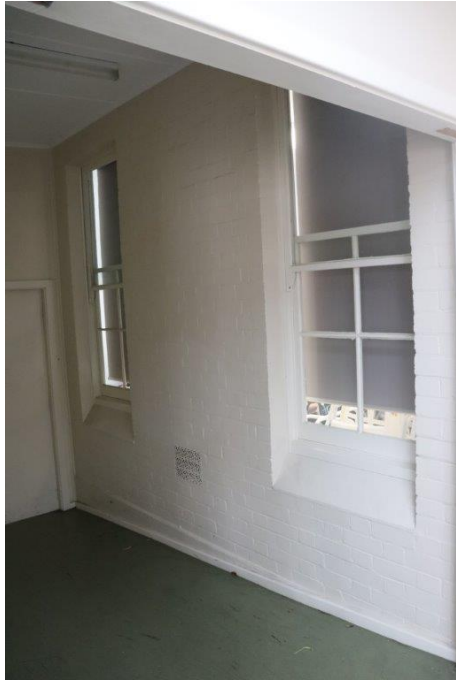
**Plate 4.18** Exposed original north-east elevation with original timber windows.

- a portion of the original north-east elevation is exposed to the south of the north-eastern space (c.1967 extension) that is characterised by white painted Flemish bond brickwork, original double hung, timber framed windows with angled sills and decorative metal vents with a spiral motif, also found externally to un-enclosed original external walls (Plate 4.18). This is reflected in the adjacent internal space (Plate 4.19). A portion of the original wall section is enclosed with a plaster wall with the original door cavity present. A portion of the timber door frame visible to the upper sections, however the original door panel is not present;

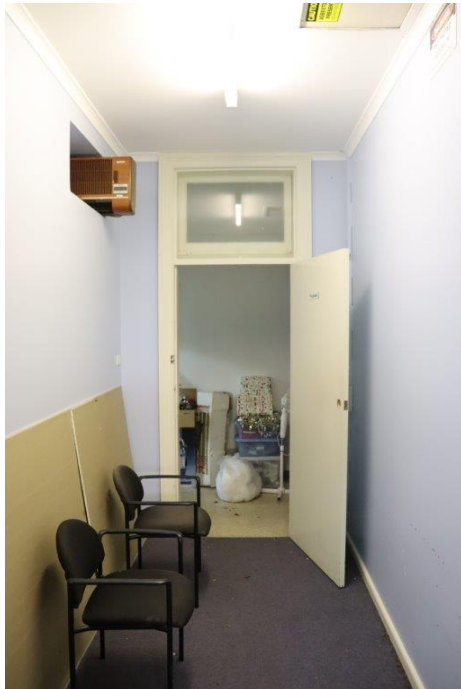
- various elements and features of the original central hallway are present including fully exposed timber framed doorway with original door hardware and fanlights with both plain and patterned glazed panels, to both ends (Plate 4.20). Small sections of original skirting boards and brickwork walls are also present. Recent plasterboard walls were introduced, segmenting the original internal spaces to the original 'Duty Room' and likely enclosing original walls to the smaller 'Clothes' and 'Lab' rooms (Plate 3.11);

**Plate 4.20** Original door opening and fanlight to hallway.

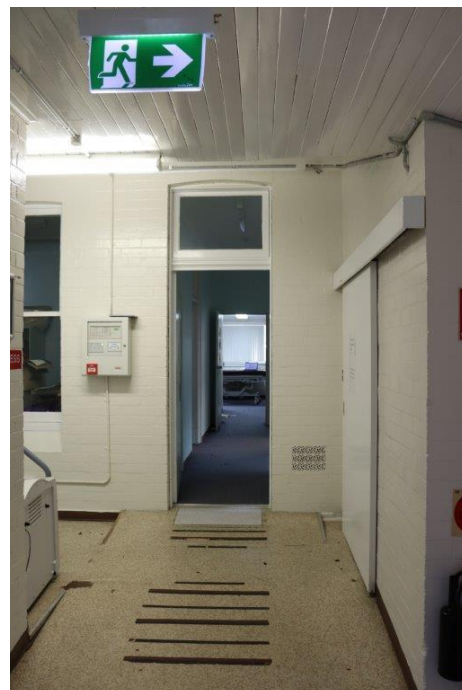
- the original south-west elevation is largely present, enclosed by the c.1934 extension. The elevation includes original Flemish bond brick walls, door cavities, door fanlights and timber framed, double hung windows (Plate 4.22 and Plate 4.23);

**Plate 4.23** Original door opening and window to enclosed south-west elevation.

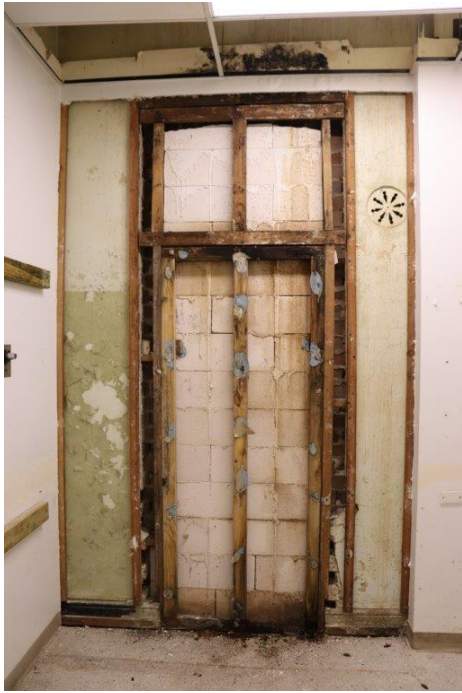
- a section of a wall to the north-western room has been exposed by the removal of plasterboard walls (Plate 4.24). This wall exhibits the original painted masonry walls, door opening and decorative vent. Concrete blocks introduced in the 1990s when the records room was constructed to fill in a window, are also evident. A section of the existing, dropped ceiling was also open, exposing the original mini-orb pressed tin ceiling and plastered cornice (Plate 4.25) located at a high level. The window cavities to the upper section windows were also present (Plate 4.25).

**Plate 4.24** Exposed section of original north-west wall and former door opening.

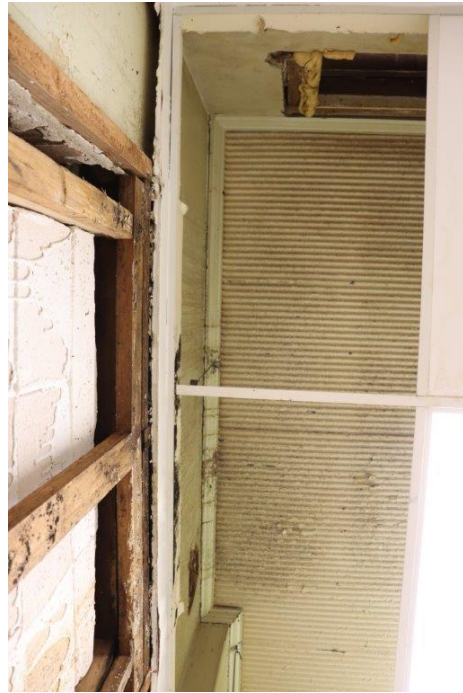
**Plate 4.25** Exposed original ceiling incl. corrugated ceiling and cornice.

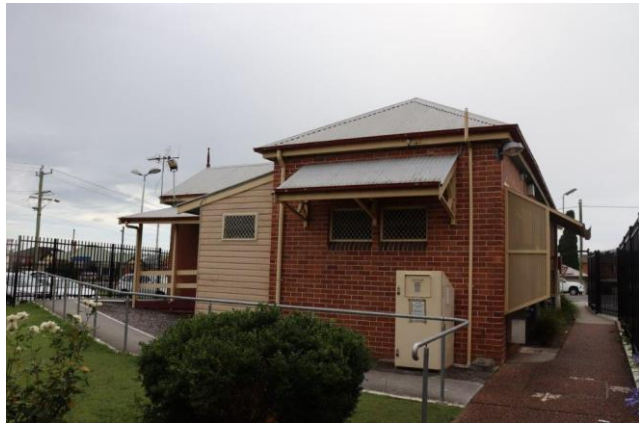
- a single storey extension has been added to the north of the building that appears to have been introduced in the late twentieth century. This section of the building includes a brick structure in stretcher bond, a small weatherboard side structure, timber framed awnings and roof structure with corrugated sheeting (Plate 4.27).

**Plate 4.27** Later addition and rear section of Building 11.

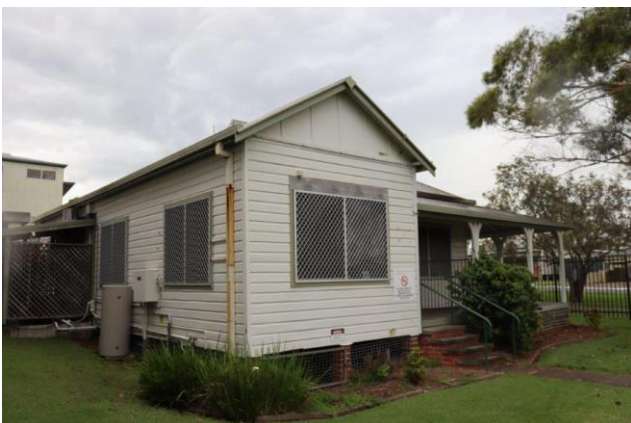
- raised building form on brick posts with a simple timber roof structure with corrugated sheeting.
- weatherboard cladding;
- large metal framed windows with flyscreens to all elevations;
- a timber deck to the north-east and north west elevation on a brick base with a timber awning supported by decorative timber posts.

The building is in a stable but poor to moderate condition. It was observed that a large percentage of the original cottage structure has been modified to introduce more recent windows, doors and roofing. The building is also a non-exceptional example of a weatherboard cottage that is common to the surrounding residential area.

**Plate 4.28** North-east elevation of Building 11.

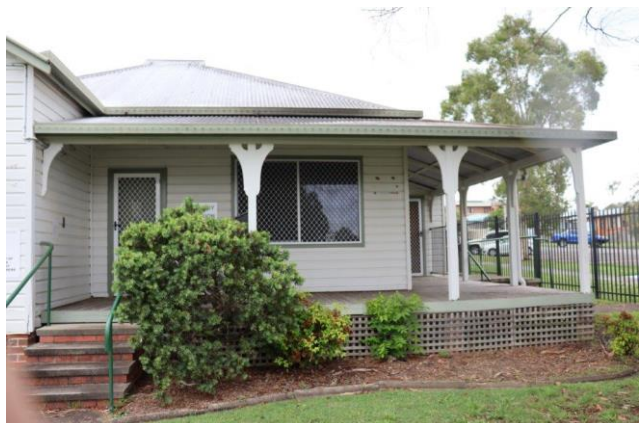
**Plate 4.29** North east elevation and verandah to Building 11.

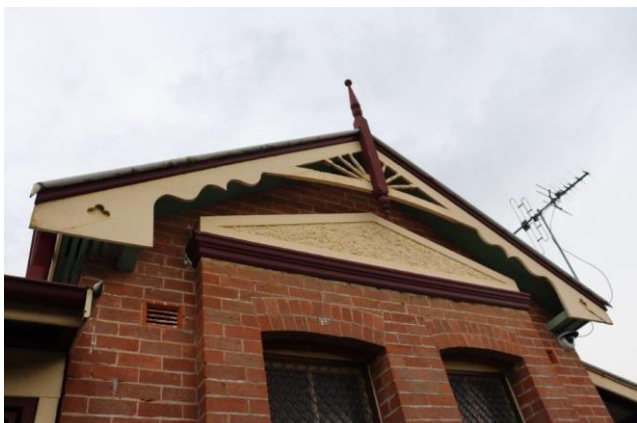
- double hung, timber framed windows with intrusive protective screens applied to framing; and
  - several decorative external features including decorative dado moulding, timber gable boards, finials, rough rendered pediments, terracotta vents, window sill moulding and stone wall bases (Plate 2.1).

**Plate 2.1** Roof structure, gable and upper section to south-east elevation of Building 11.

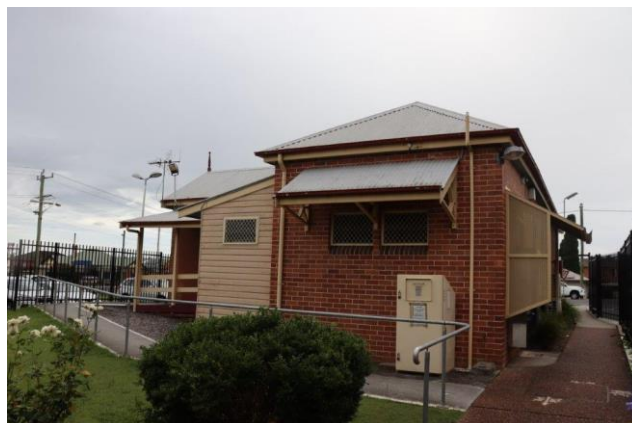
- a single storey extension has been added to the north of the building that appears to have been introduced in the late twentieth century. This section of the building includes a brick structure in stretcher bond, a small weatherboard side structure, timber framed awnings and roof structure with corrugated sheeting (Plate 2.2).

**Plate 2.2** Later addition and rear section of Building 11.

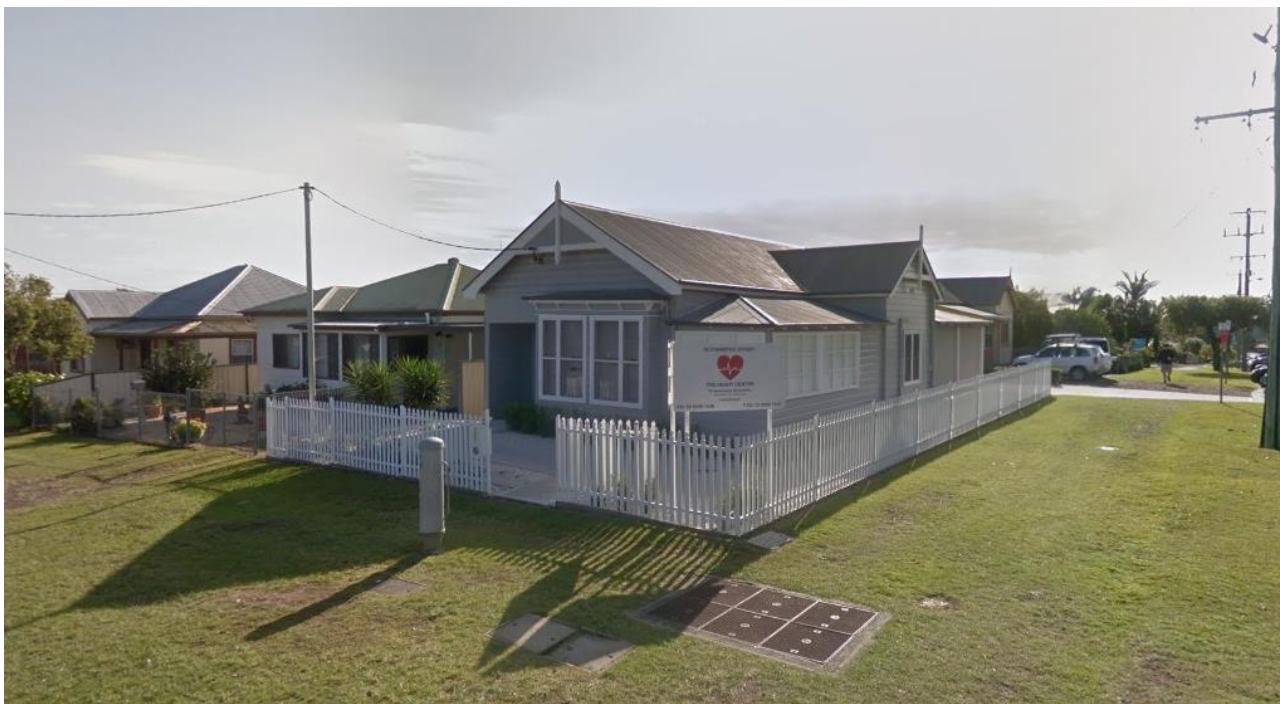
Item 128 is a single storey, weatherboard cottage with corrugated iron roofing, gables, finials, decorative bay window to the main elevation along Commerce Street and a rear skillion verandah and driveway accessed from York Street (Plate 2.3). The building appears to have been re-roofed and repainted in recent times and includes various external structural additions and extensions. The SHI listing for the item (SHI Online DB: 1660022) notes the building is known as the Former Royal Hotel that was historically located on Manchester Street in the township of Tinonee approximately 5 km to the south-west of Taree. It is unclear as to when the building was first constructed, when it was moved to Taree and when it changed to its current function as a 'The Heart Centre' (cardiologist's office and practice). This building is not managed by or associated with MBH.

**Plate 2.3** Item 128, Dwelling, 'former Blood Bank and former Tinonee Royal Hotel' Source: Google Maps.

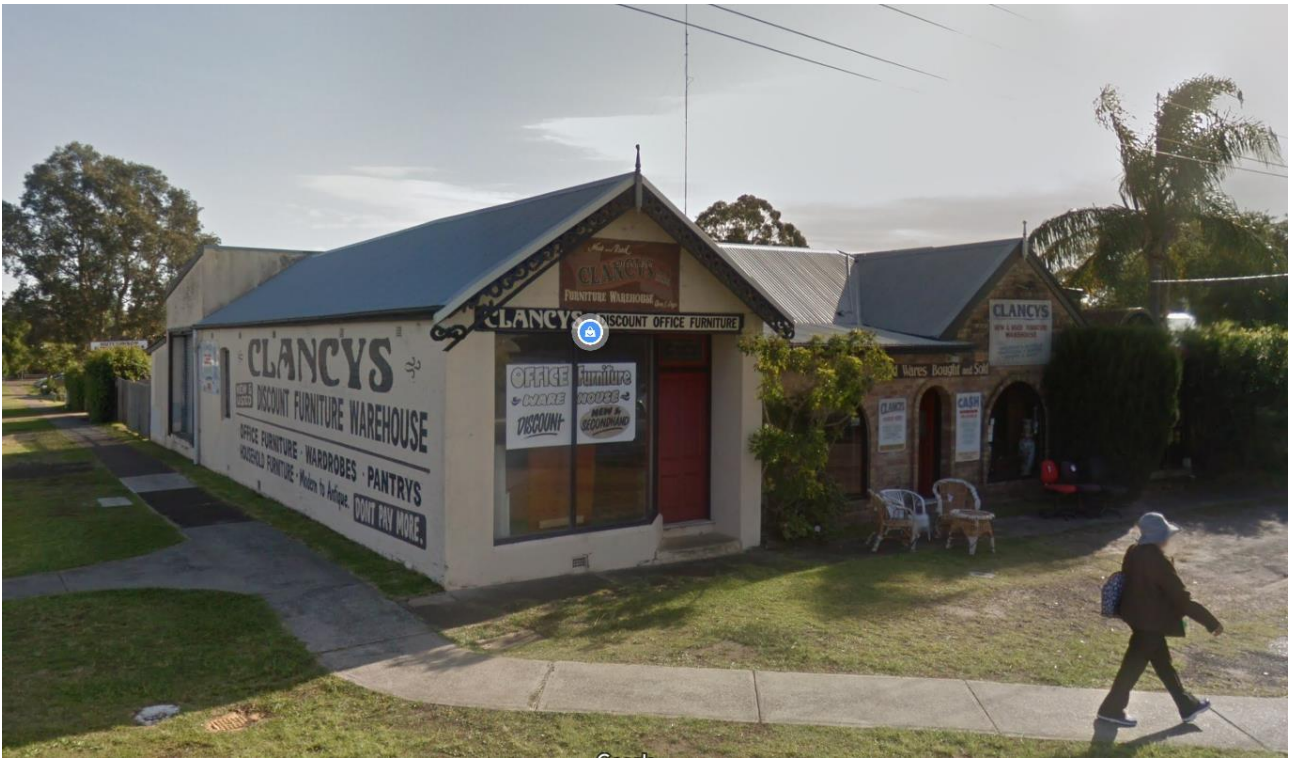
Item 153 is a single storey, brick and cement rendered (stone patterned) building (Plate 2.4). The building exhibits prominent gable ends to street facing gables with decorative barge boards and finials. The SHI listing for the item (SHI Online DB: 1660053) notes that the building has been compromised by later additions including a brick awning introduced to the High Street elevation and rear extension to the rear of the building along Pulteney Street. The construction date of the building is unknown. The building currently functions as a furniture warehouse.

Plate 2.4 Item 153, Commercial building. Source: Google Maps.

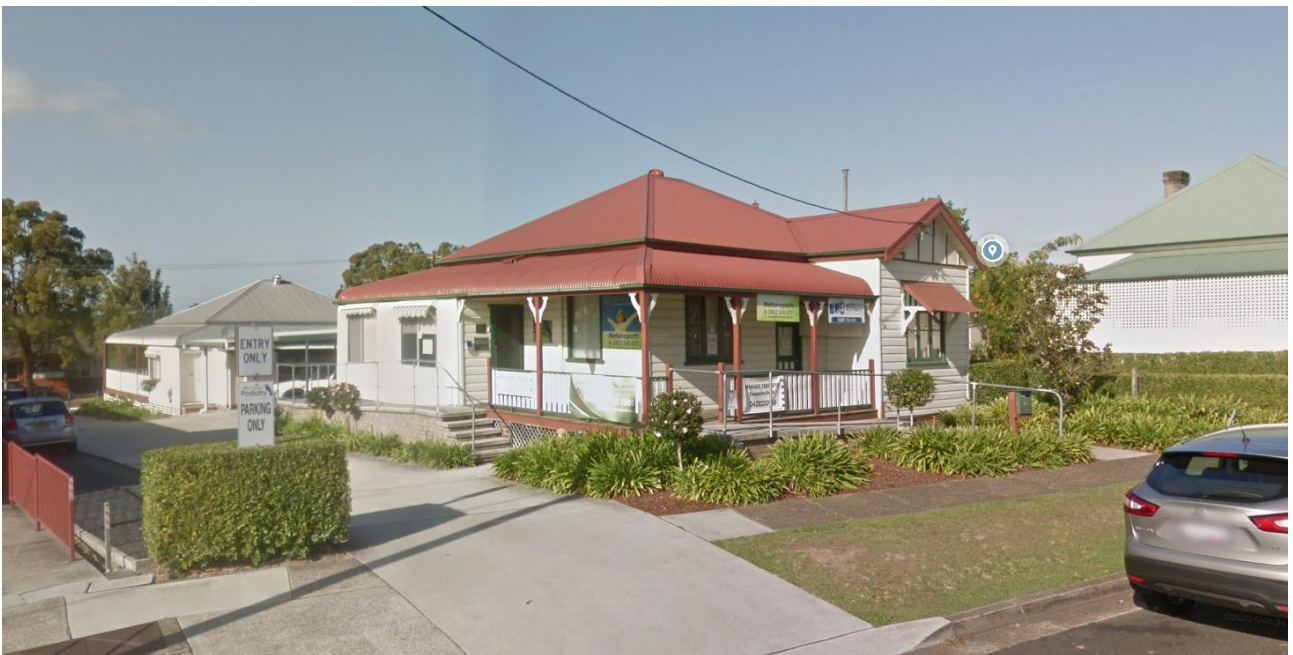
Item 155 is a single storey weatherboard cottage with corrugated sheeted roofing, front awning to verandah with decorative posts, decorative gables and timber framed widows with window awnings (Plate 2.5). The SHI listing for the item (SHI Online DB: 1660056) notes that the building was likely constructed in the early twentieth century as a residence and forms part of a group of similar buildings with numbers 86, 96 (Item 156) and 100 located along High Street. The building currently functions as 'Nutritious Movement Exercise Physiology' (physiotherapists practice) and is not associated with the function of MBH.

Plate 2.5 Item 155, Dwelling. Source: Google Maps.

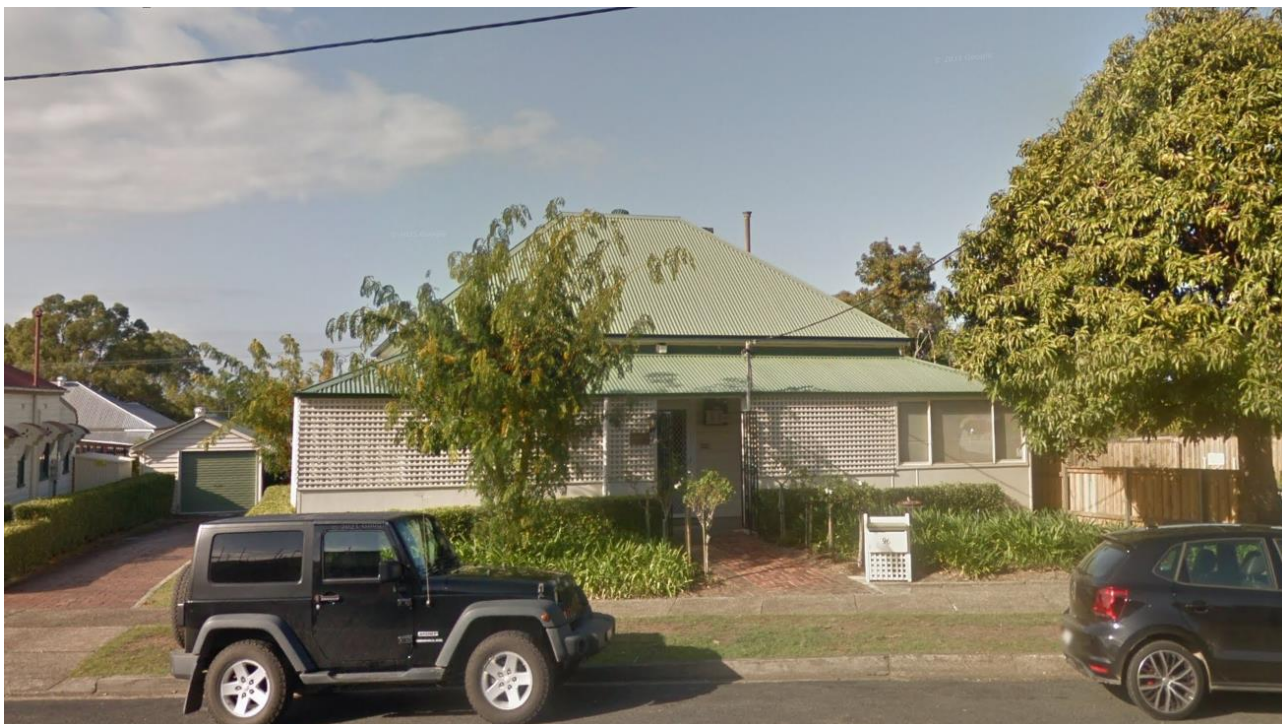
Item 156 is a single storey weatherboard cottage with corrugated roof sheeting and a front verandah enclosed with gridded panel screening (Plate 2.6). The SHI listing for the item (SHI Online DB: 1660057) notes that the building was likely constructed in the late nineteenth century, originally functioned as a residence forms part of a group of similar buildings with numbers 86, 94 (Item 155) and 100 located along High Street. The building currently functions as a residence.

Plate 2.6 Item 156, Dwelling. Source: Google Maps.
