REPORT TO  
**HEALTH INFRASTRUCTURE**

ON  
**SUPPLEMENTARY GEOTECHNICAL INVESTIGATION**

FOR  
**PROPOSED CESSNOCK  
HOSPITAL REDEVELOPMENT**

AT  
**24 VIEW STREET, CESSNOCK, NSW**

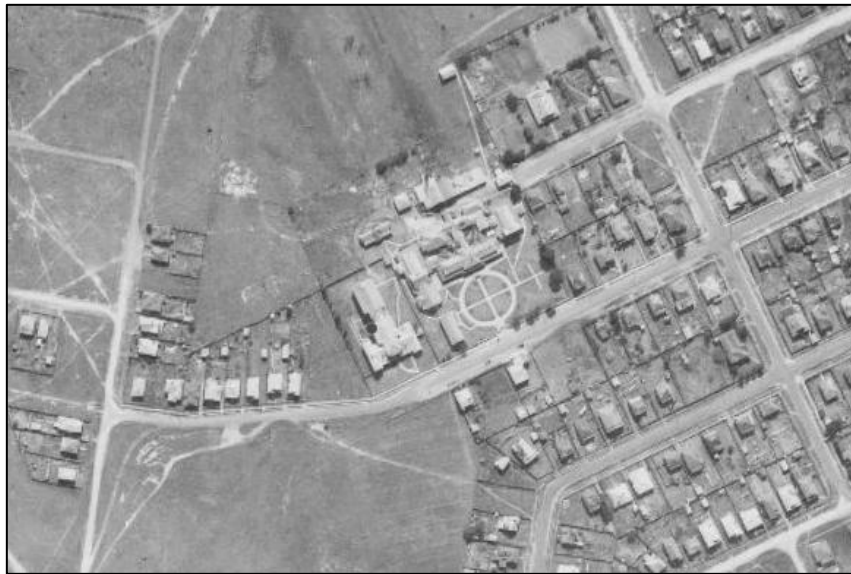
Plate 1 – 1944 historical aerial imagery

Based on publicly available historical aerial imagery, in 1944 the majority of the existing southern portion of the site has been developed, with many of the structures shown still present at the time of our investigation albeit with minor alterations, as shown in Plate 1 below. The northern portion of the site remained largely undeveloped. There is also evidence of a drainage channel in the northern portion of the site which potentially is a natural gully landform.

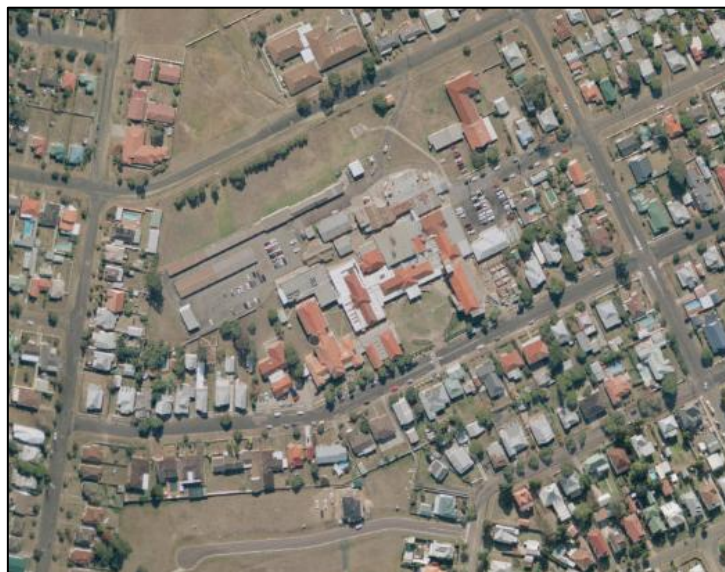
Plate 2 – 2006 historical aerial imagery

The aerial imagery from 2006 shows the construction of the external on-grade car park within the western portion of the site and the access road from Jurd Street. The single storey structures that bound the external car park to the north and west are also present. Reference should be made to Plate 2 below.

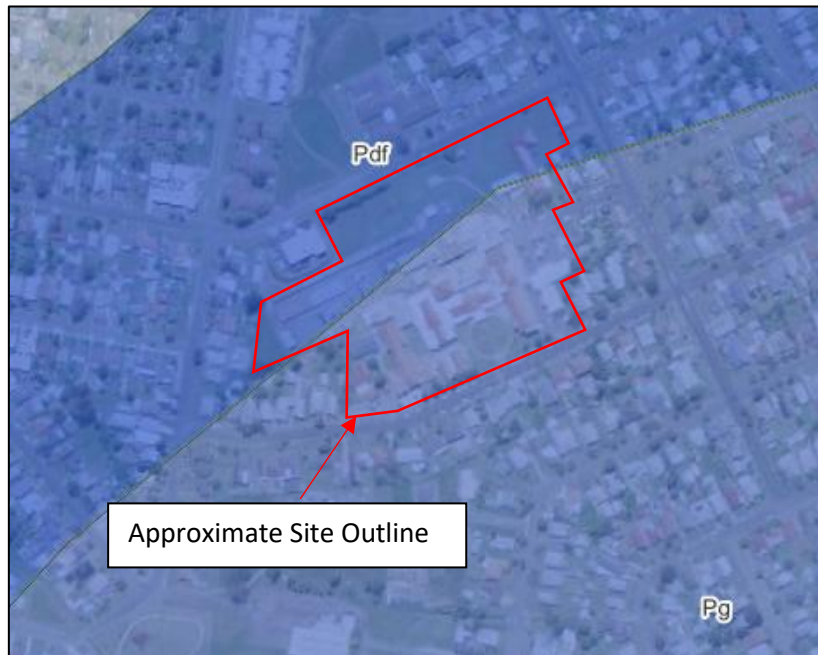
Plate 3 – Excerpt from Singleton 1:250,000 Geological Series Sheet (Pdf-Farley Formation, Pg-Greta Coal Measure)

The *Singleton 1:250,000 Geological Series Sheets* indicate that the southern portion of the site is underlain by the Greta Coal Measures, which typically comprises sandstone, conglomerate, shale and coal seams. The northern portion of the site is mapped as being underlain by the Farley Formation which typically comprises mudstone, sandstone, shale and limestone. Reference should be made to Plate 3 below.

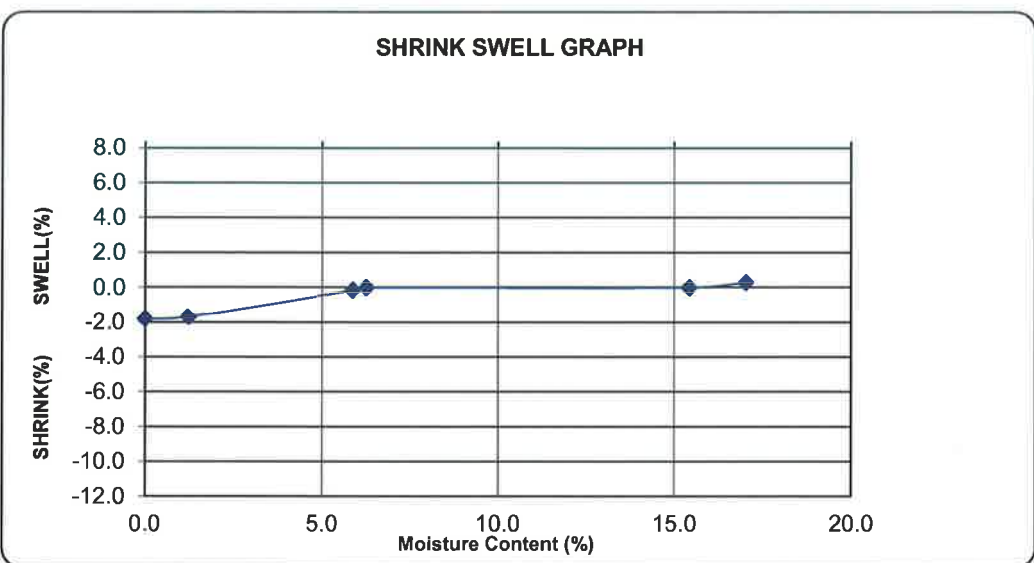
**SHRINK SWELL GRAPH**

Borehole No.: 3		Depth: 0.50 - 0.88m			
MOISTURE CONTENT (SWELL)		ESTIMATED UNCONFINED COMPRESSIVE STRENGTH			
BEFORE TEST	AFTER TEST	BEFORE	TEST	AFTER	TEST
15.4%	17.0%	330,520	kPa	>320	kPa
LOAD	SETTLEMENT UNDER LOAD BEFORE SATURATION		SWELL ON SATURATION		SHRINKAGE
25	-0.8%		0.3%		1.7%

**SHRINK SWELL INDEX**  
1.05 %/pF

The results of the shrink-swell testing from samples taken from BH3, BH7 and BH20 returned values of 1.05%/pF, 1.52%/pF and 1.20%/pF, respectively. This indicates the soils tested have a moderate potential for shrink/swell reactivity with changes in moisture content. Reference should be made to the attached STS Table C and C1 for further details.

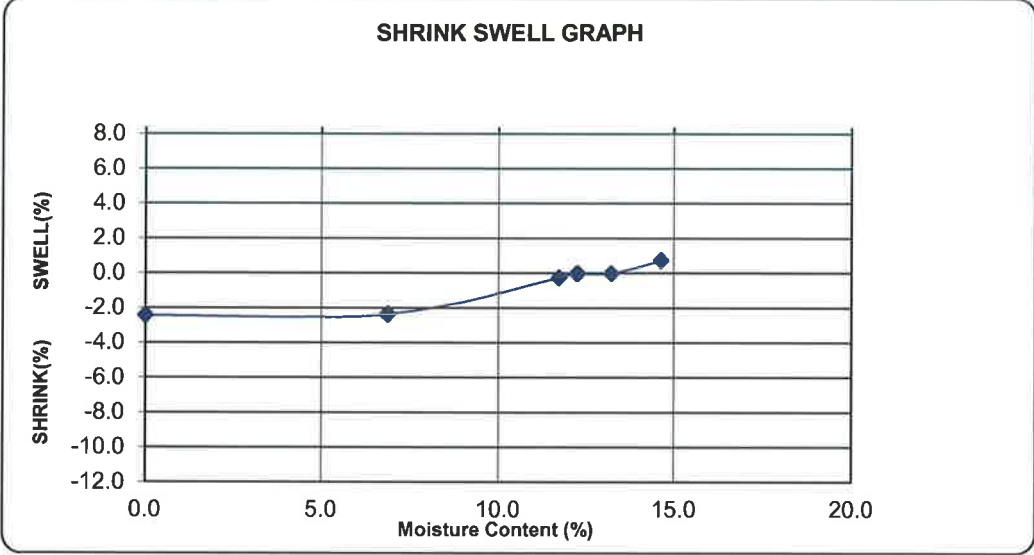
**SHRINK SWELL GRAPH**

Borehole No.: 7		Depth: 1.50 - 1.89m			
MOISTURE CONTENT (SWELL)		ESTIMATED UNCONFINED COMPRESSIVE STRENGTH			
BEFORE TEST	AFTER TEST	BEFORE	TEST	AFTER	TEST
13.2%	14.6%	200,280	kPa	>290	kPa
LOAD	SETTLEMENT UNDER LOAD BEFORE SATURATION	SWELL ON SATURATION		SHRINKAGE	
25	-0.8%	0.7%		2.4%

**SHRINK SWELL INDEX**  
**1.52 %/pF**

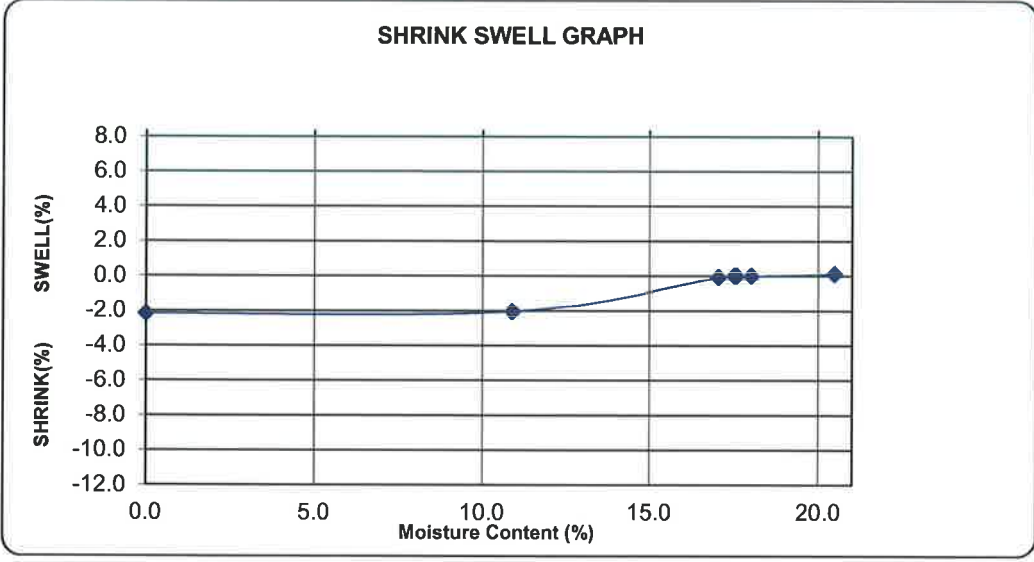
**SHRINK SWELL GRAPH**

Borehole No.: 20		Depth: 0.60 - 0.91m			
MOISTURE CONTENT (SWELL)		ESTIMATED UNCONFINED COMPRESSIVE STRENGTH			
BEFORE TEST	AFTER TEST	BEFORE	TEST	AFTER	TEST
18.0%	20.5%	400,440	kPa	>280	kPa
LOAD	SETTLEMENT UNDER LOAD BEFORE SATURATION	SWELL ON SATURATION	SHRINKAGE		
25	-2.0%	0.1%	2.1%

<b>SHRINK SWELL INDEX</b>
<b>1.20 %/pF</b>

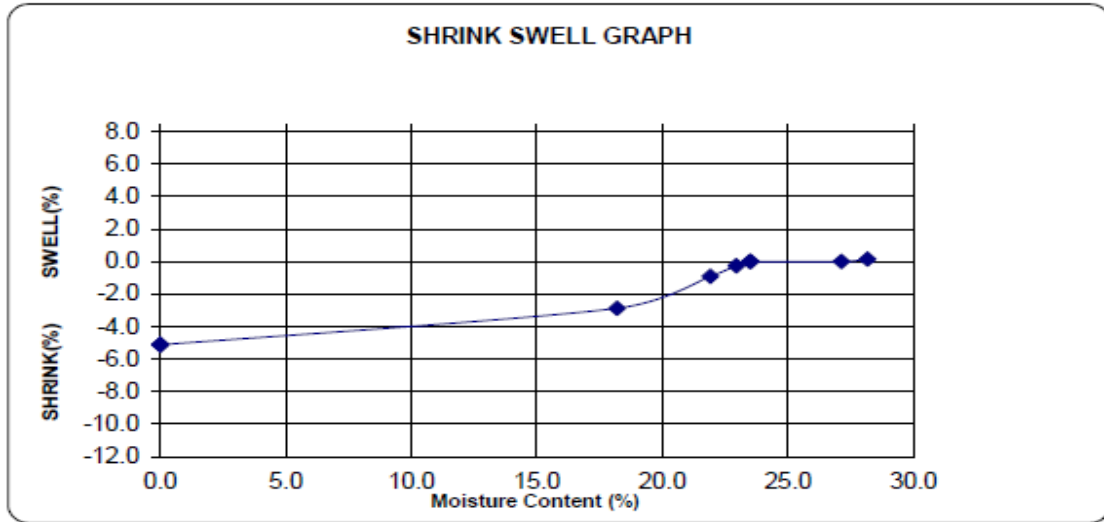
Borehole No.: 105		Depth: 0.50 - 0.80m			
MOISTURE CONTENT (SWELL)		ESTIMATED UNCONFINED COMPRESSIVE STRENGTH			
BEFORE TEST	AFTER TEST	BEFORE	TEST	AFTER	TEST
27.1%	28.2%	90,140	kPa	100	kPa
LOAD	SETTLEMENT UNDER LOAD BEFORE SATURATION	SWELL ON SATURATION	SHRINKAGE		
25	-1.9%	0.1%	5.0%

**SHRINK SWELL INDEX**  
 2.80 %/pF

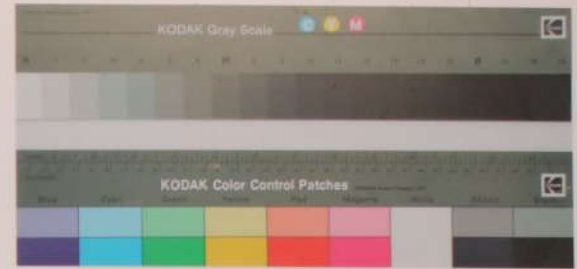
Job No: 36230BF  
Borehole No: BH104  
Depth: 5.51m to 11.67m

3623DBF BH104 START CORING AT 5.51m

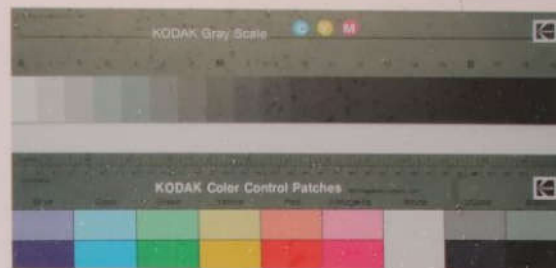
Job No: 36230BF  
Borehole No: BH105  
Depth: 3.66m to 9.76m

36230BF      BH105      START CORING AT 3.66m

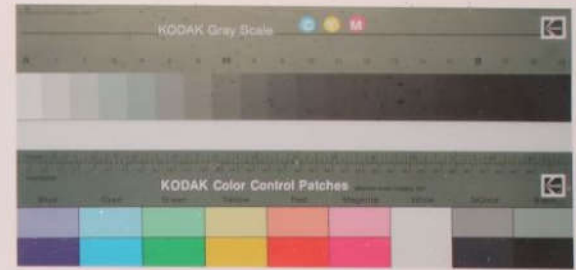
Job No: 36230BF  
Borehole No: BH106  
Depth: 3.64m to 9.74m

36230BF BH106 : START CORING AT 3.64m

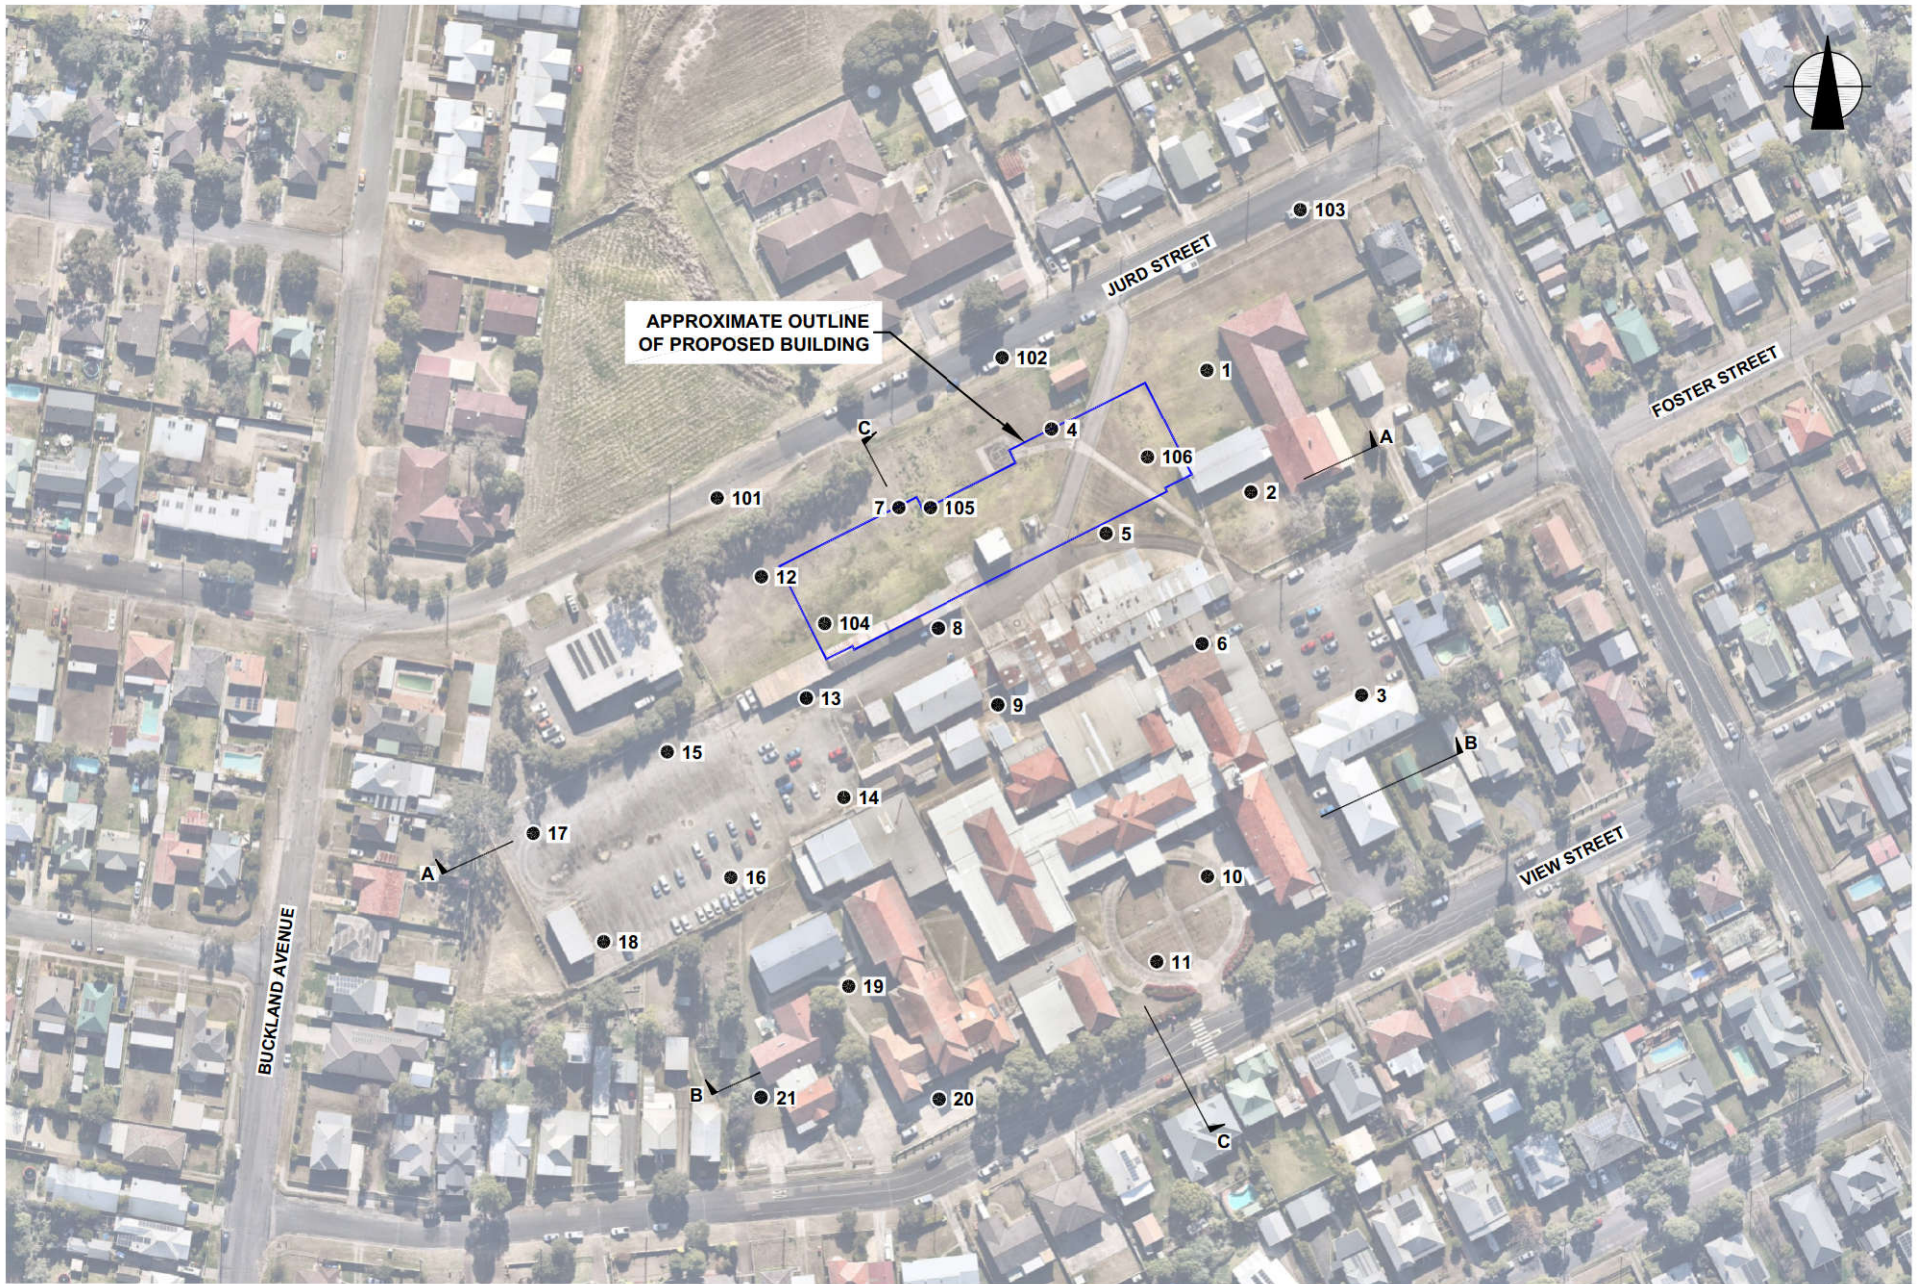
1. REFER TO FIGURE 3 FOR SECTION A-A.
2. REFER TO FIGURE 4 FOR SECTION B-B.
3. REFER TO FIGURE 5 FOR SECTION C-C.

The boreholes encountered a generalised subsurface profile comprising shallow to moderately deep fill over residual clay soils, with bedrock at predominately shallow to moderate depths. Groundwater was only encountered in a select few boreholes but was considered to be perched water seepage rather than the groundwater table. The more pertinent details of the materials encountered are provided below. Reference should be made to the borehole logs for details of the encountered subsurface conditions at each location and Figures 3 to 5 for Section A-A, B-B and C-C.
