TREE SURVEY

ARBORICULTURAL IMPACT ASSESSMENT & TREE PROTECTION PLAN

Batemans Bay Community Health
7 Pacific Street, Batemans Bay
Version 3

10 June 2024

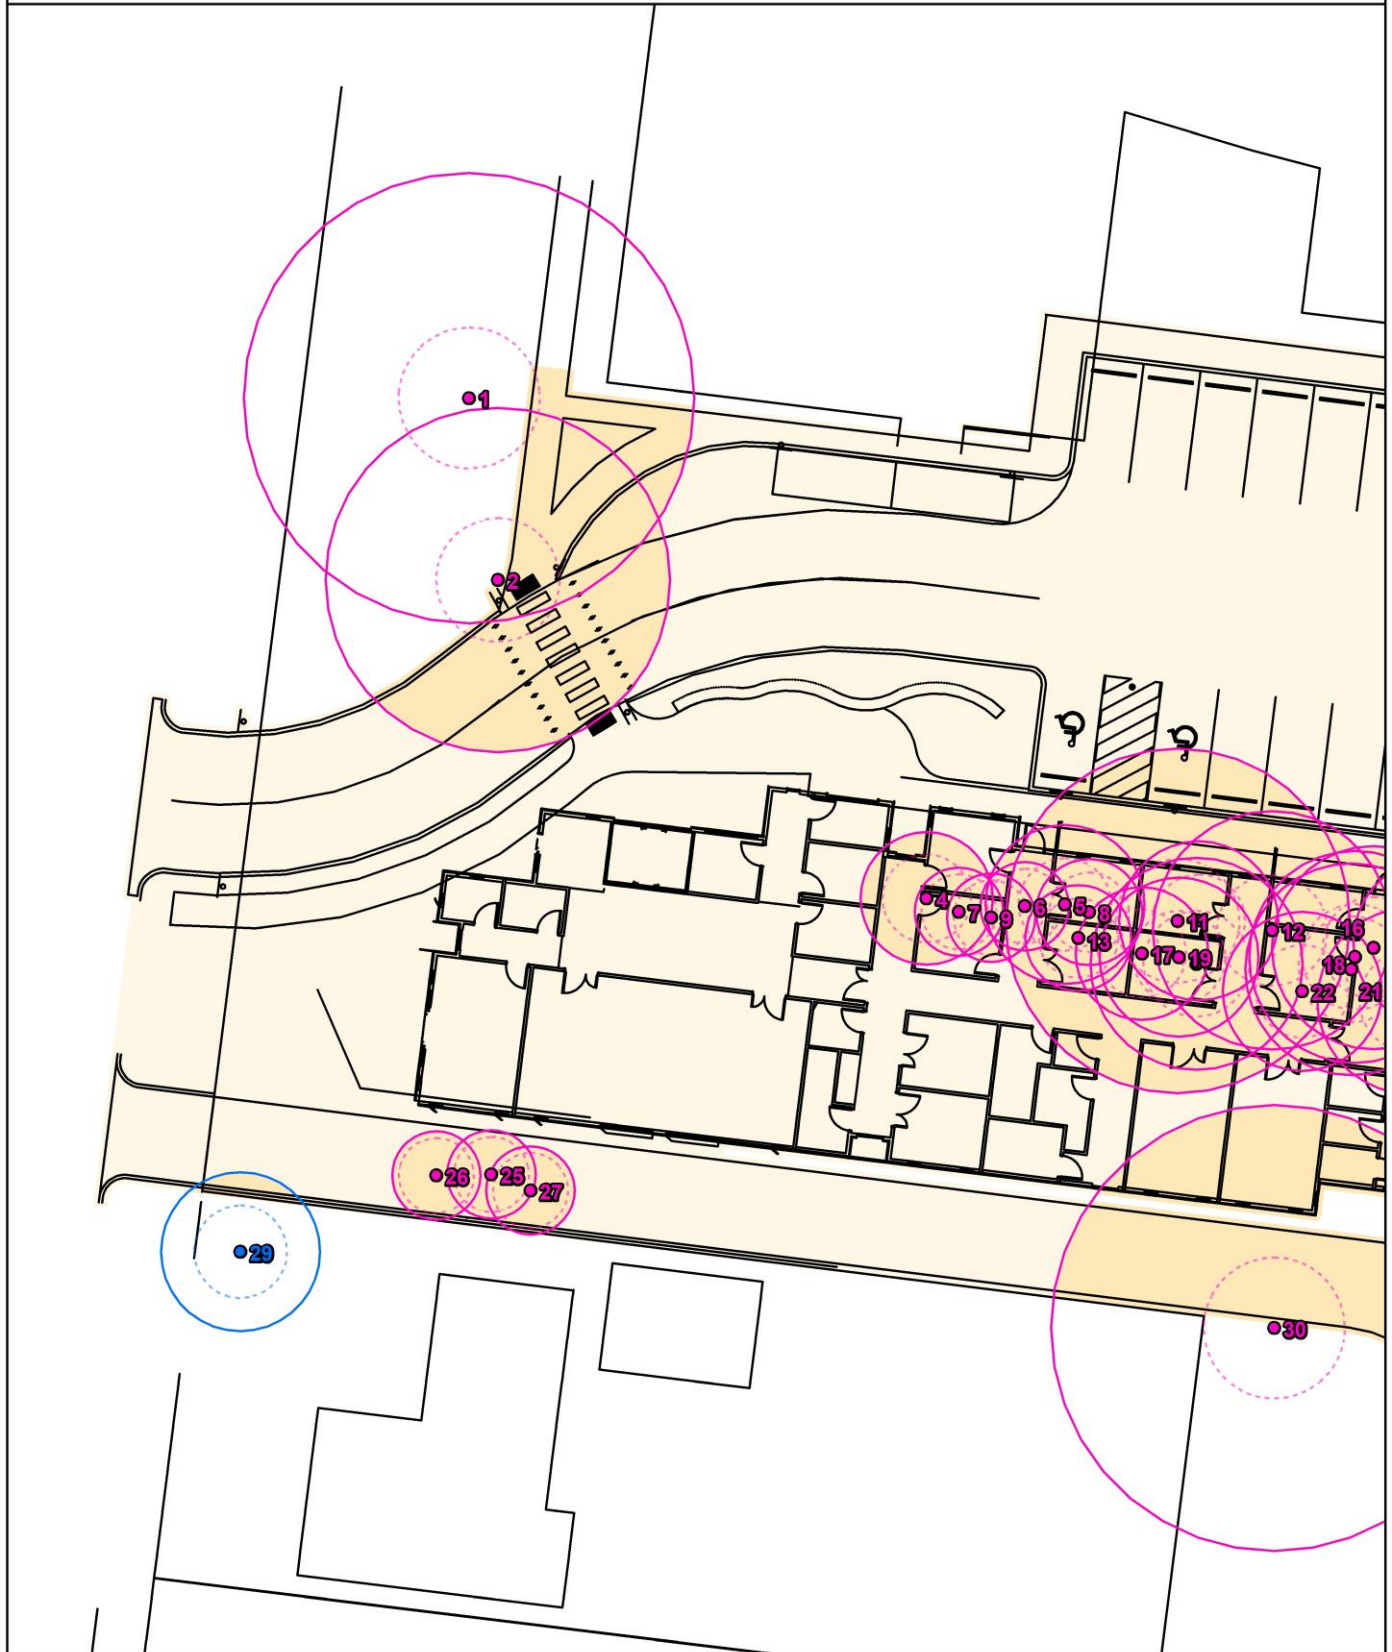
- **Nil encroachment (0%):** A total of **2** trees will be subject to nil encroachment.
- **Minor encroachment (<10%):** A total of **2** trees will be subject to minor encroachment.
- **Major encroachment (>10%):** A total of **27** trees will be subject to major encroachment.

A total of **27** trees will be subject to a major encroachment of greater than 10% within the TPZ:

- **Remove:** A total of **25** trees will be subject to a major encroachment of greater than 20% within the TPZ. Encroachment of greater than 20% can begin to impact the structural root zone (SRZ) and is more likely to compromise tree stability” (Costello, Watson, and Smiley (2017, p.21²). Impacts within the SRZ are not recommended as it may lead to the destabilisation and/or decline of the tree. These trees are located inside or directly adjacent to the proposed construction footprint and cannot be retained under the current proposal.

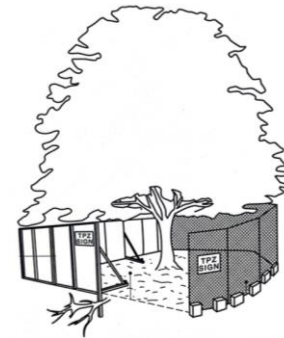
- Temporary mesh panel fencing (minimum height of 1.8m).
- Installed prior to site establishment and remain intact until the completion of works.
- Protective fencing must not be removed or altered without the approval of the project arborist.
- Prominently signposted with 300mm x 450mm boards stating, "NO ACCESS - TREE PROTECTION ZONE."
- Certified and inspected by the project arborist.

If tree protection fencing is not practical due to site constraints, tree protection delineation must be installed as an alternative. Specifications for tree protection barriers are as follows:

- Star pickets spaced at 2m intervals,
- Connected by a continuous high-visibility barrier/hazard mesh or flagging rope.
- Maintained at a minimum height of 1m.
