Royal Prince Alfred Hospital Redevelopment (RPAH  
Redevelopment)

Construction Noise and Vibration Monitoring Report 8

Project ID	20230239.17
Document Title	Construction Noise and Vibration Monitoring
Attention To	CPB Contractors Pty Limited

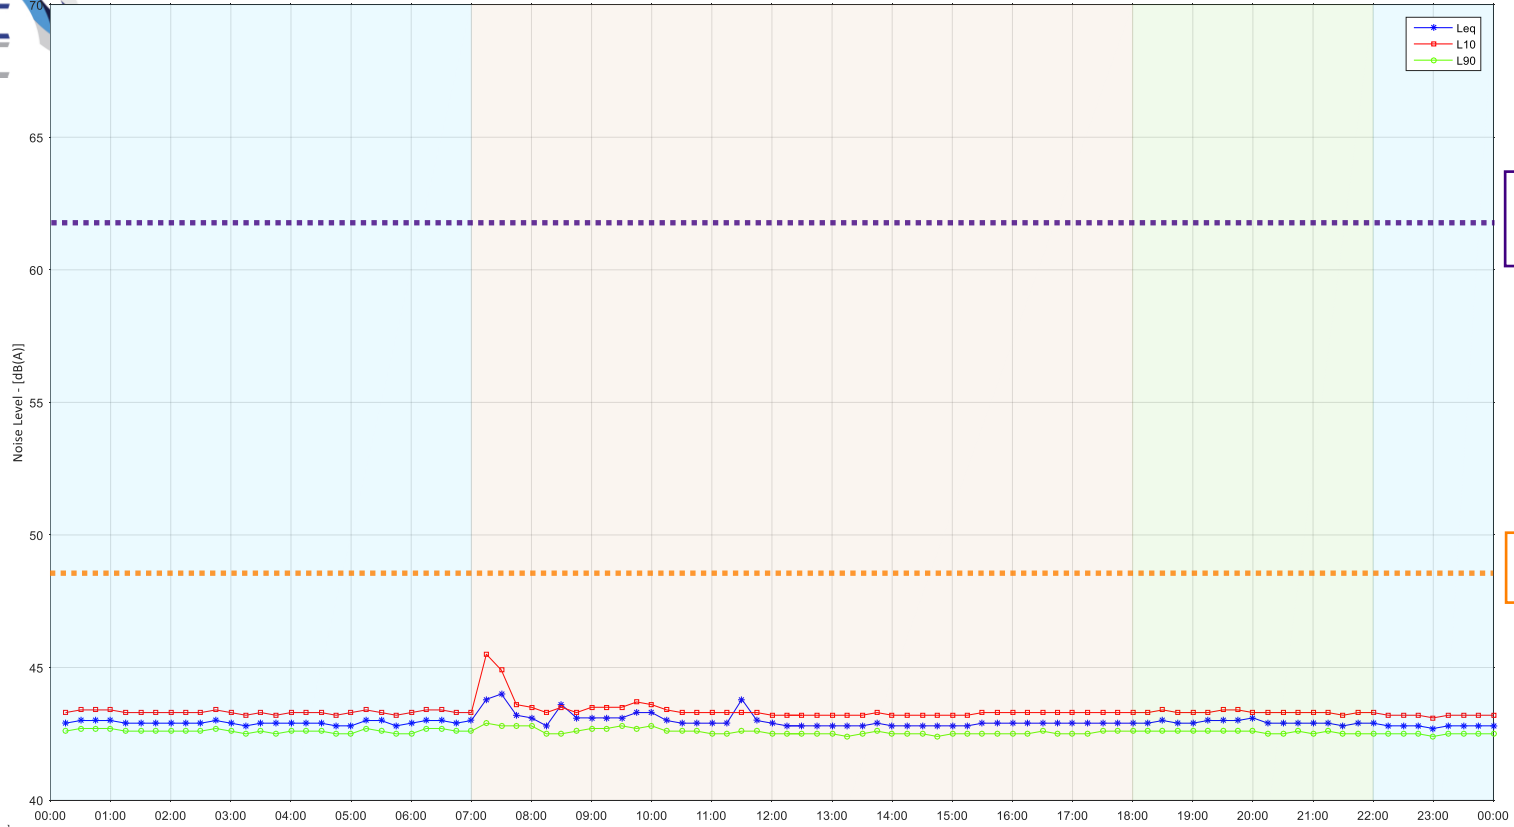
### Centenary Institute - L4 Surgery Room: Sunday 24 March, 2024

**Animal Housing / Breeding / Observation Room NML**  
 $\leq 62\text{dB(A)}L_{\text{eq}}$

**Animal Operating Room NML**  
 $\leq 48\text{dB(A)}L_{\text{eq}}$

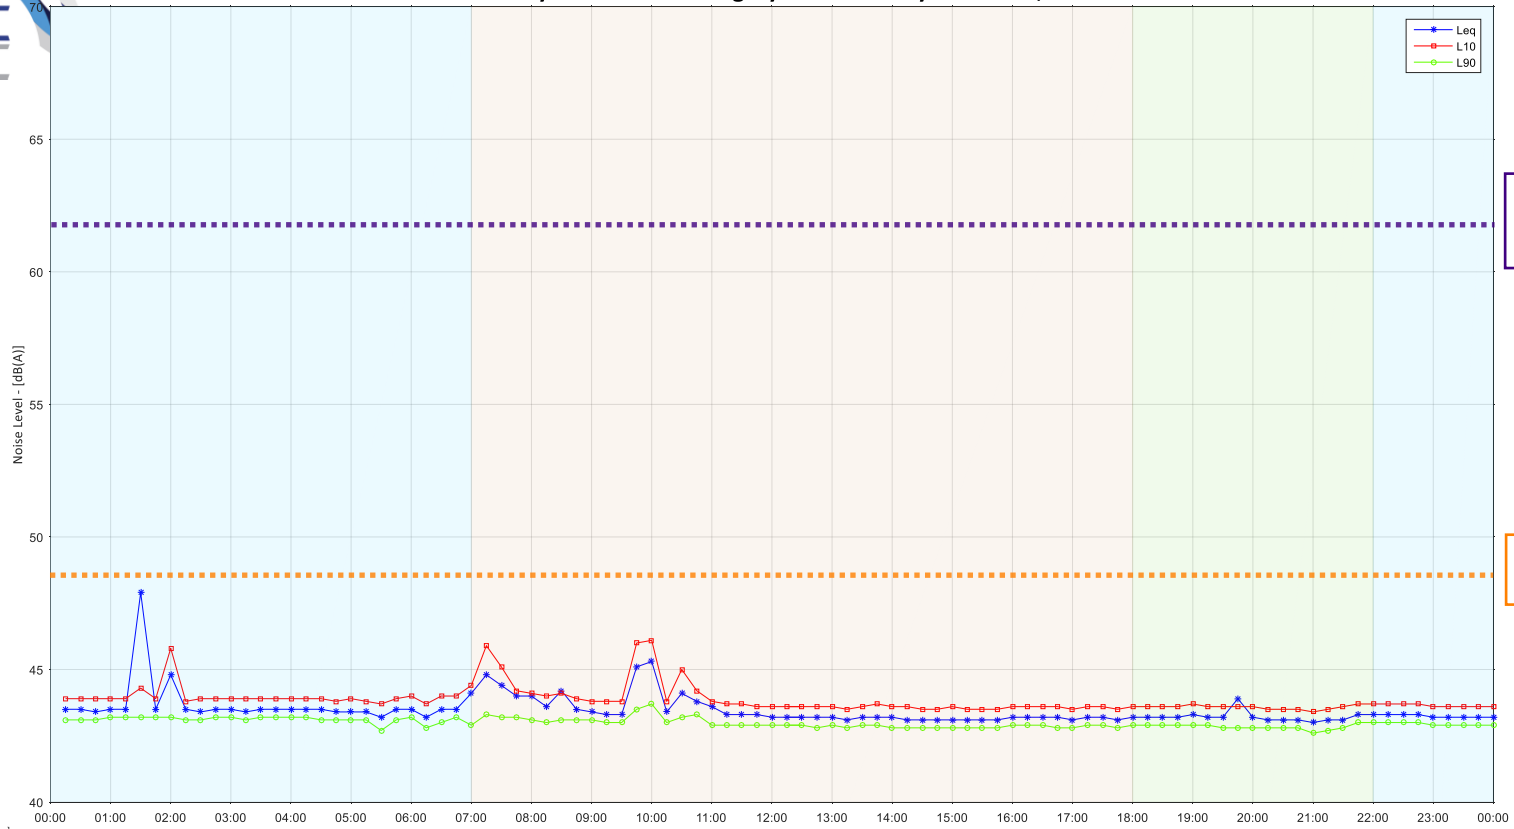
### Centenary Institute - L4 Surgery Room: Friday 29 March, 2024

Animal Housing / Breeding / Observation Room NML  $\leq 62\text{dB(A)}L_{\text{eq}}$

Animal Operating Room NML  $\leq 48\text{dB(A)}L_{\text{eq}}$
