Royal Prince Alfred Hospital Redevelopment (RPAH  
Redevelopment)

Construction Noise and Vibration Monitoring Report 11

Client Doc. No. RPA-ACO-ACL-RPT-MW-000014 - Rev A

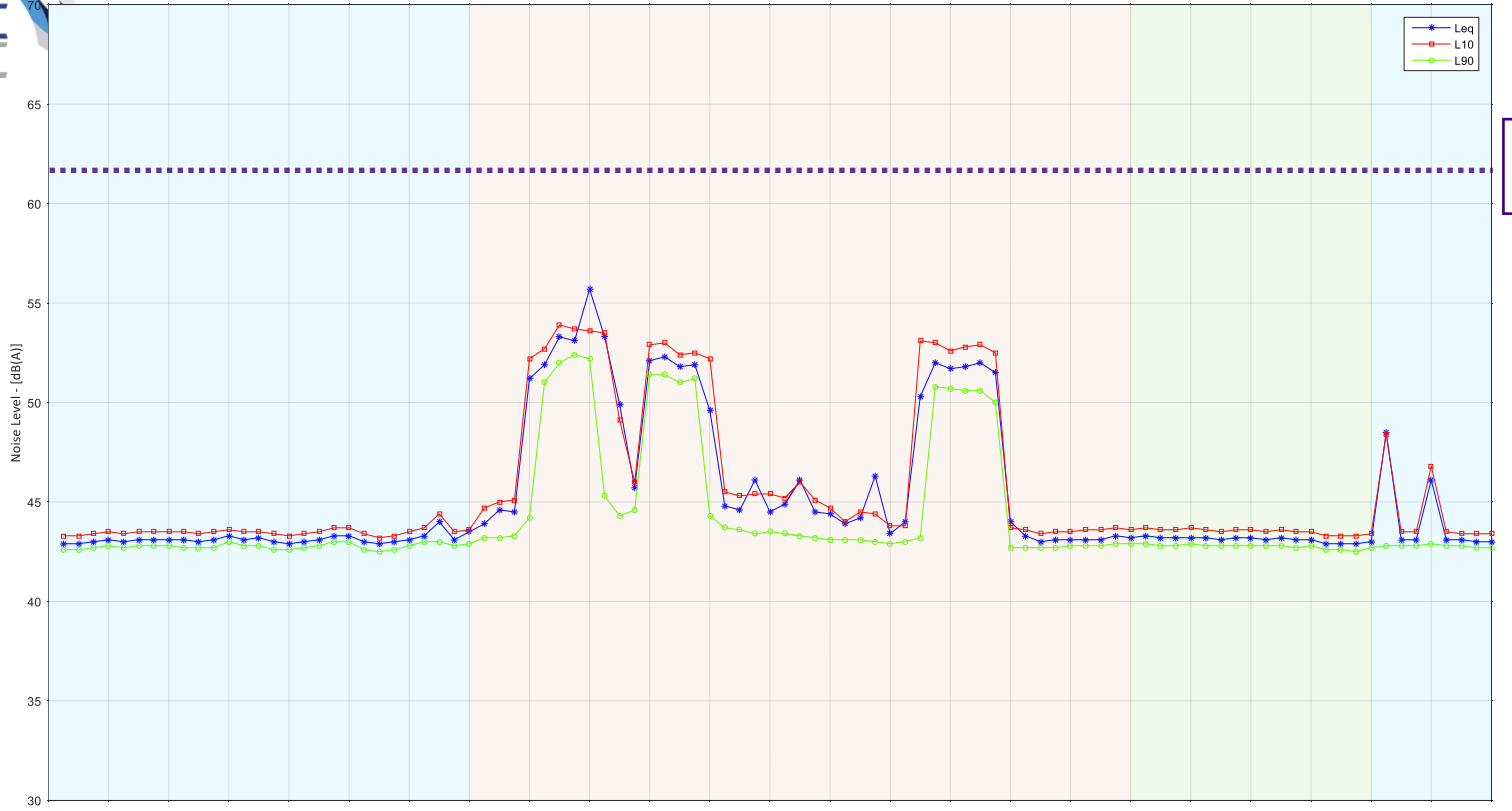
### Centenary Institute - L4 Surgery Room: Tuesday 30 April, 2024

Animal Housing / Breeding /  
Observation Room NML  
 $\leq 62\text{dB(A)}_{L_{eq}}$

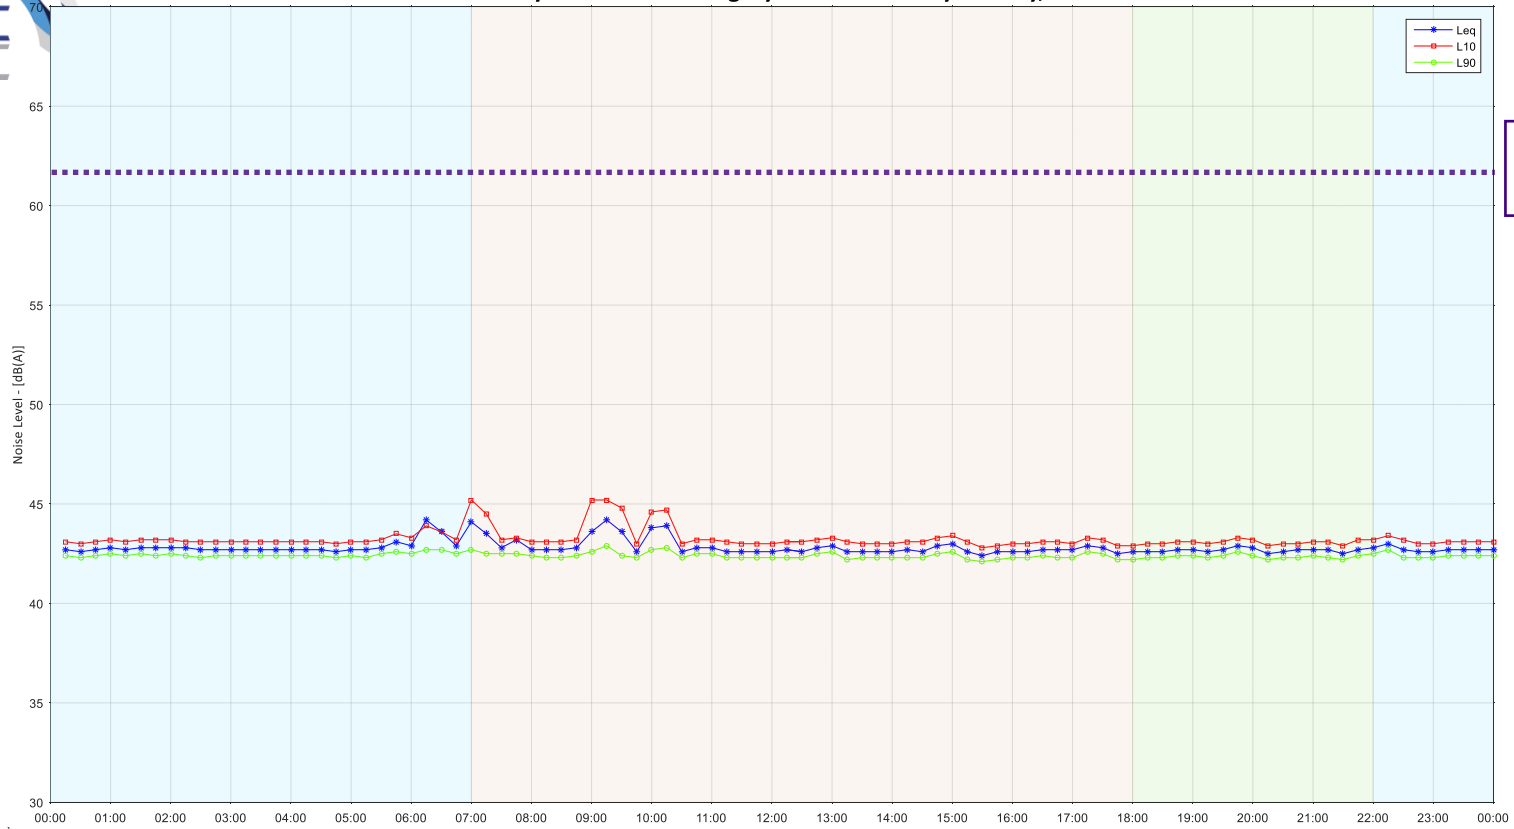
### Centenary Institute - L4 Surgery Room: Saturday 04 May, 2024

**Animal Housing / Breeding /  
Observation Room NML  
≤ 62dB(A)<sub>L<sub>eq</sub></sub>**

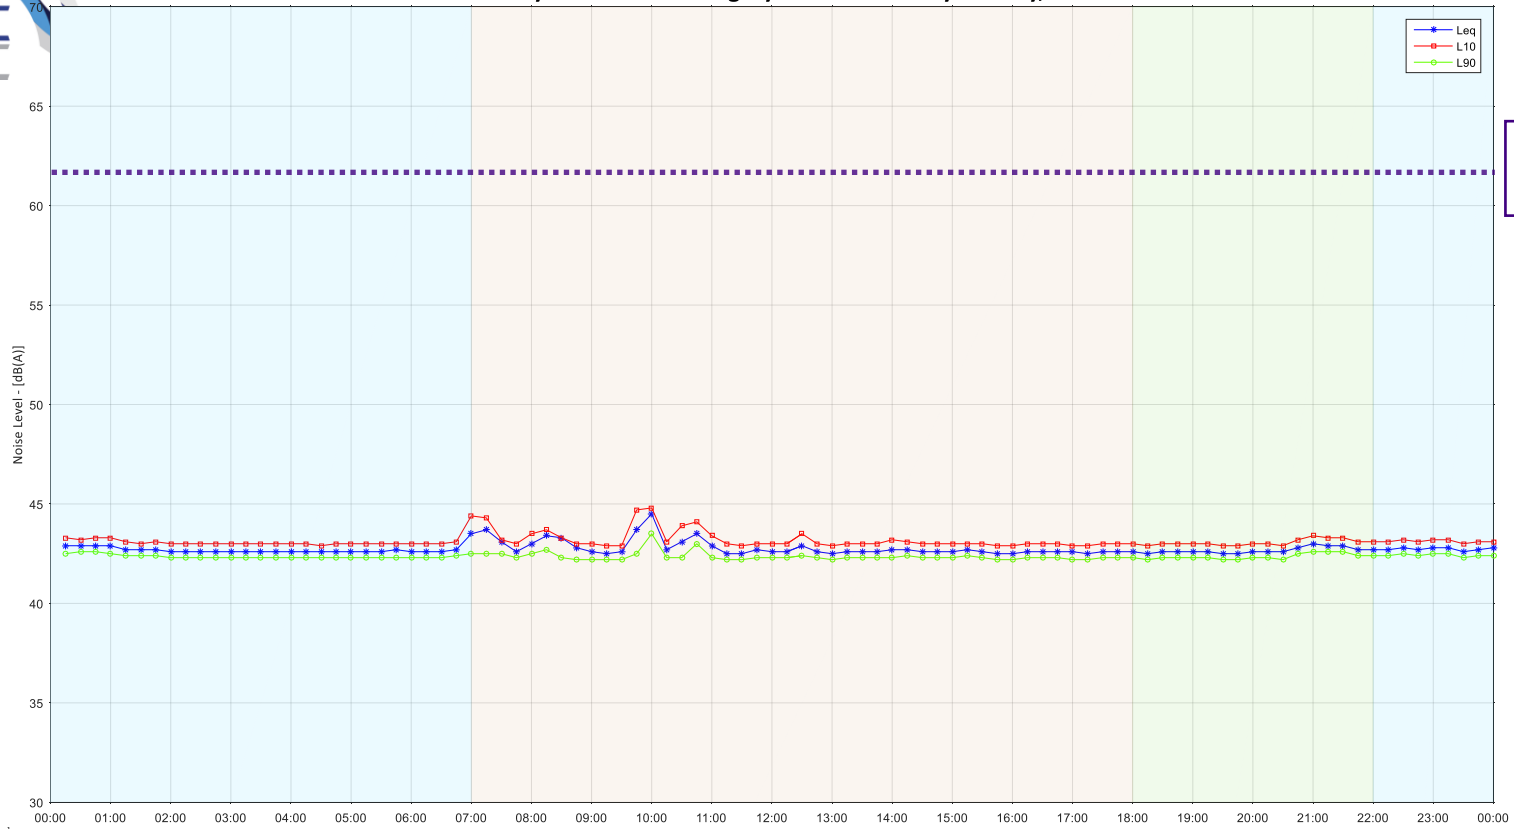
### Centenary Institute - L4 Surgery Room: Saturday 11 May, 2024

Animal Housing / Breeding /  
Observation Room NML  
 $\leq 62\text{dB(A)}_{L_{eq}}$
