Royal Prince Alfred Hospital Redevelopment (RPAH  
Redevelopment)

Construction Noise and Vibration Monitoring Report 18

Client Doc. No. RPA-ACO-ACL-RPT-MW-000021 - Rev A

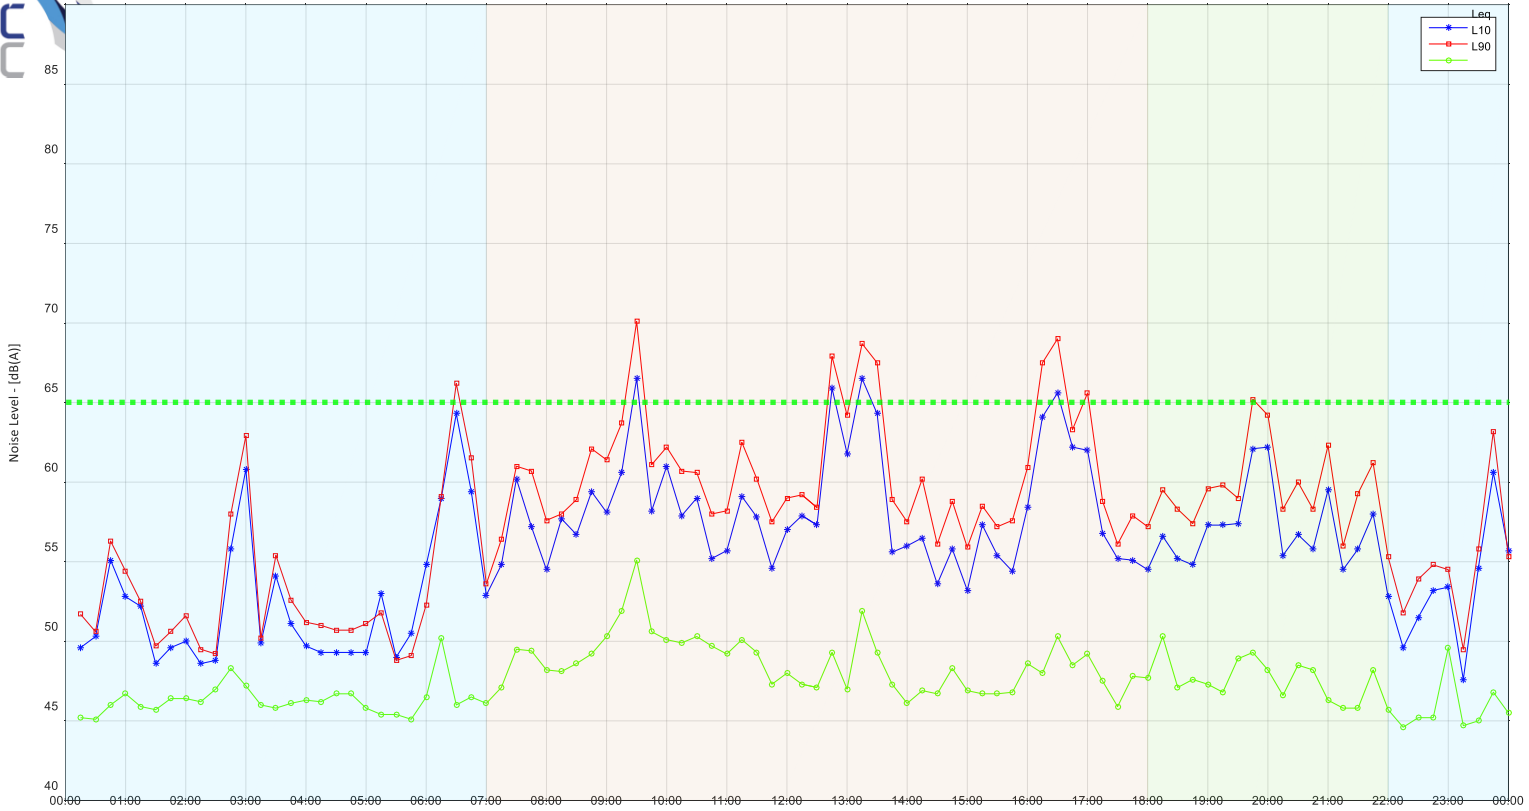
### RPA Hospital Main Building - L3 NICU: Wednesday 14 August, 2024

- Noise levels were observed to be measured above the NML within the NICU space on the following dates:
  - 05/08/2024.
  - 06/08/2024.
  - 07/08/2024.
  - 12/08/2024.

- 14/08/2024.
  - 15/08/2024.
- Noise levels were never observed to be above the NML for longer than one 15-minute period, and hence it is likely that these events were caused by internal operational activity within the space, as opposed to construction works, noting that construction works are typically continuous in nature.

**NICU NML**  
**(Including correction)**  
**≤ 65dB(A)<sub>L<sub>eq</sub></sub>**

- All other measured levels above the NML have been found to occur outside of construction hours.
- Ongoing monitoring to continue within the NICU space.
