New Shellharbour Hospital, 86 Dunmore Road, Dunmore NSW

Audit Number: MP203

Site Audit Report

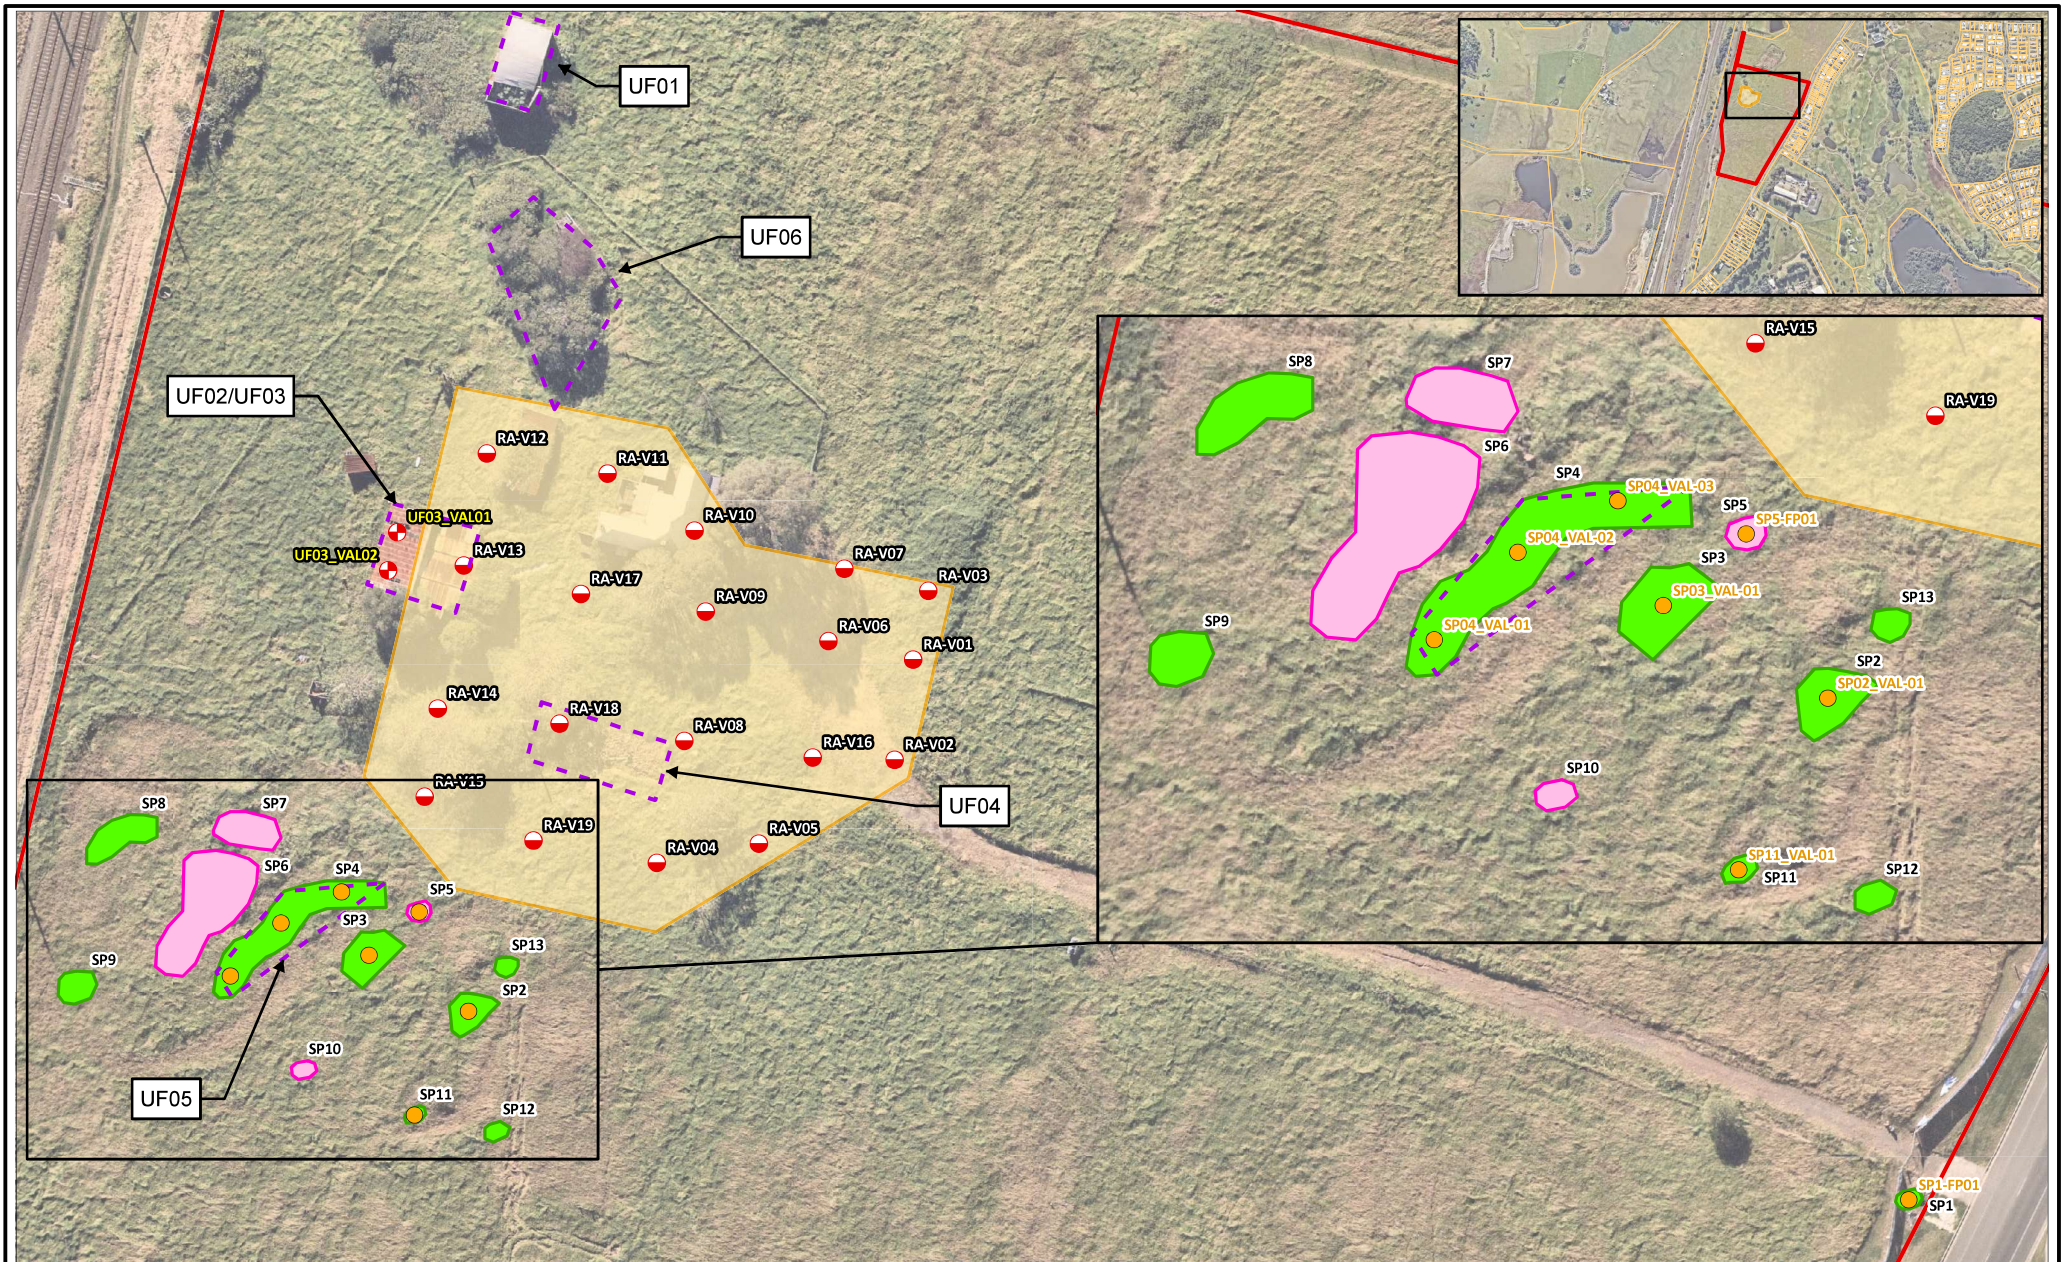
- Legend**
- ▭ Approximate Site Boundary
 - Remediation Area
 - Unexpected Finds
 - ACM stockpile
 - Stockpile
 - Validation Samples
 - Unexpected Finds Validation Samples
 - Stockpile Validation Locations

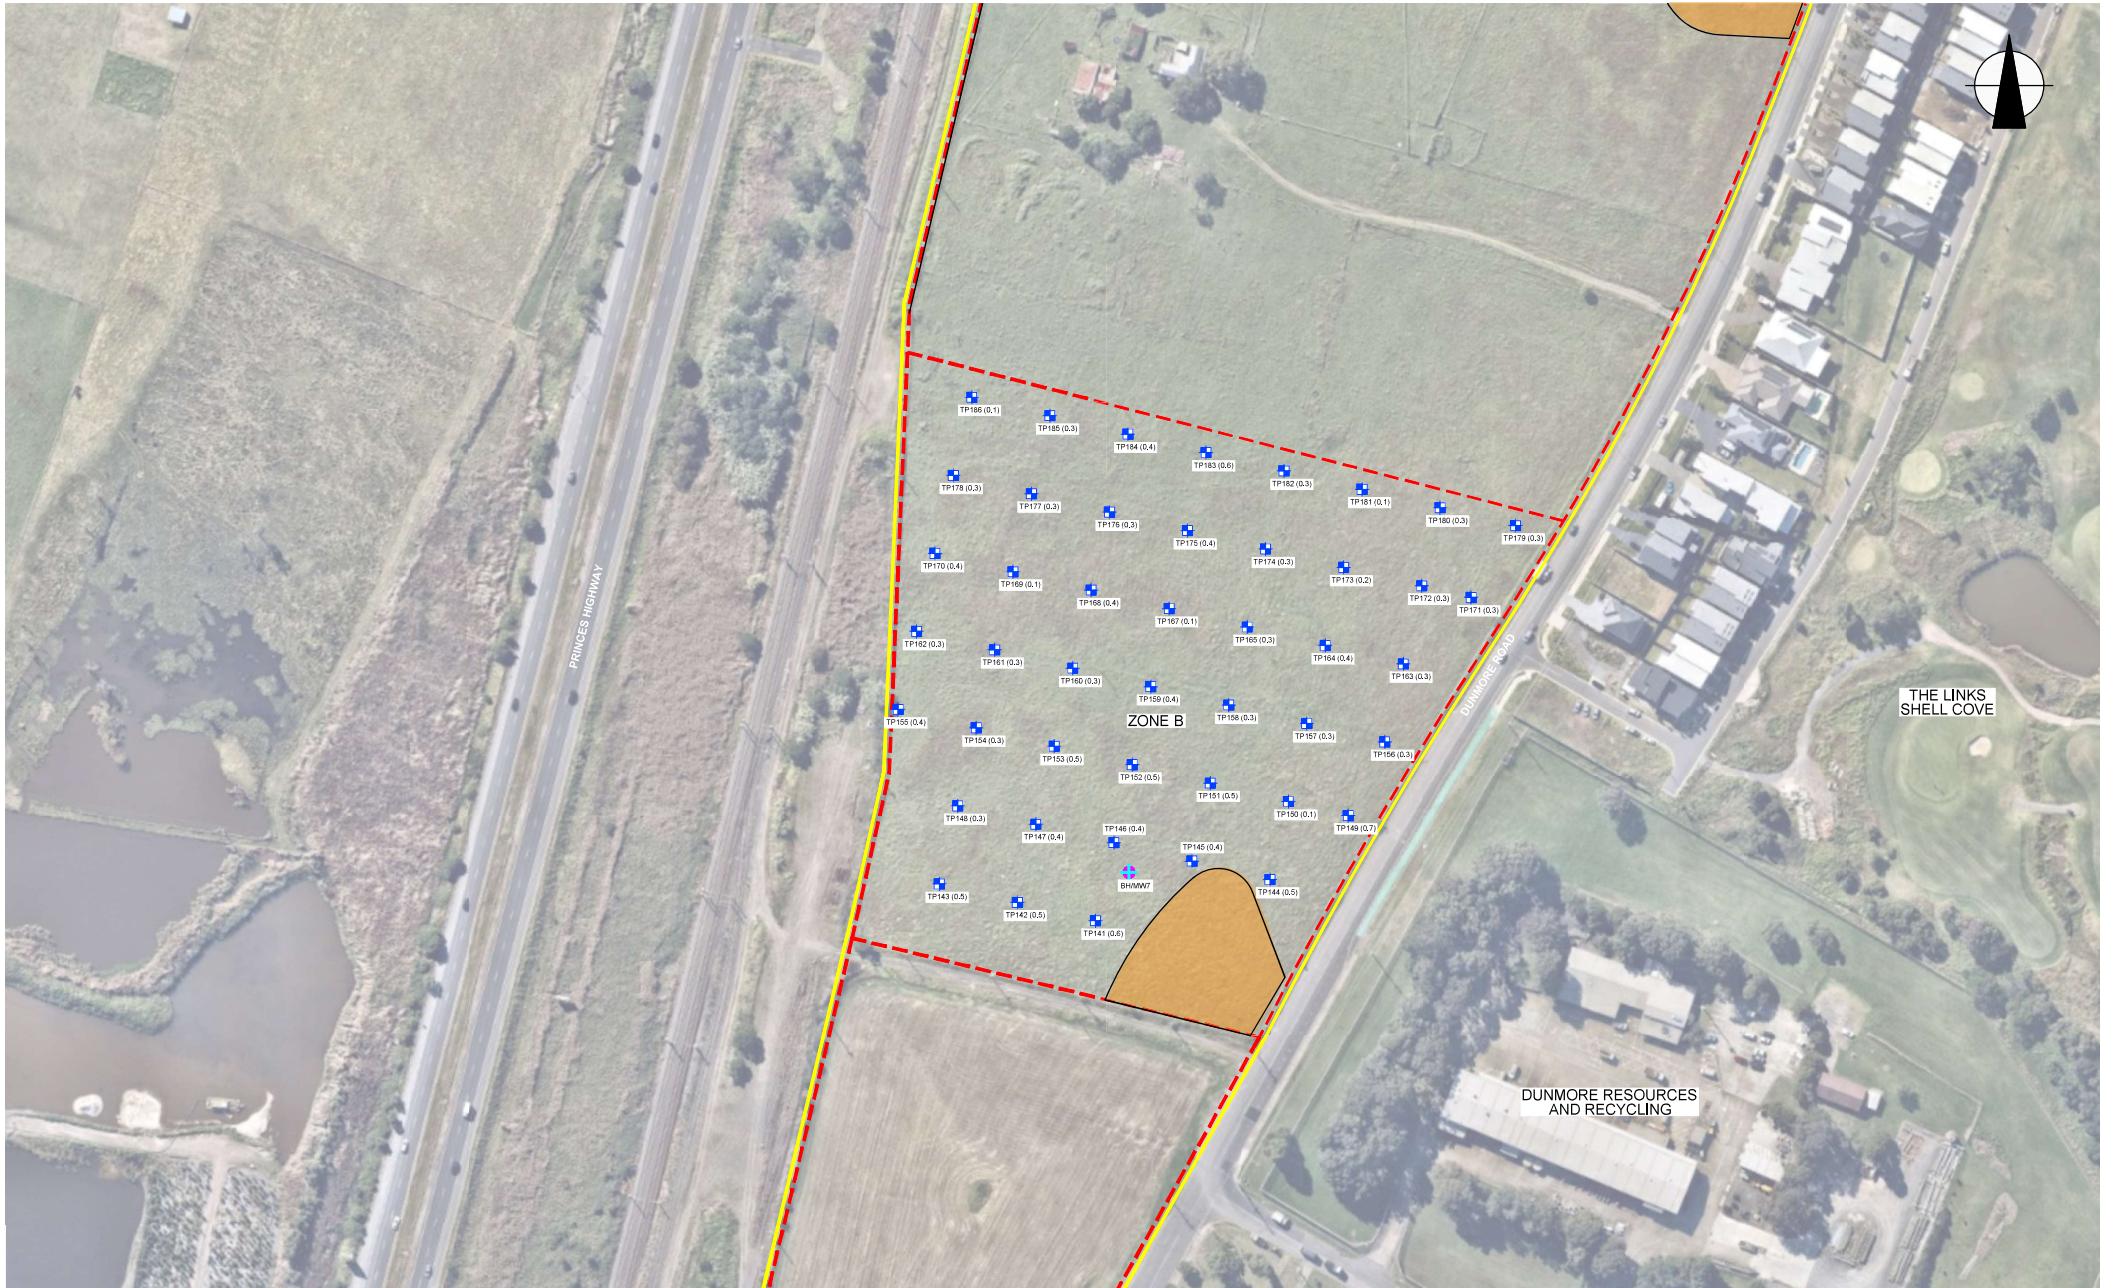
TITLE: SAMPLE LOCATION PLAN ZONE B	
Location: 86 DUNMORE ROAD, SHELLHARBOUR, NSW	
Project No: E34300PTrpt2	Figure No: 2b
JKEnvironments

- - - APPROXIMATE ZONE BOUNDARIES
- - - APPROXIMATE WIDER PROPERTY BOUNDARY
- ABORIGINAL AREAS (EMM REPORT)
- + BH/MW(Fill Depth) BOREHOLE AND GROUNDWATER MONITORING WELL LOCATION, NUMBER AND DEPTH OF FILL (m)
- + TP(Fill Depth) TEST PIT LOCATION, NUMBER AND DEPTH OF FILL (m)
