## RNA Project Culloden & Gymnasium, Macquarie University

### Monitoring Report 1

Project ID	20240975.4
Document Title	Monitoring Report 1
Attention To	Excel Plant Hire Pty Ltd

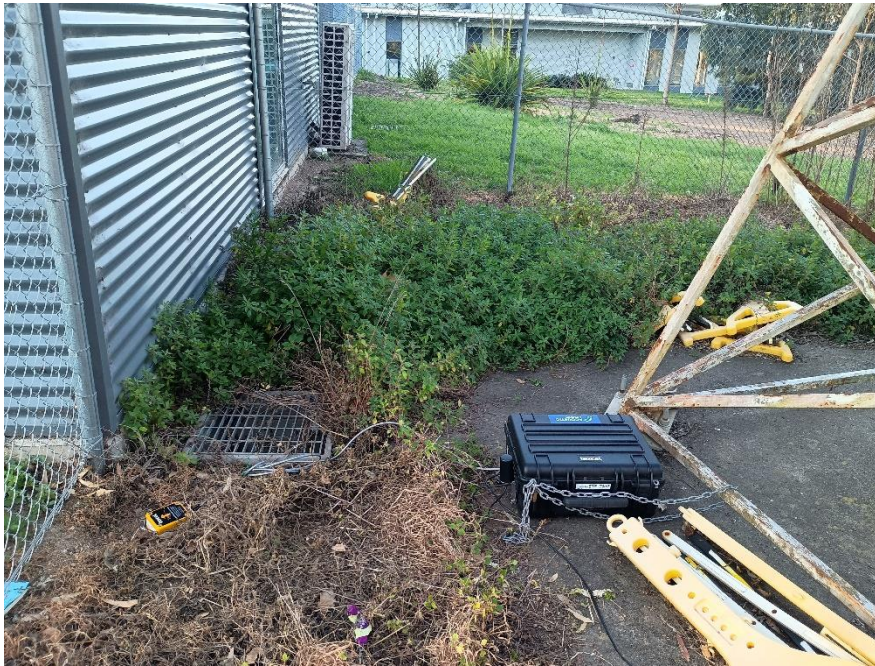
**Figure 3. 7900 Vibration Monitor located at North-East of the site (for E1)**

One vibration monitor has been installed on Monday 9<sup>th</sup> September 2024 at the North-East of the construction site on ground level. This location is representative of the potential vibration impacts to receiver E1 (see Figure 1). The location of the monitor is shown in the Figure below.

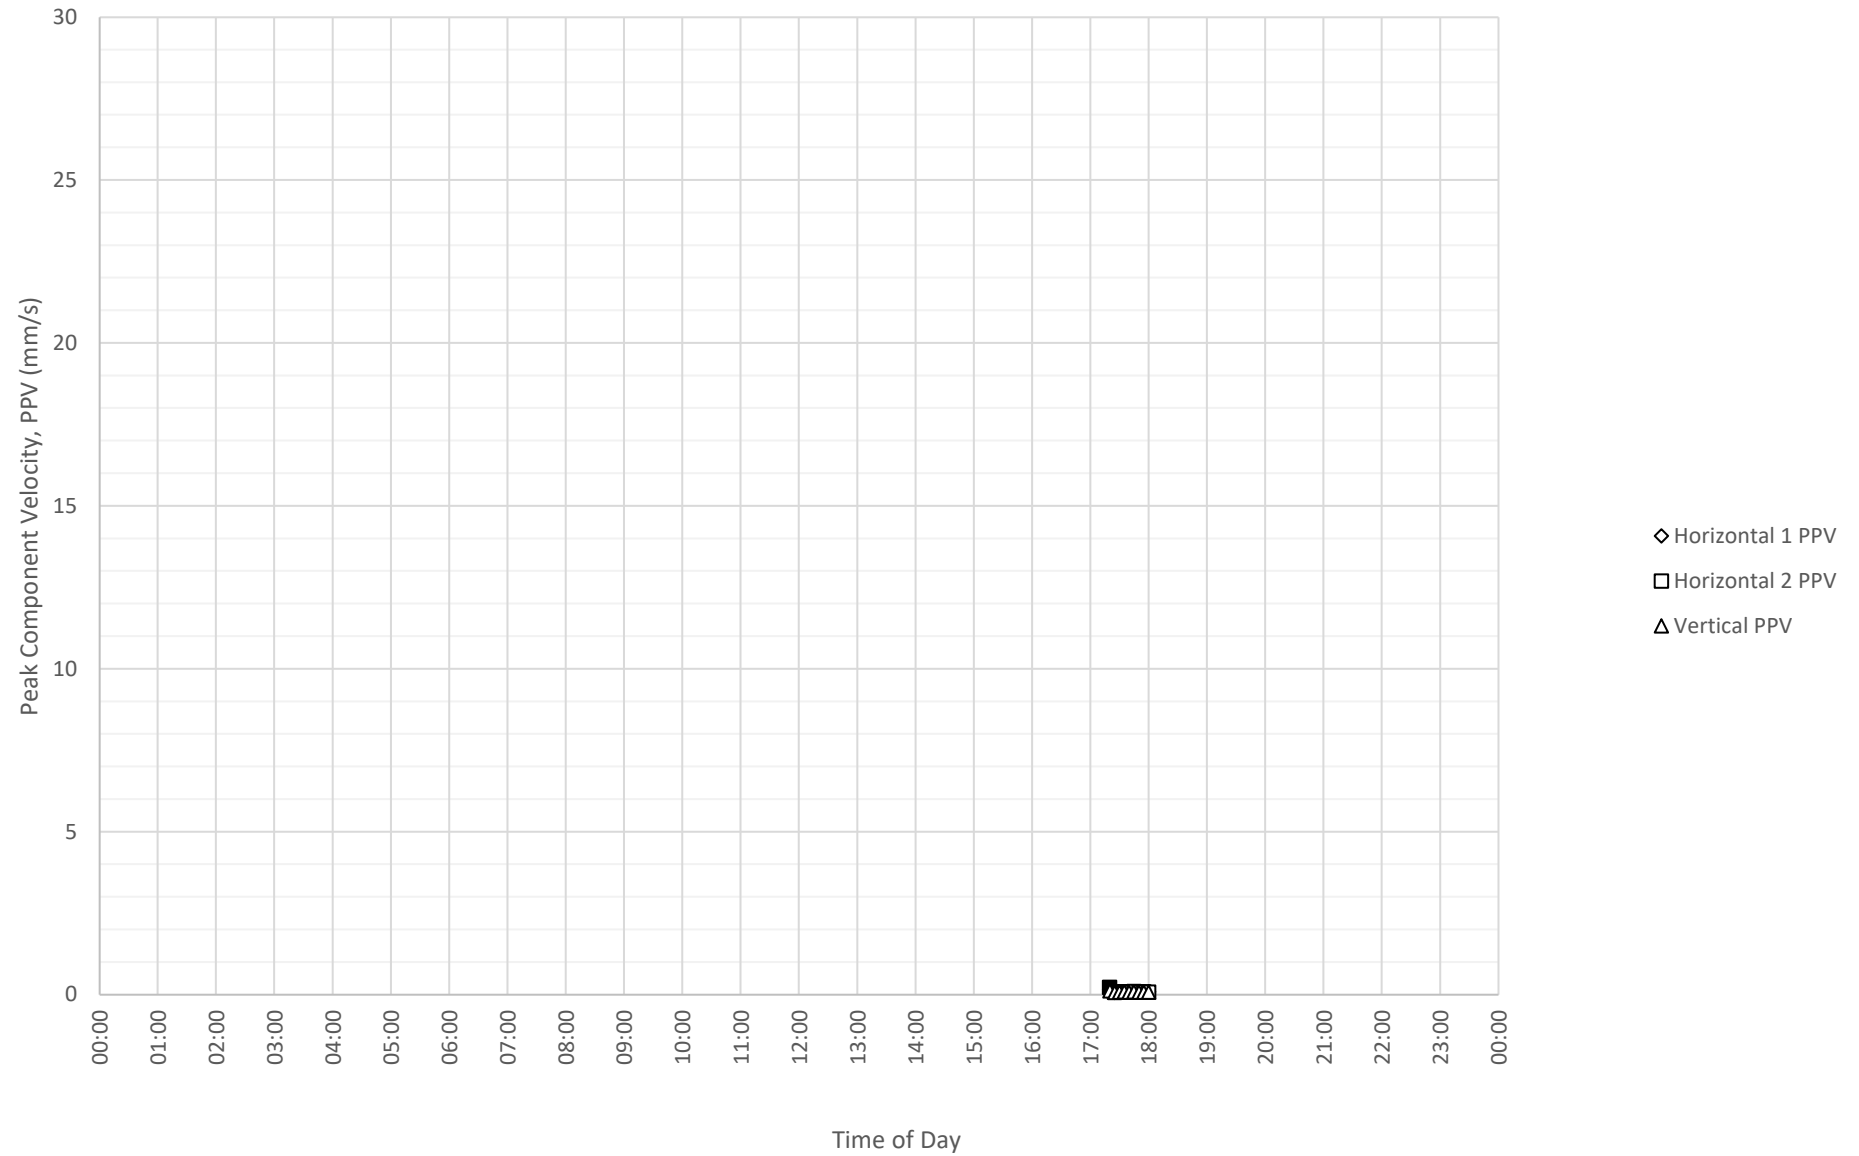
# Daily Monitored Vibration Levels at Residential Receivers at NorthWest of N3 parking at Macquarie University on 9-09-2024

Frequency Content of Vibration Levels at Residential Receivers at NorthWest of N3 parking at Macquarie University on 9-09-2024

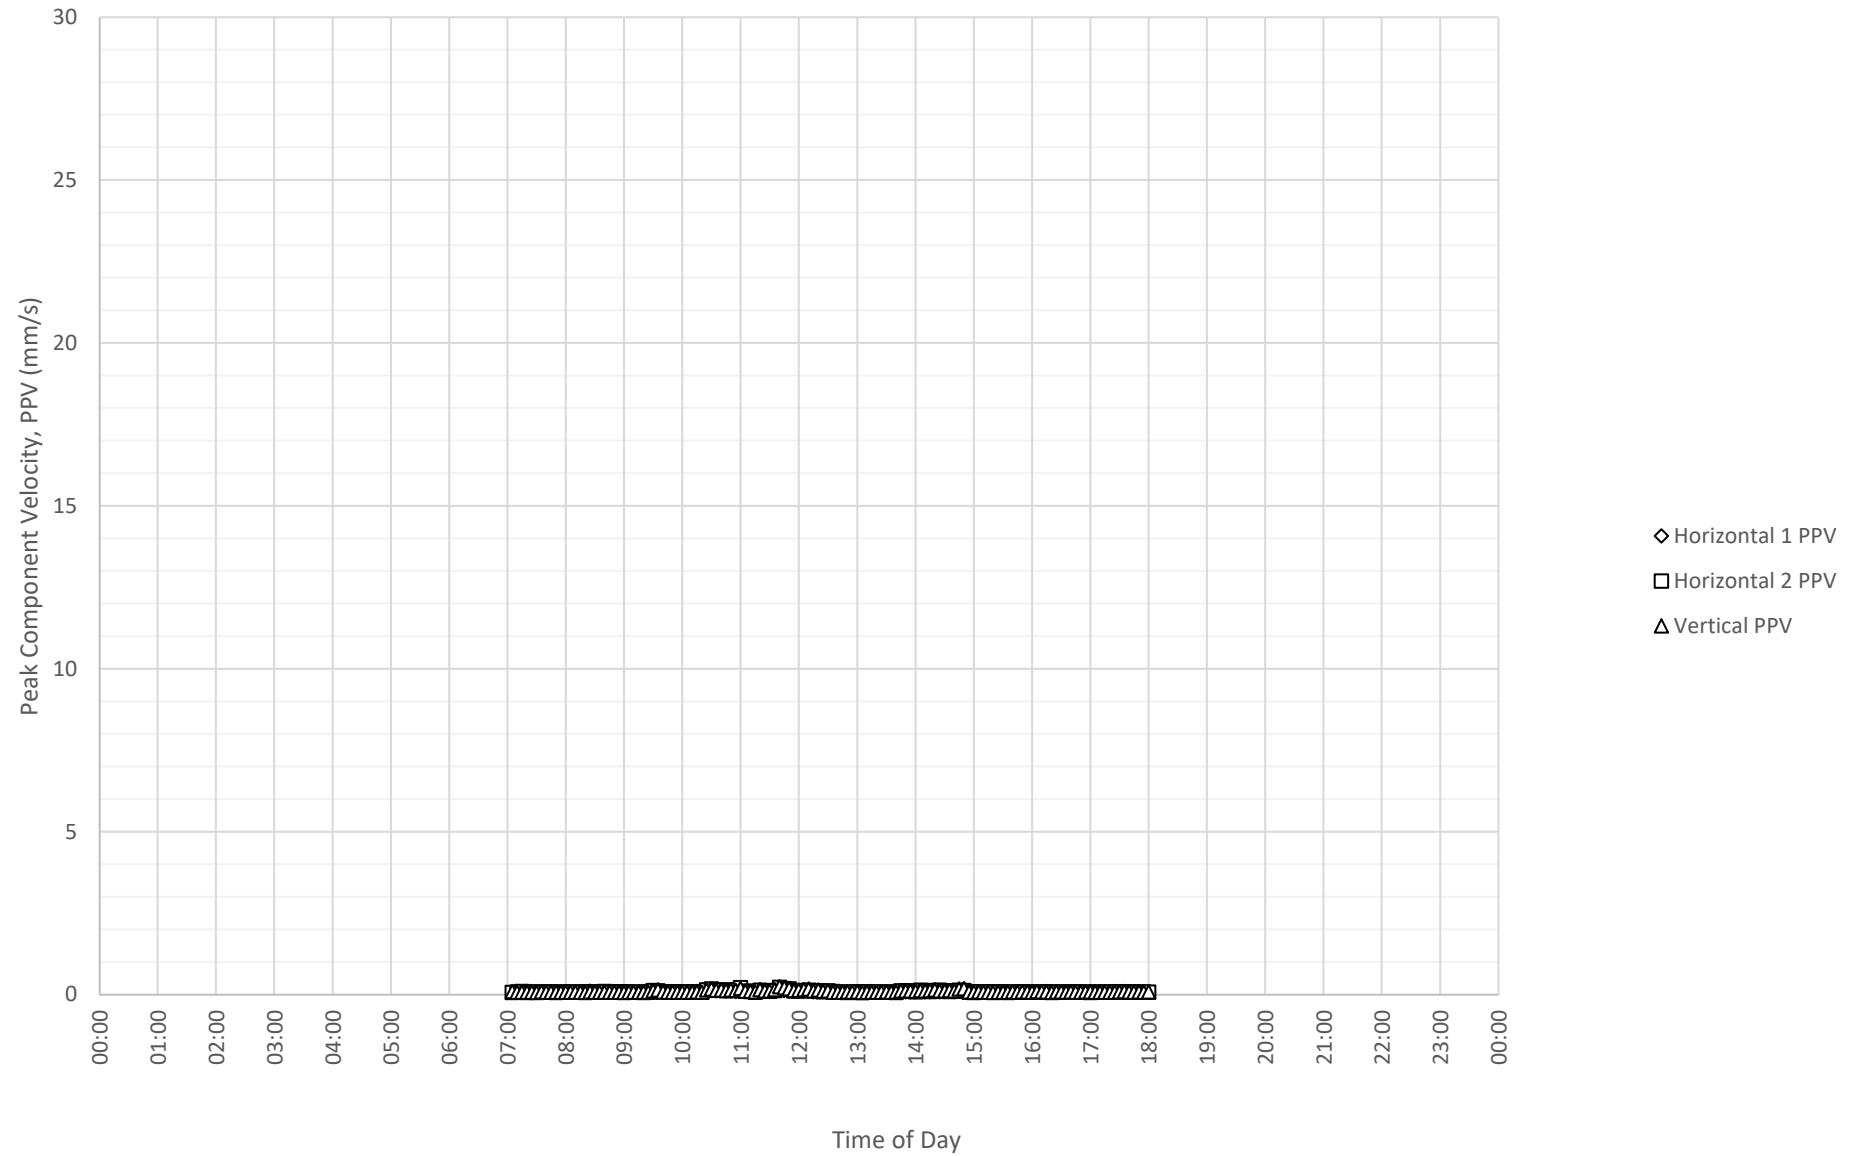
# Daily Monitored Vibration Levels at Residential Receivers at NorthWest of N3 parking at Macquarie University on 10-09-2024

Frequency Content of Vibration Levels at Residential Receivers at NorthWest of N3 parking at Macquarie University on 10-09-2024

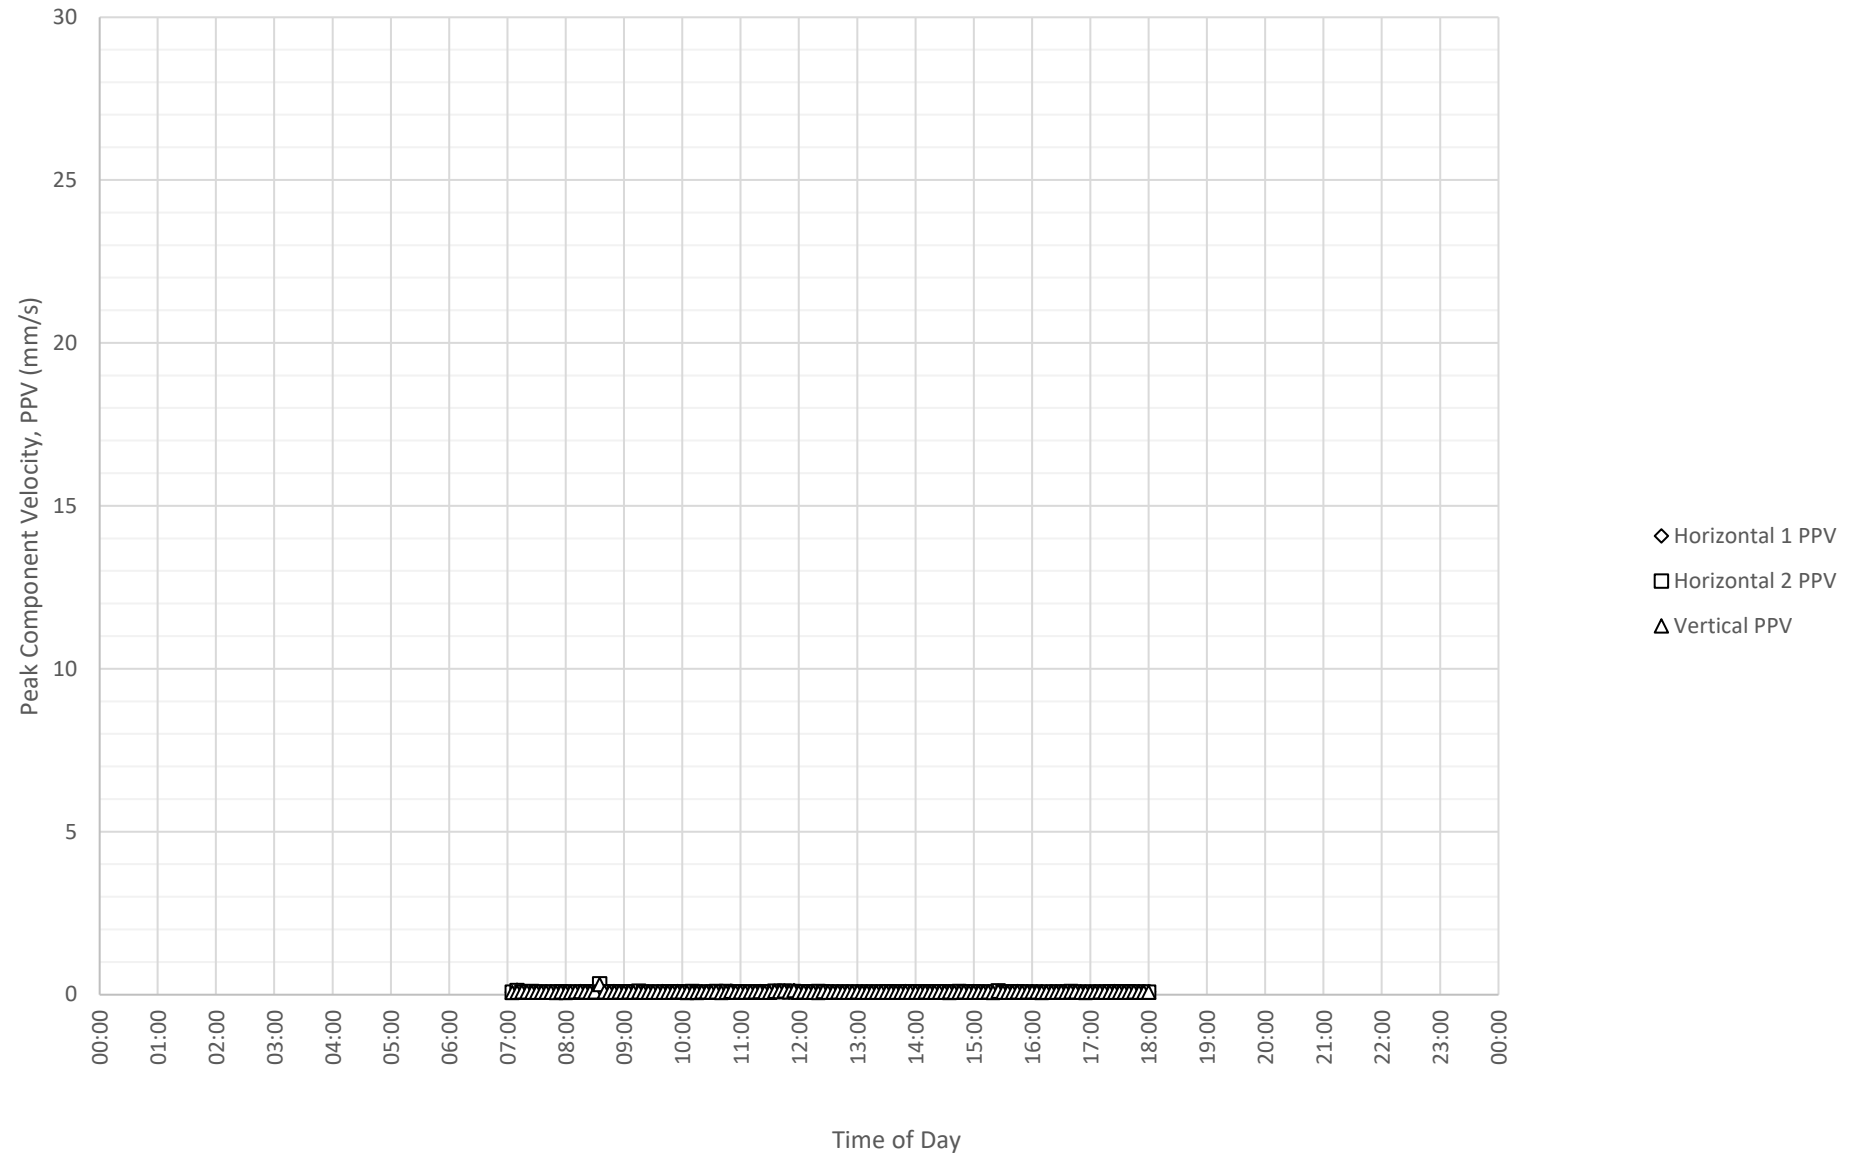
# Daily Monitored Vibration Levels at Residential Receivers at NorthWest of N3 parking at Macquarie University on 11-09-2024

Frequency Content of Vibration Levels at Residential Receivers at NorthWest of N3 parking at Macquarie University on 11-09-2024

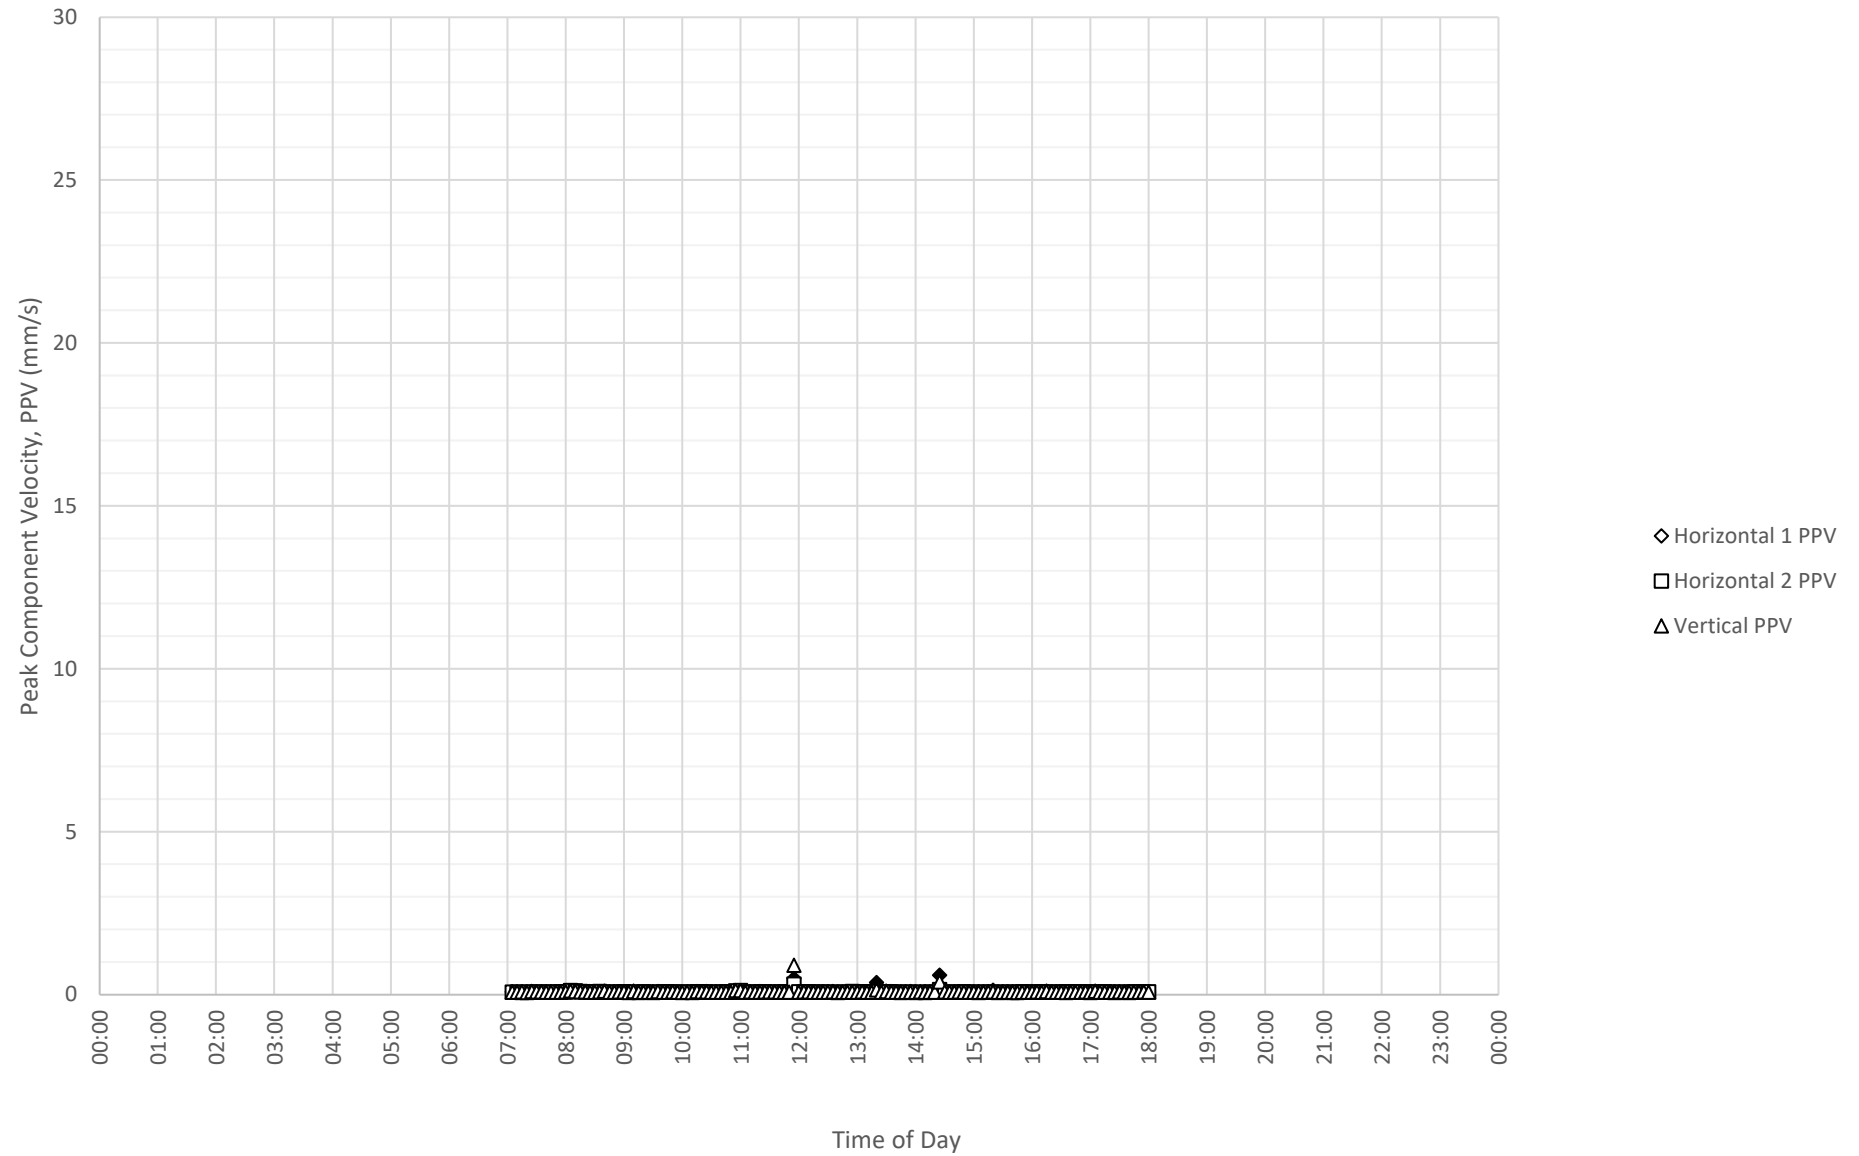
### Daily Monitored Vibration Levels at Residential Receivers at NorthWest of N3 parking at Macquarie University on 12-09-2024

Frequency Content of Vibration Levels at Residential Receivers at NorthWest of N3 parking at Macquarie University on 12-09-2024

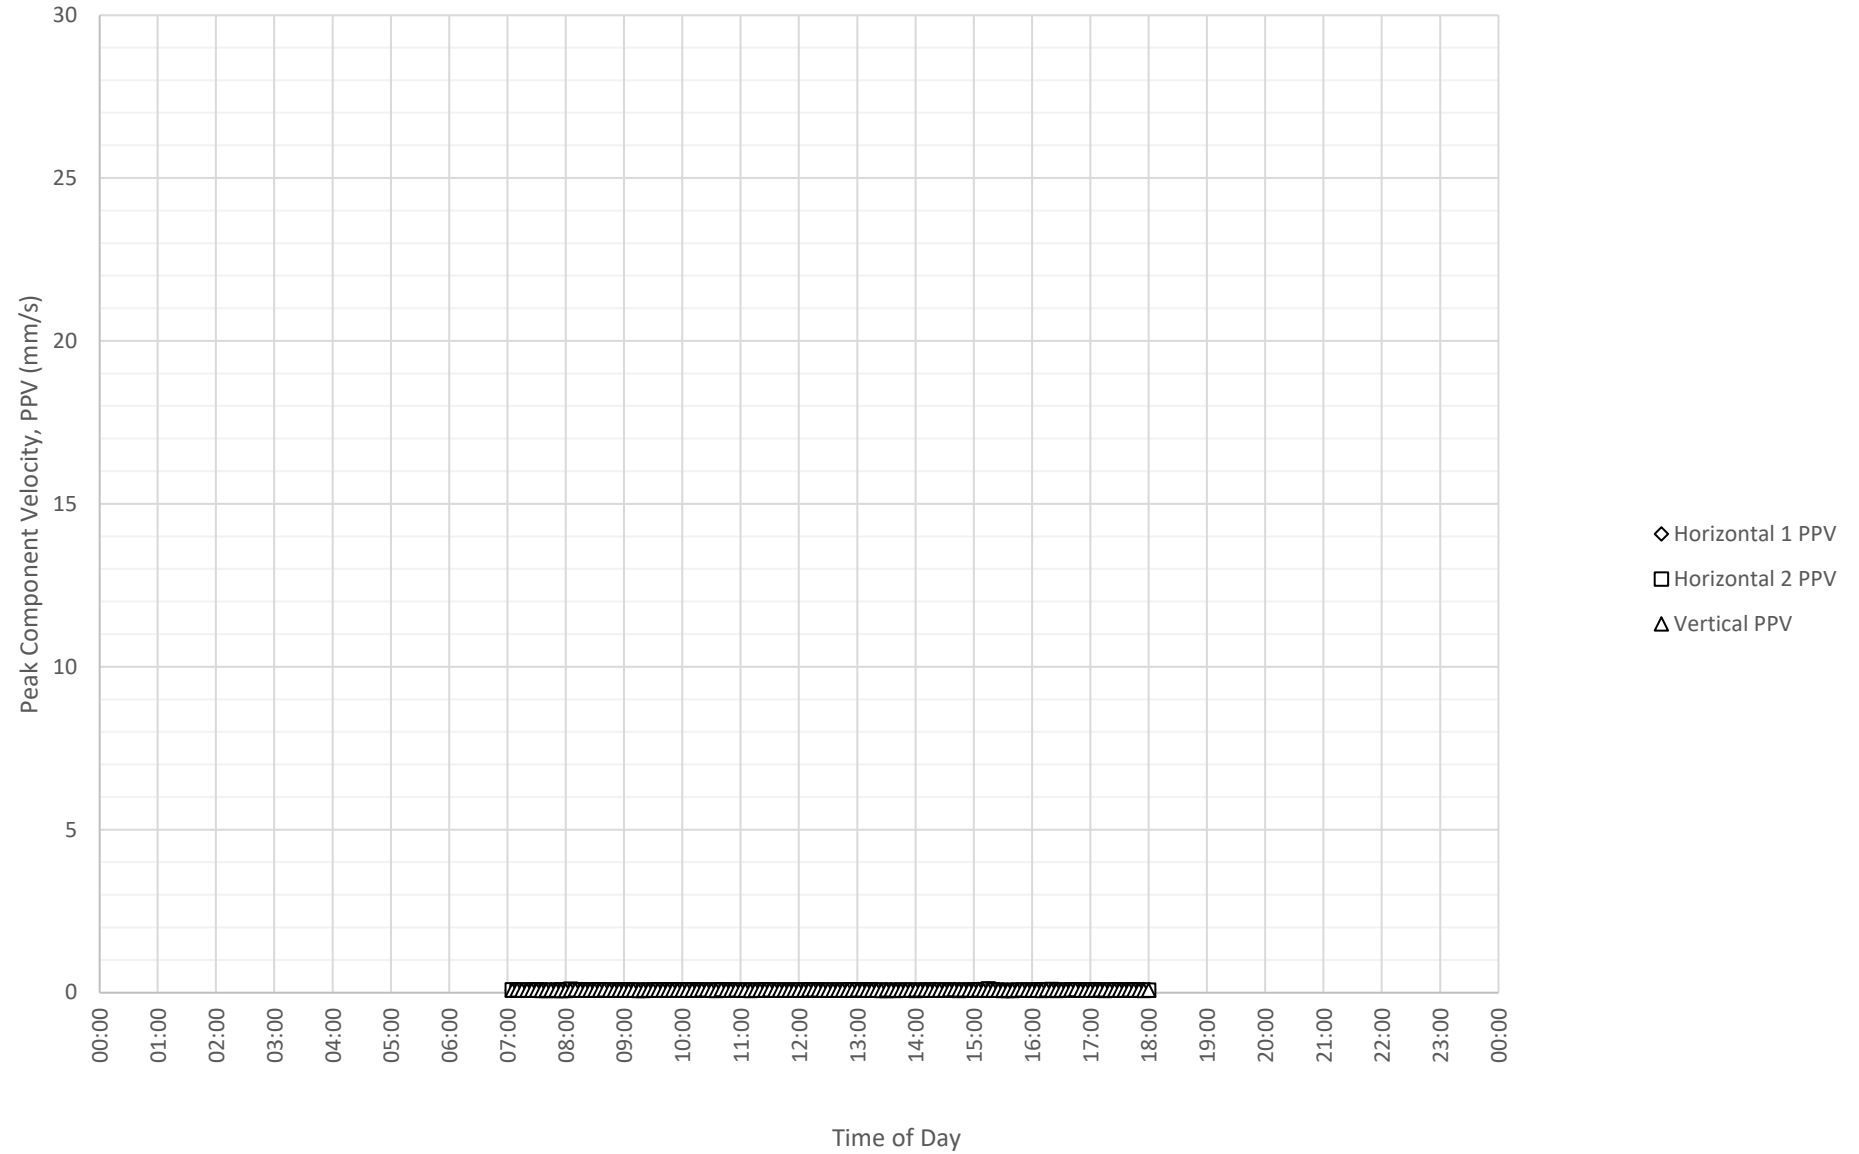
### Daily Monitored Vibration Levels at Residential Receivers at NorthWest of N3 parking at Macquarie University on 13-09-2024

Frequency Content of Vibration Levels at Residential Receivers at NorthWest of N3 parking at Macquarie University on 13-09-2024

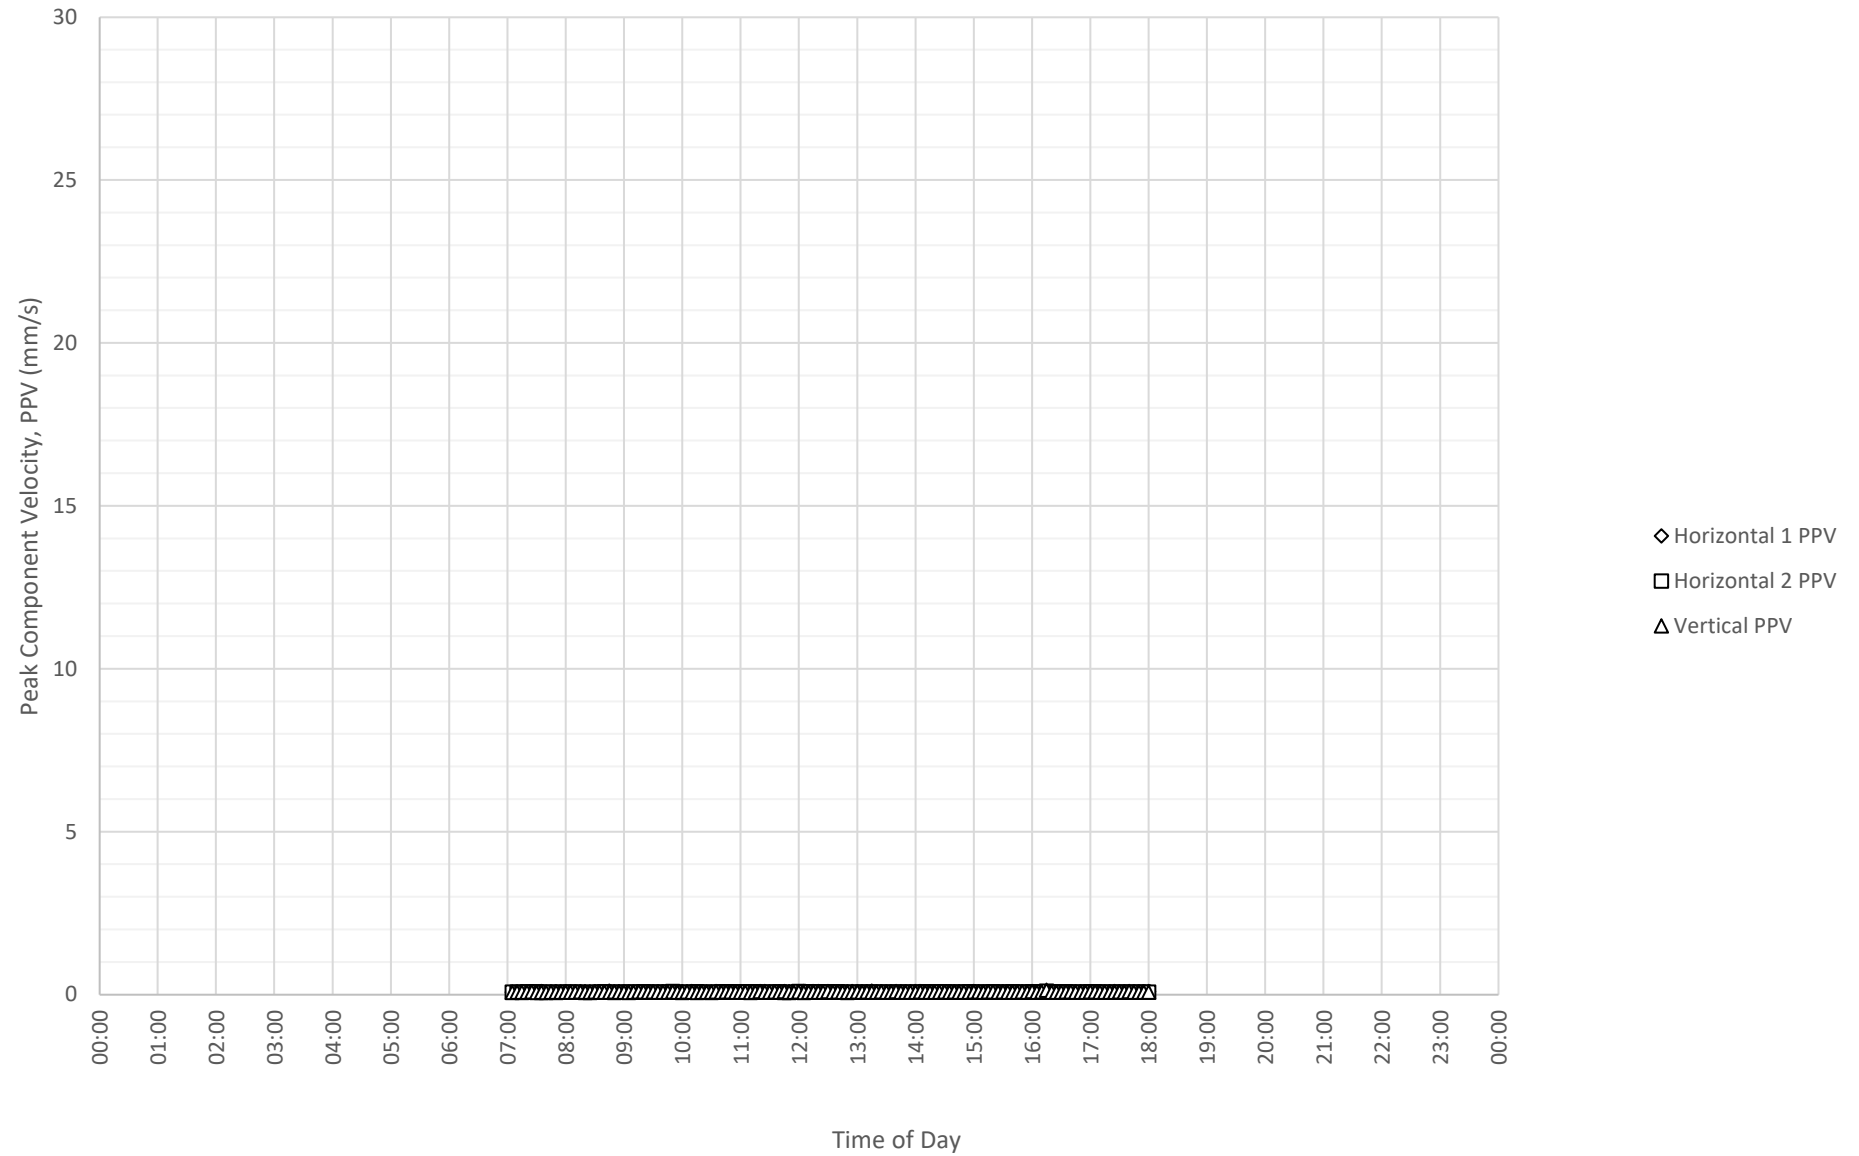
# Daily Monitored Vibration Levels at Residential Receivers at NorthWest of N3 parking at Macquarie University on 14-09-2024

Frequency Content of Vibration Levels at Residential Receivers at NorthWest of N3 parking at Macquarie University on 14-09-2024

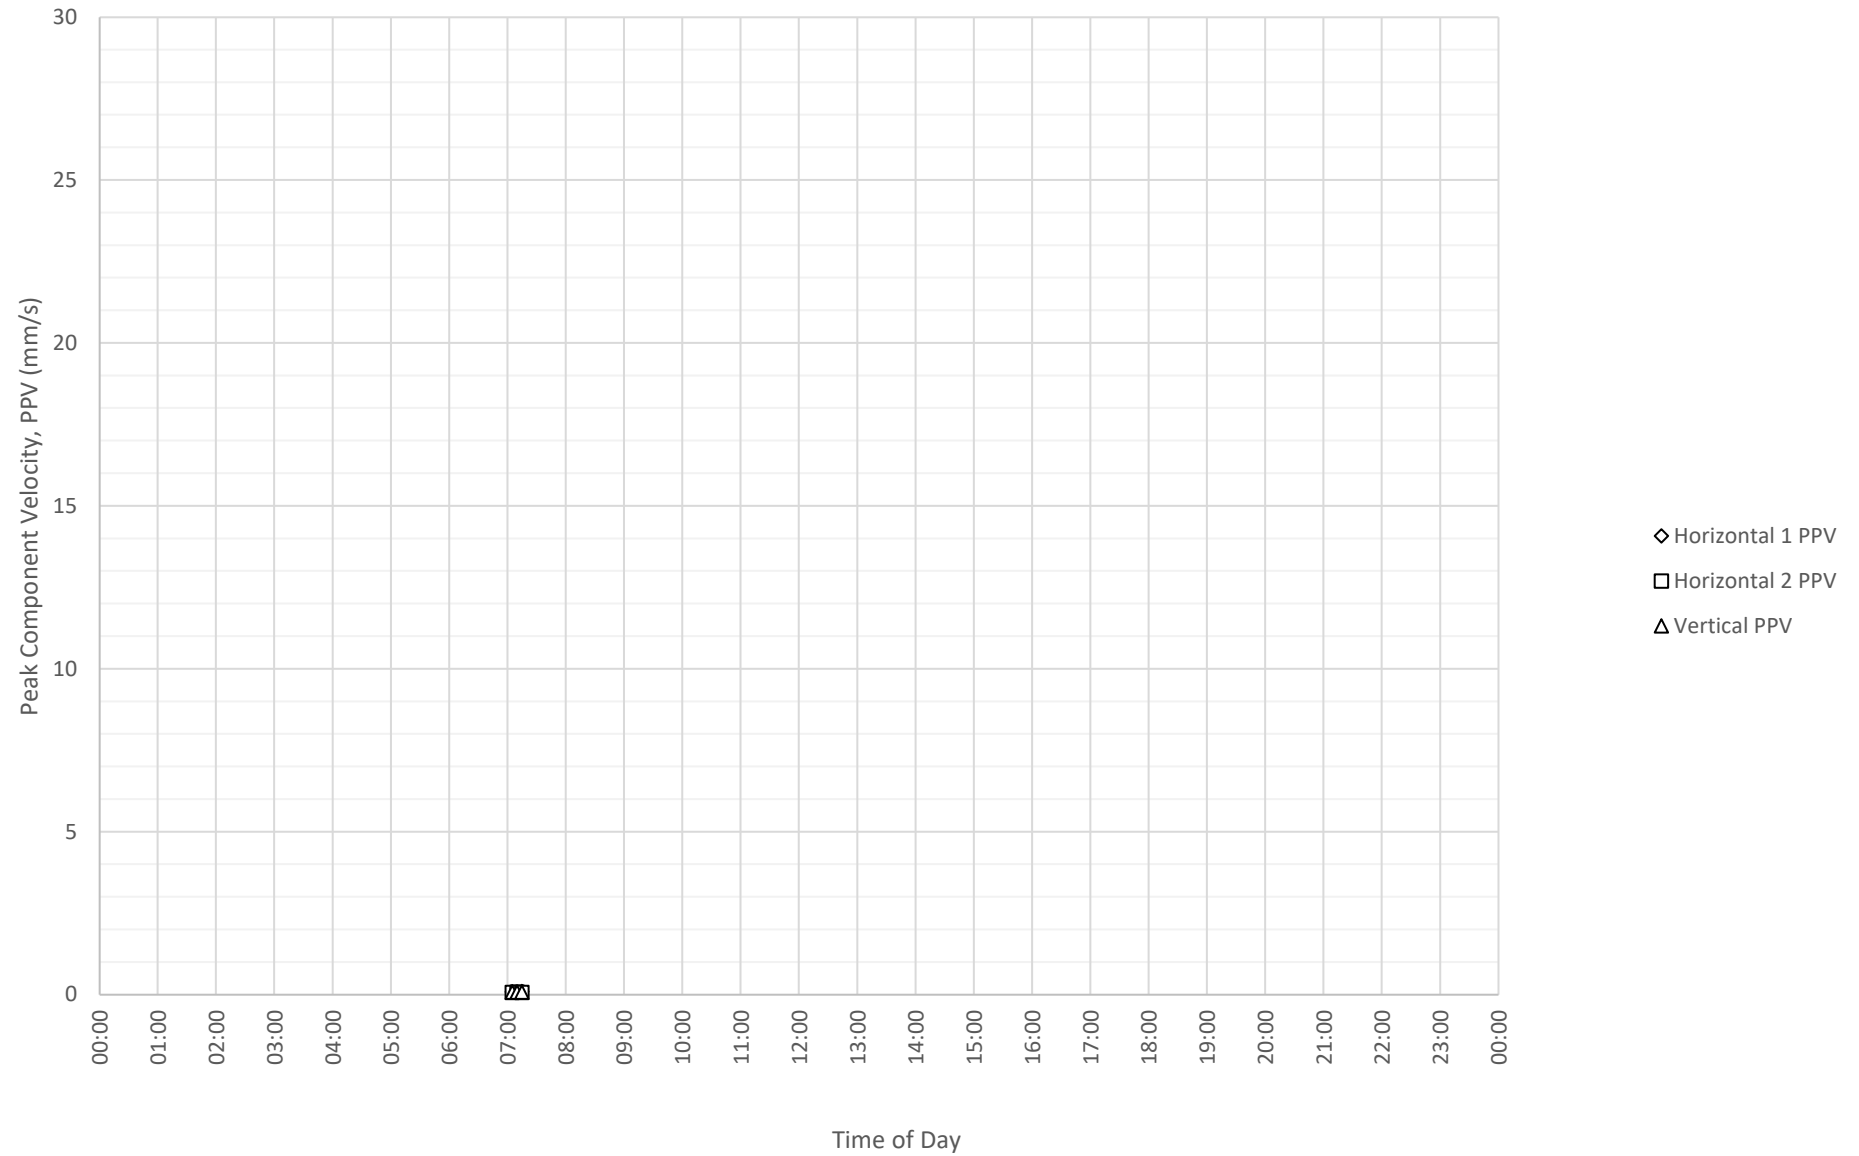
### Daily Monitored Vibration Levels at Residential Receivers at NorthWest of N3 parking at Macquarie University on 15-09-2024

Frequency Content of Vibration Levels at Residential Receivers at NorthWest of N3 parking at Macquarie University on 15-09-2024

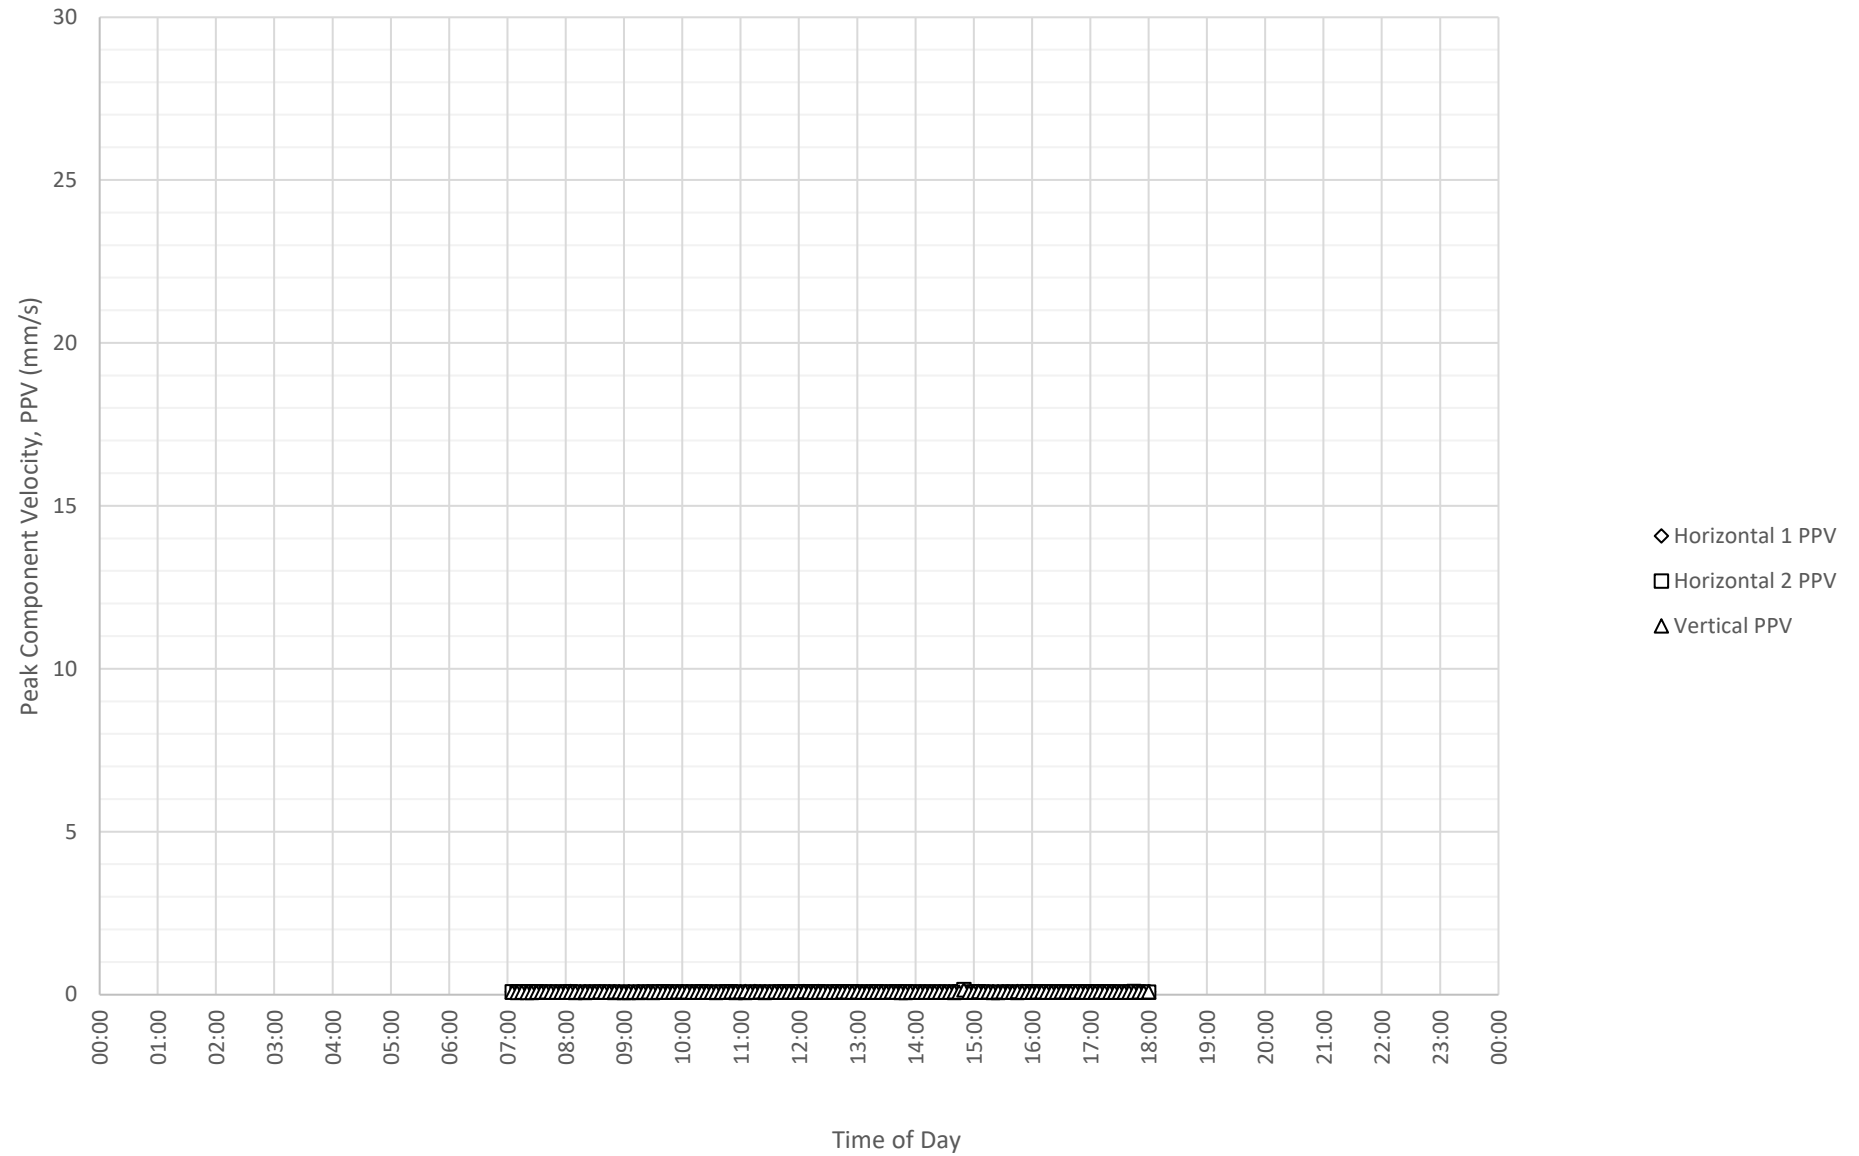
# Daily Monitored Vibration Levels at Residential Receivers at NorthWest of N3 parking at Macquarie University on 16-09-2024

Frequency Content of Vibration Levels at Residential Receivers at NorthWest of N3 parking at Macquarie University on 16-09-2024

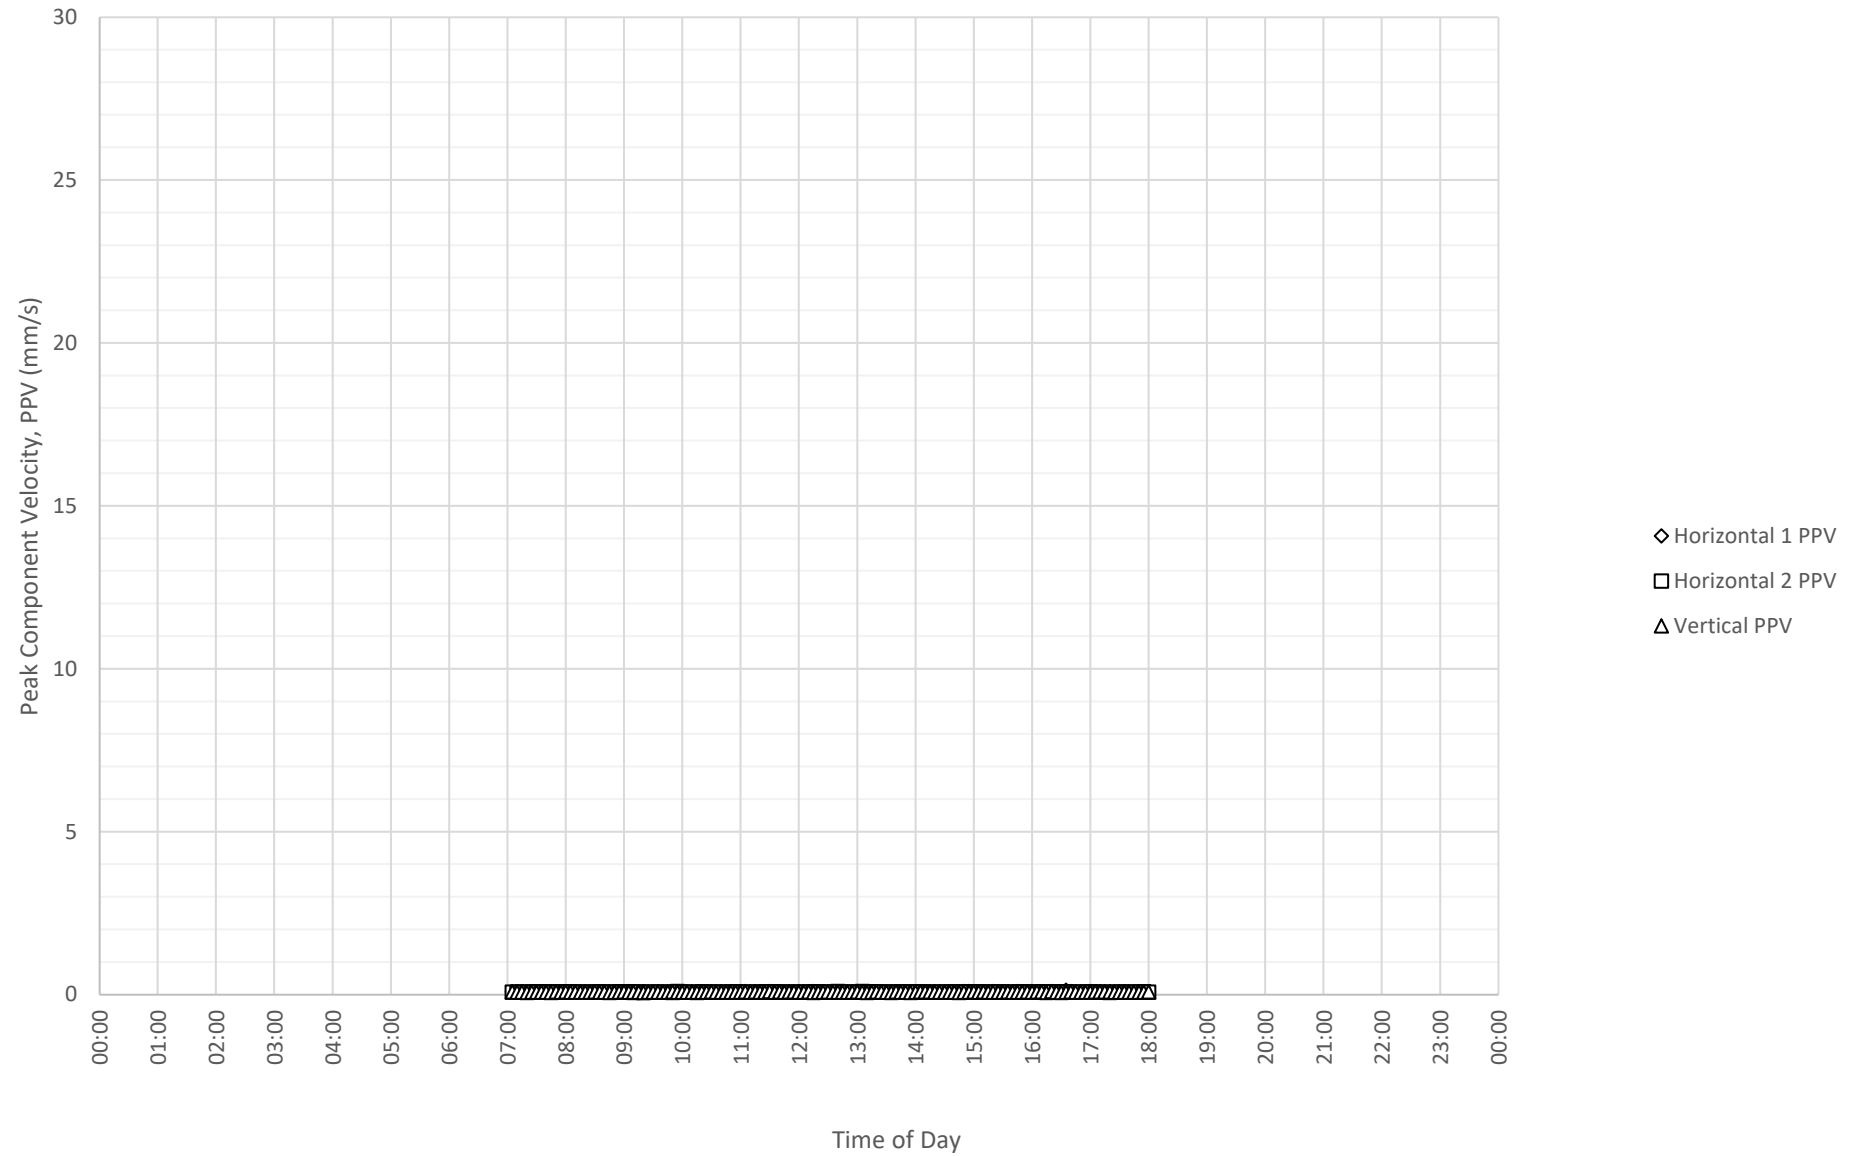
# Daily Monitored Vibration Levels at Residential Receivers at NorthWest of N3 parking at Macquarie University on 17-09-2024

Frequency Content of Vibration Levels at Residential Receivers at NorthWest of N3 parking at Macquarie University on 17-09-2024

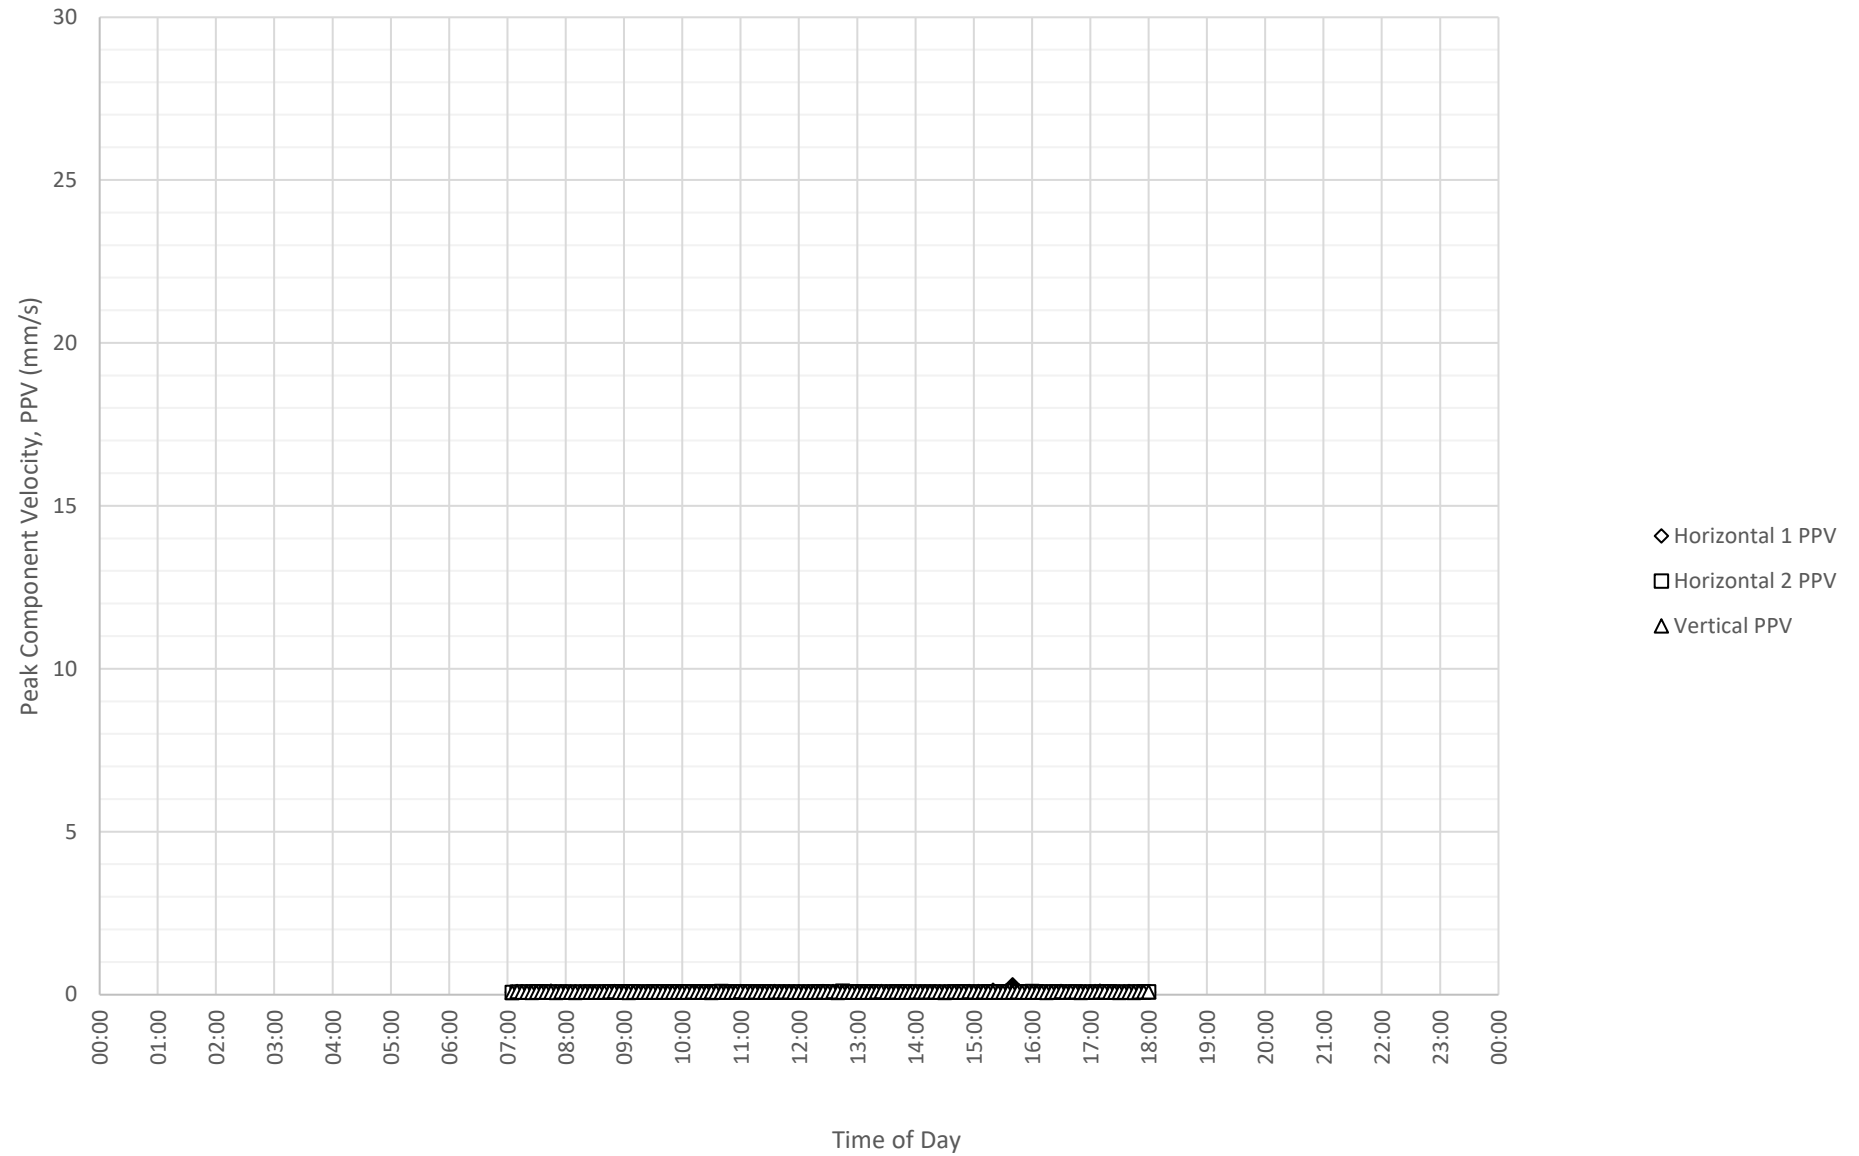
# Daily Monitored Vibration Levels at Residential Receivers at NorthWest of N3 parking at Macquarie University on 18-09-2024

Frequency Content of Vibration Levels at Residential Receivers at NorthWest of N3 parking at Macquarie University on 18-09-2024
