## RNA Project Culloden & Gymnasium, Macquarie University

### Monitoring Report 1

Project ID	20240975.4
Document Title	Monitoring Report 1
Attention To	Excel Plant Hire Pty Ltd

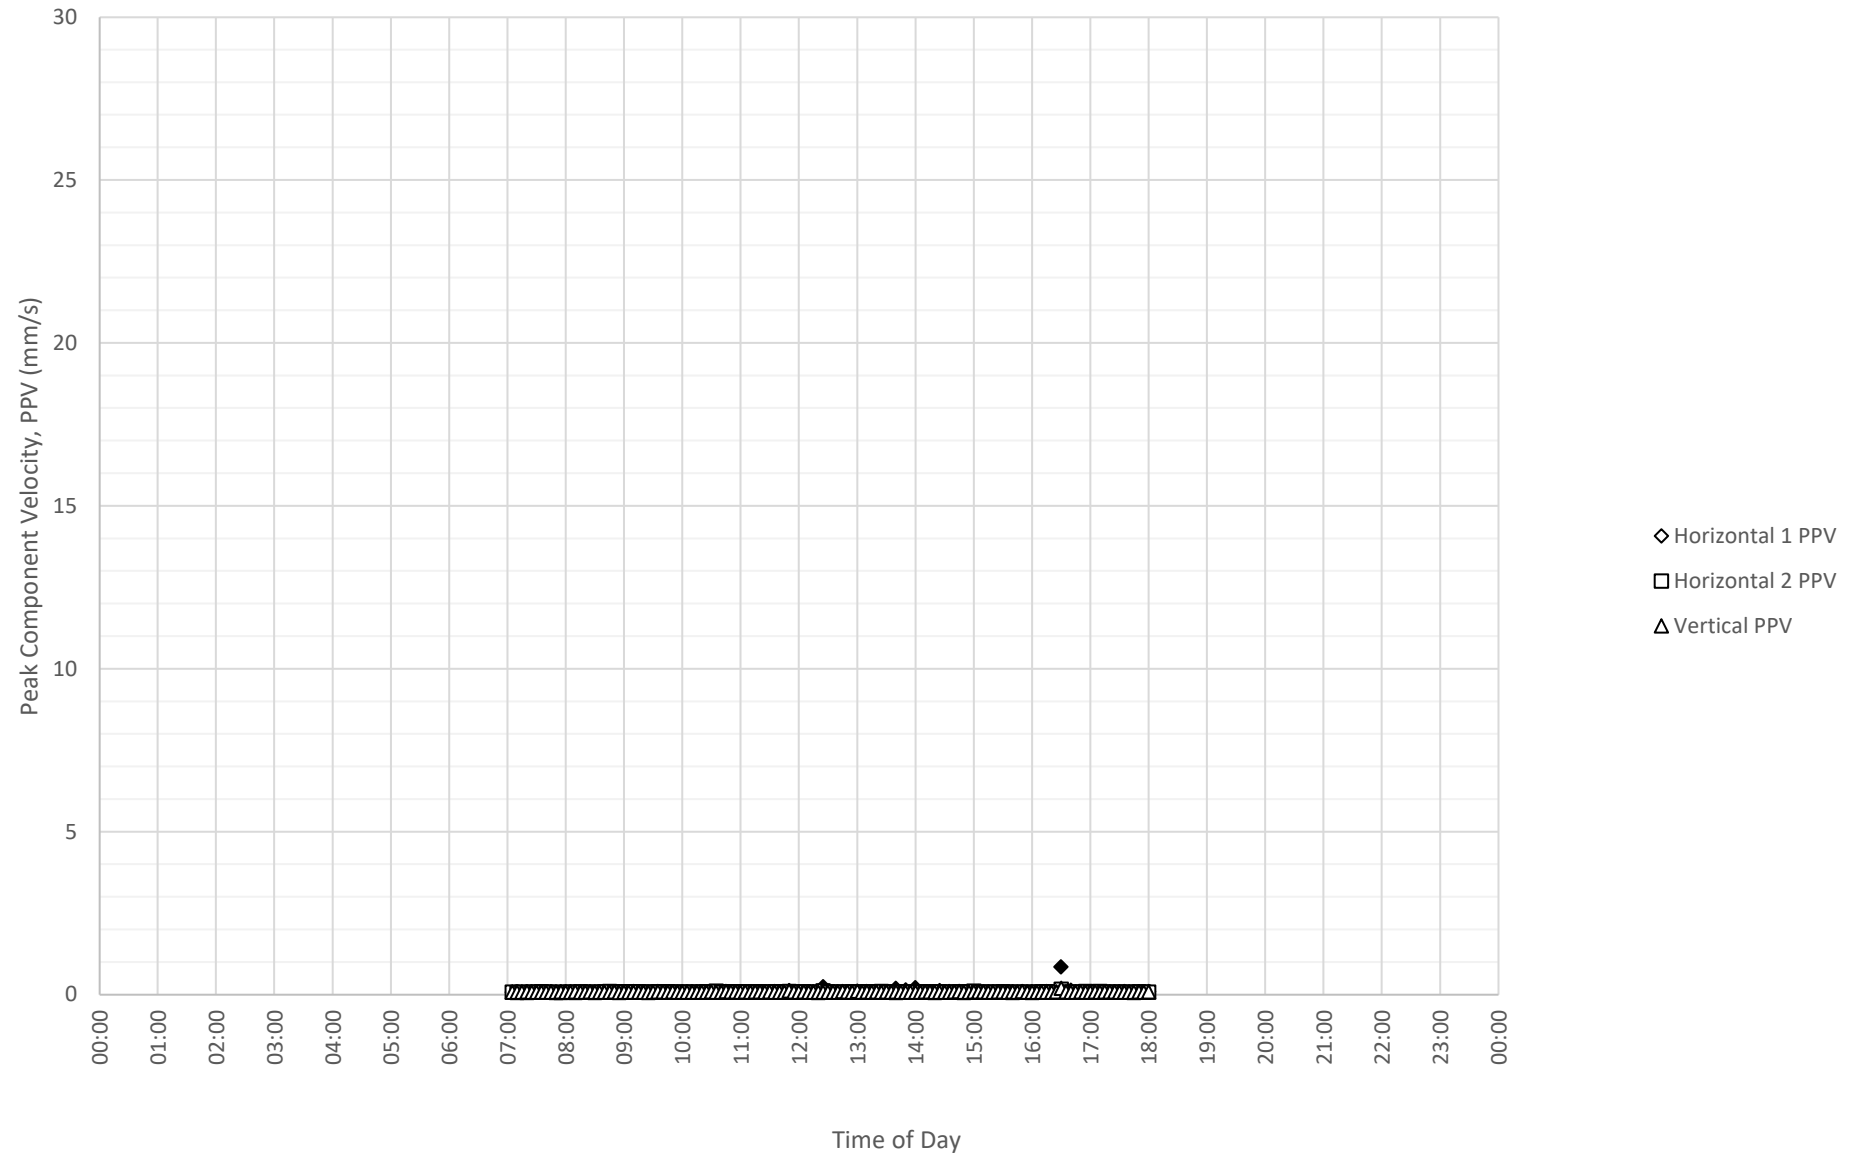
### Daily Monitored Vibration Levels at Residential Receivers at NorthWest of N3 parking at Macquarie University on 19-09-2024

Frequency Content of Vibration Levels at Residential Receivers at NorthWest of N3 parking at Macquarie University on 19-09-2024

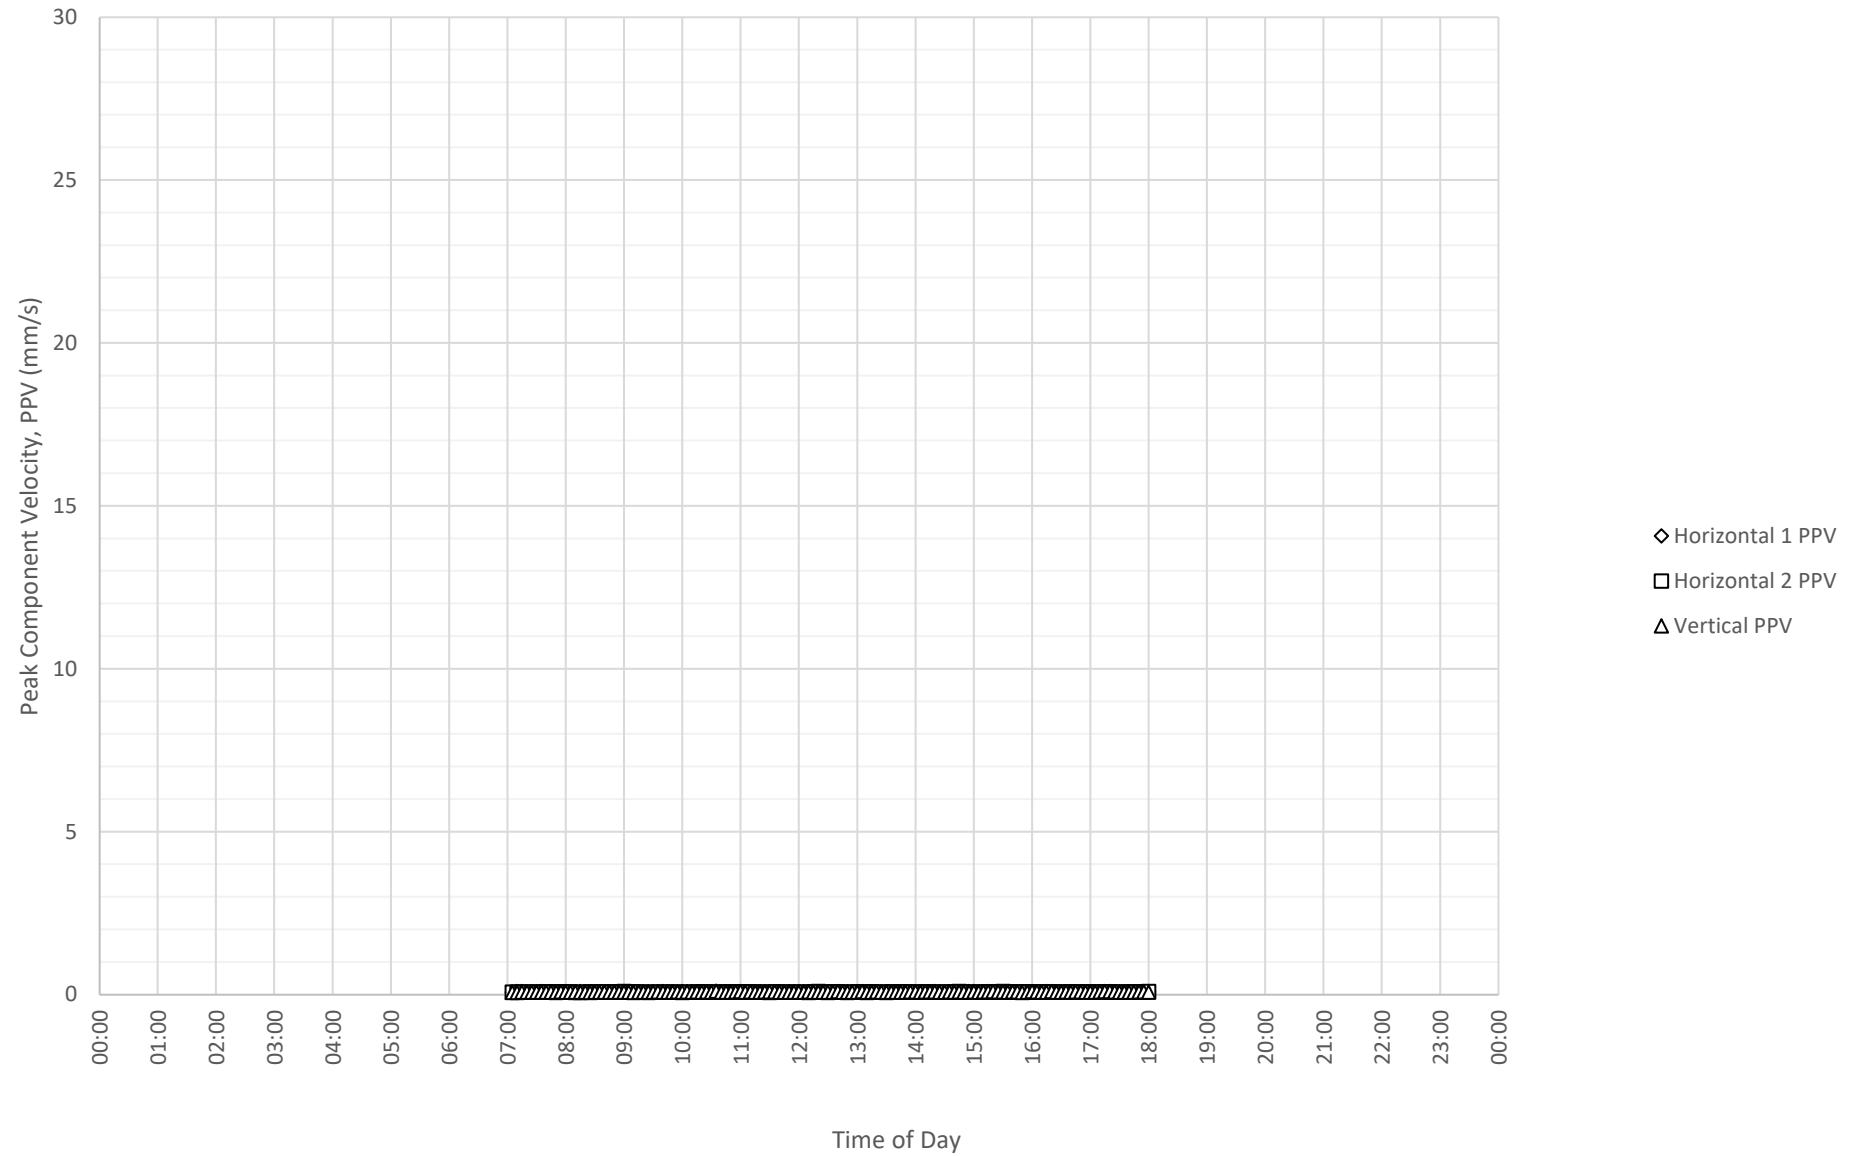
# Daily Monitored Vibration Levels at Residential Receivers at NorthWest of N3 parking at Macquarie University on 20-09-2024

Frequency Content of Vibration Levels at Residential Receivers at NorthWest of N3 parking at Macquarie University on 20-09-2024

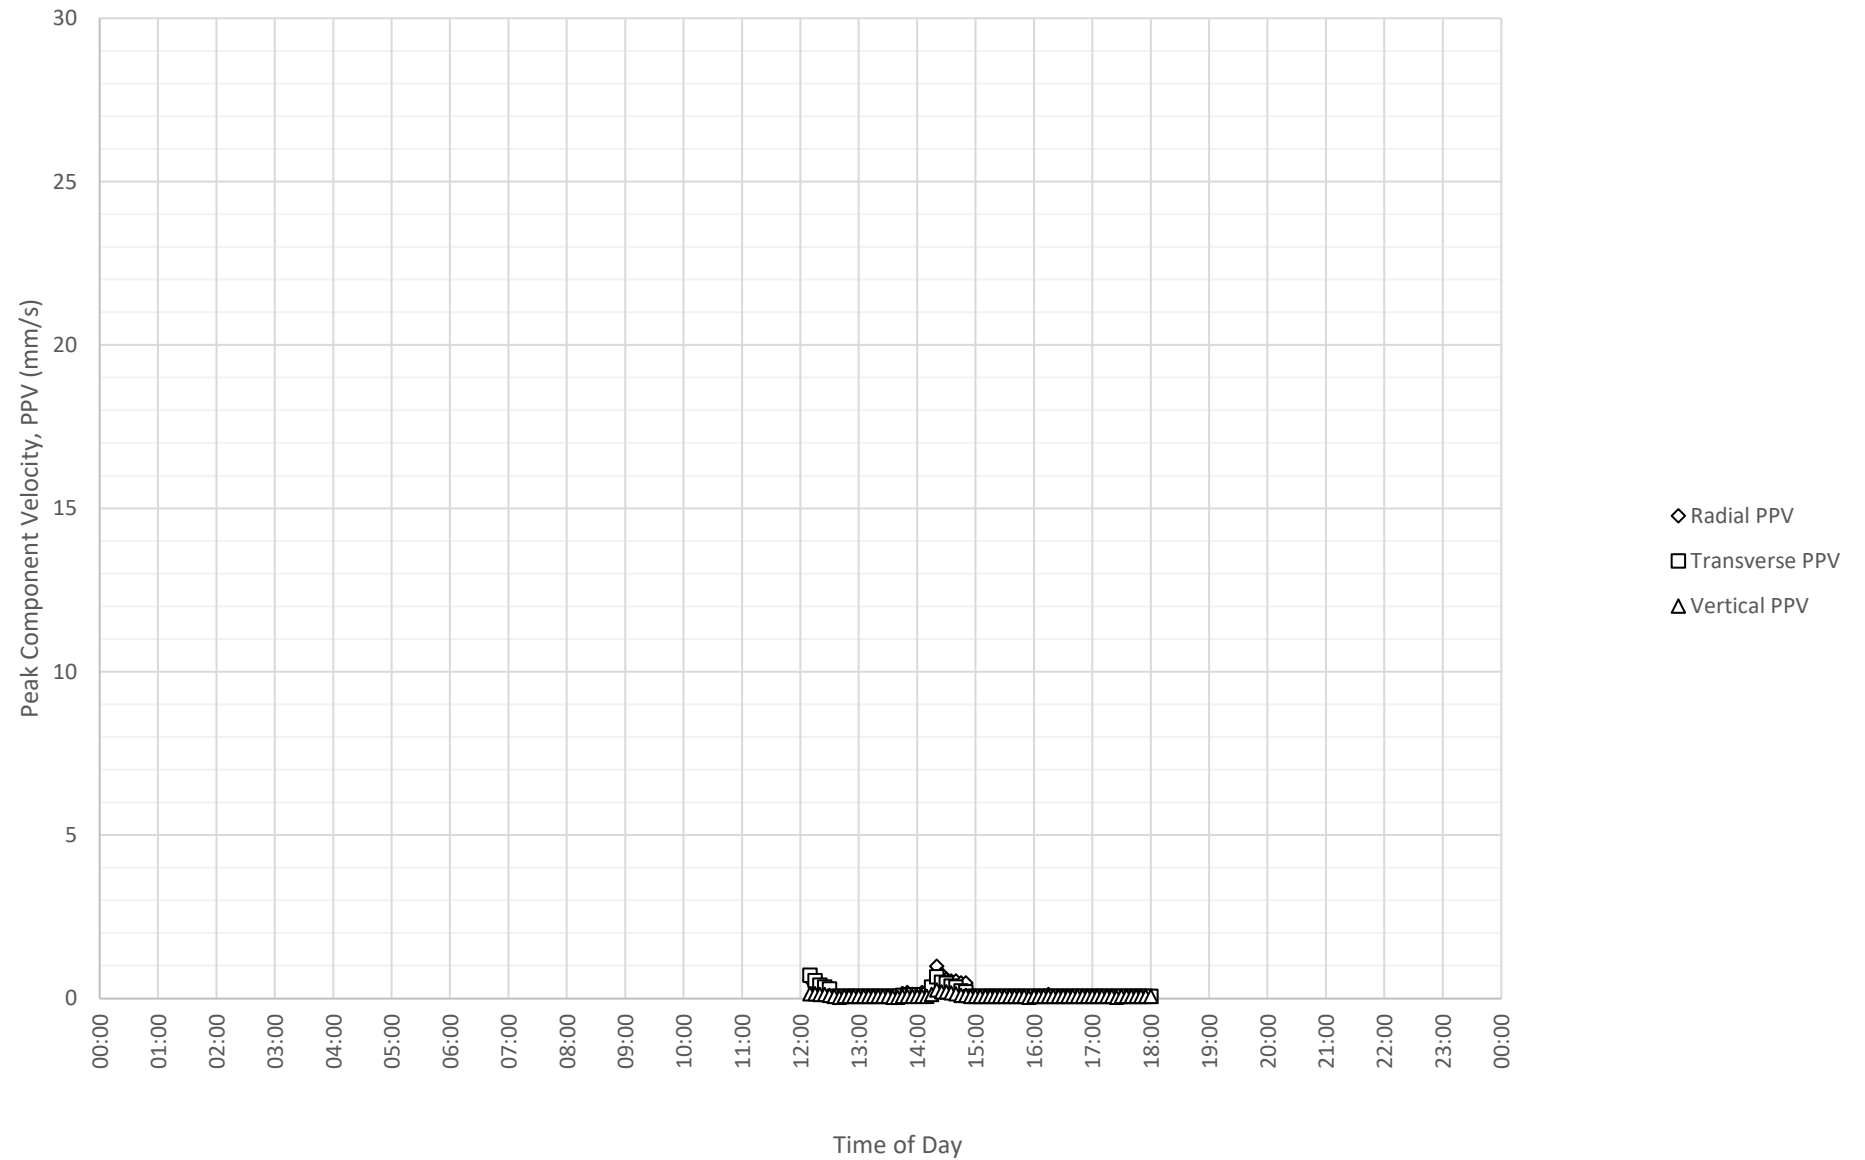
Daily Monitored Vibration Levels at Macquarie University Astronomical Observatory on 10-09-2024

# Frequency Content of Vibration Levels at Macquarie University Astronomical Observatory on 10-09-2024

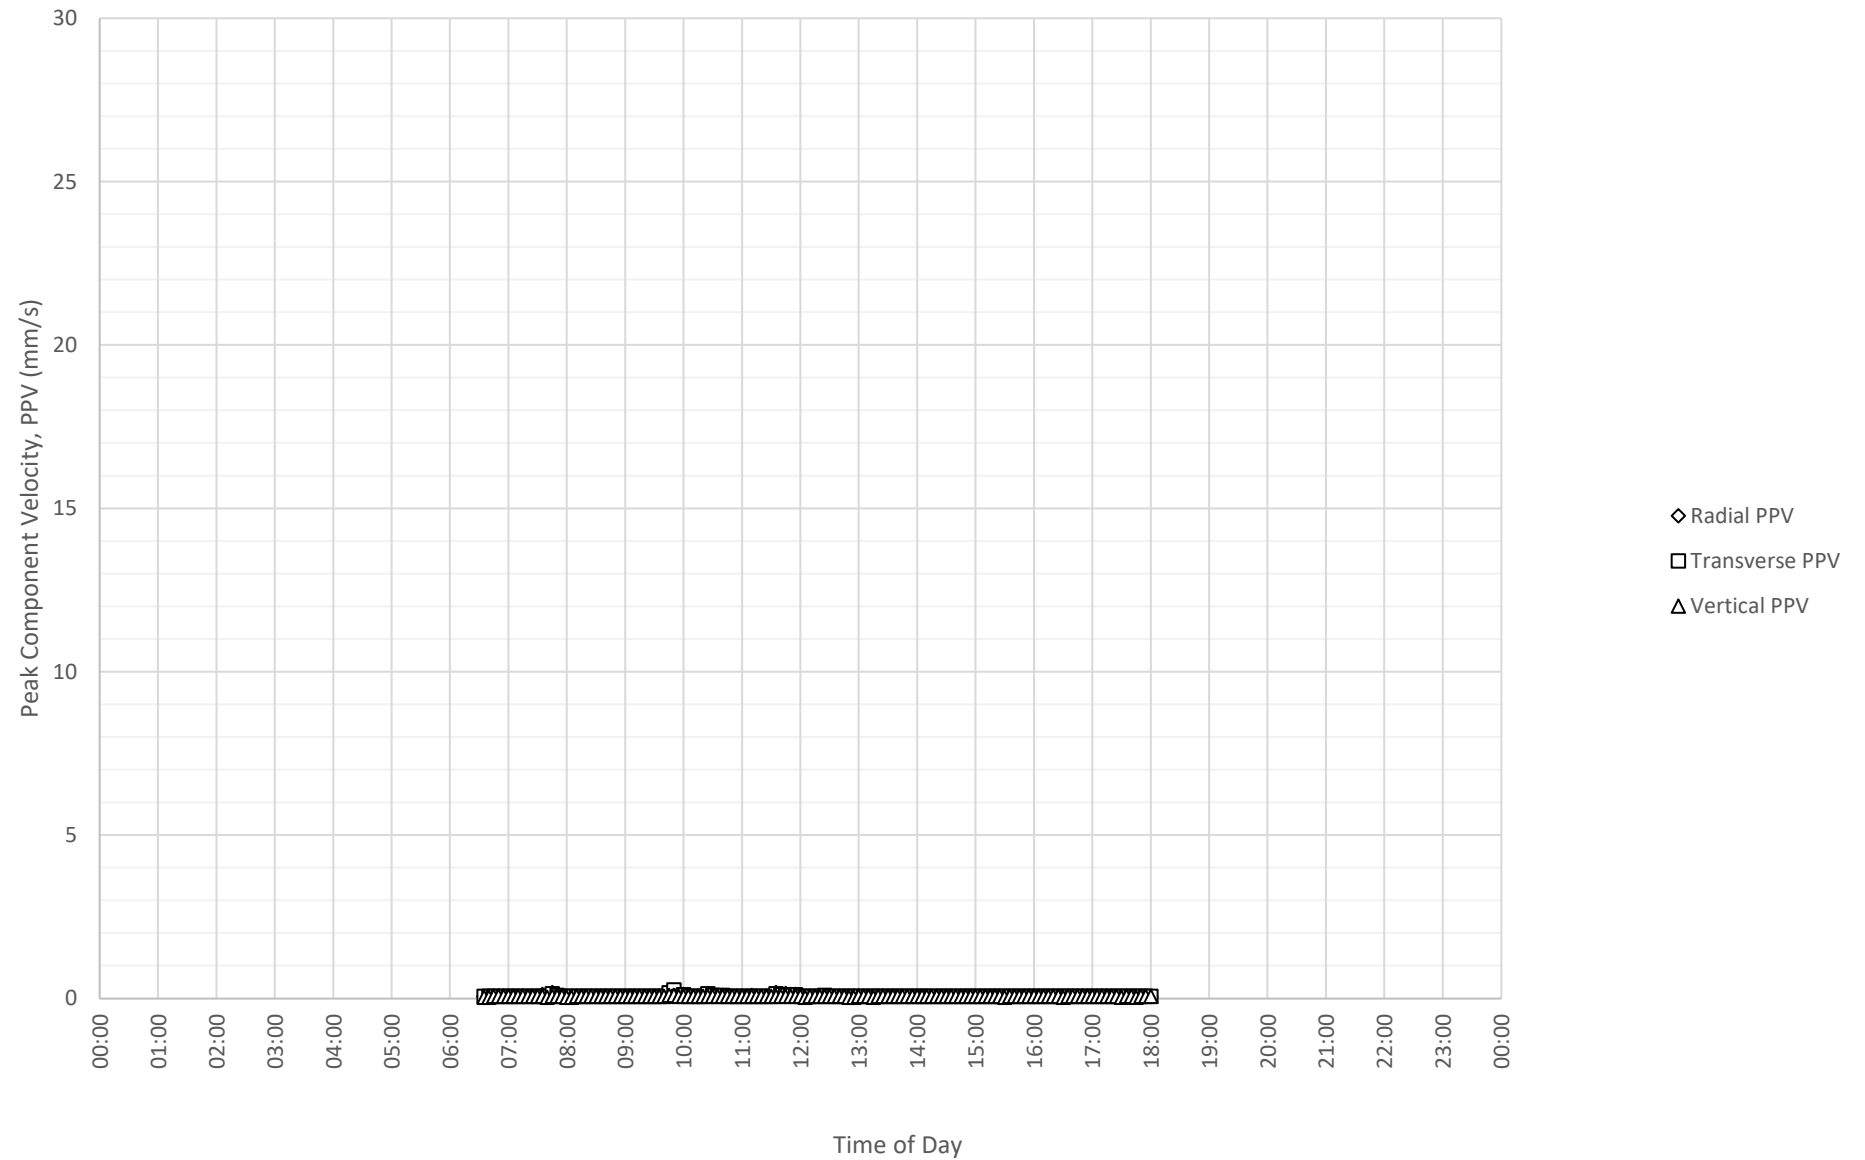
Daily Monitored Vibration Levels at Macquarie University Astronomical Observatory on 11-09-2024

# Frequency Content of Vibration Levels at Macquarie University Astronomical Observatory on 11-09-2024

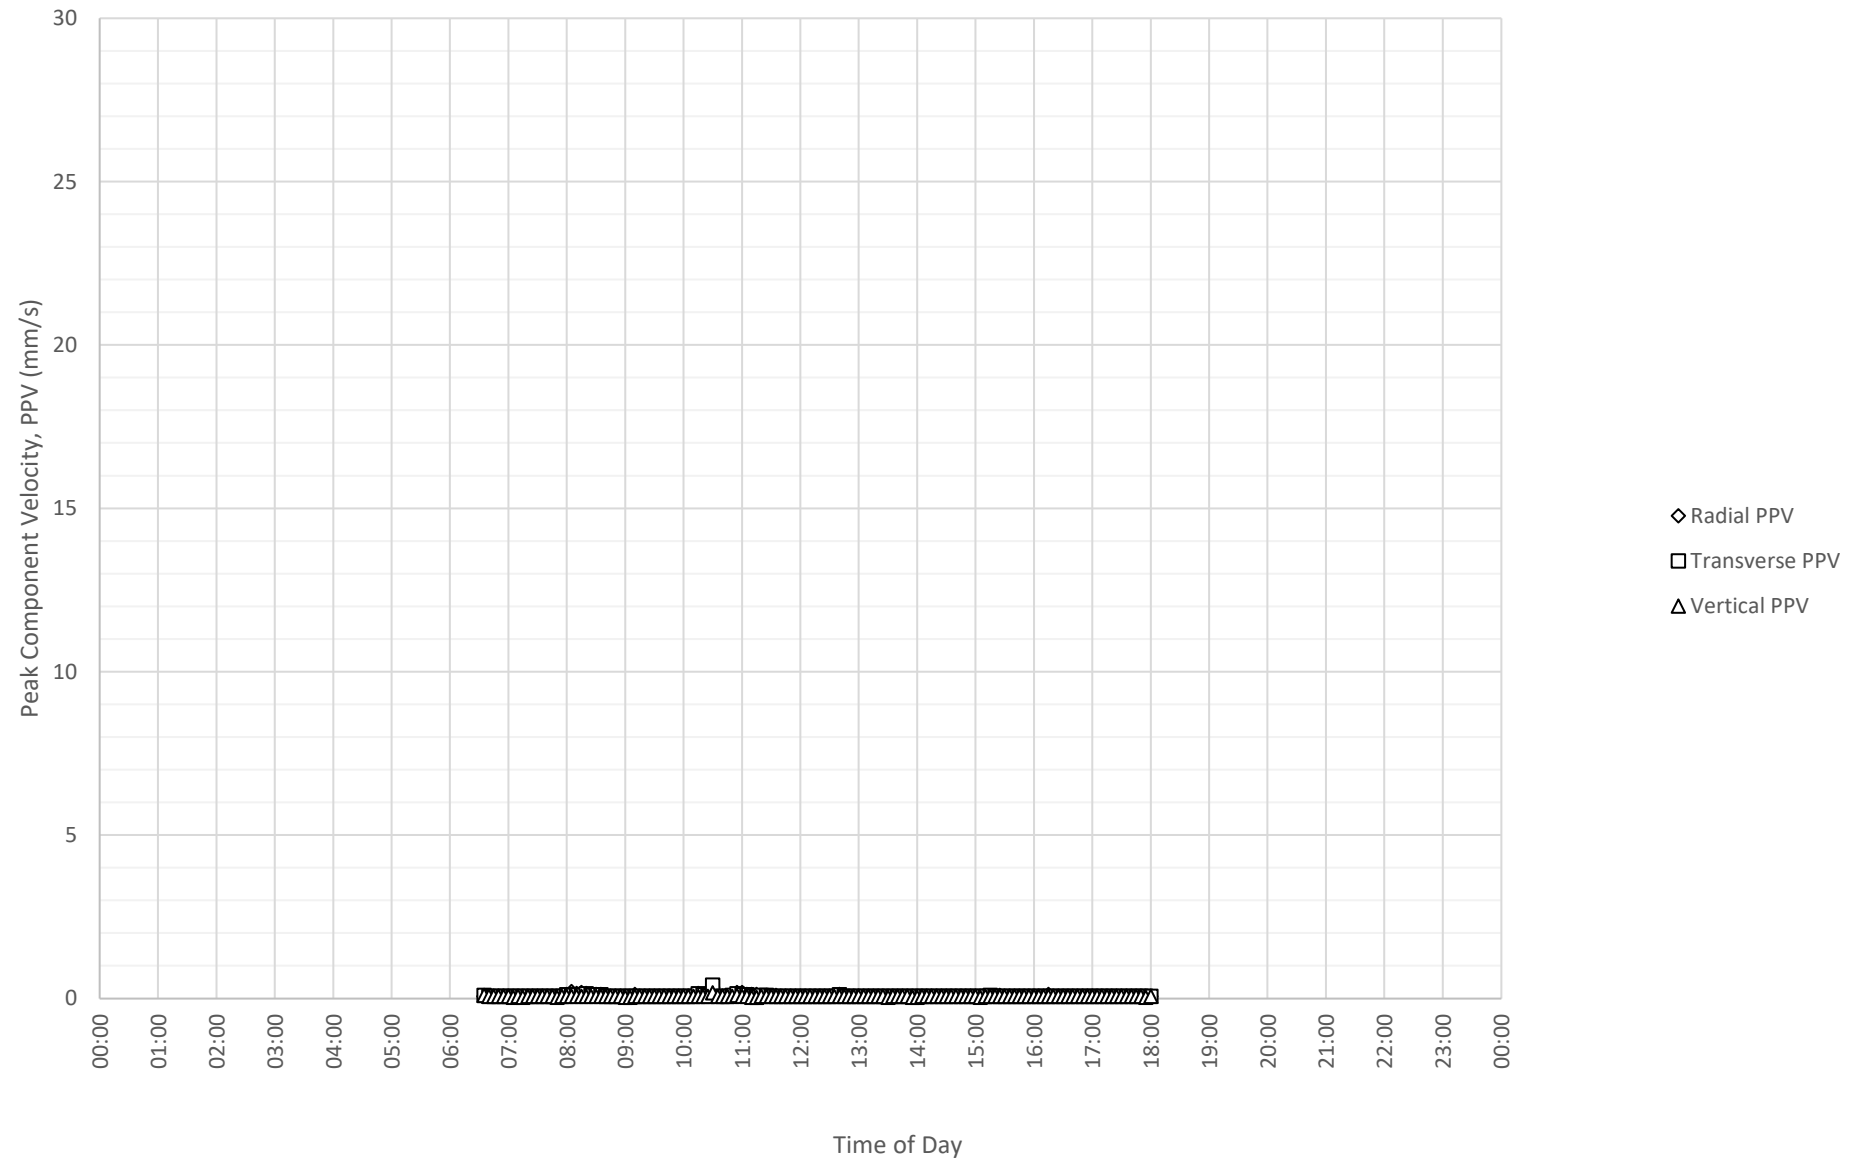
Daily Monitored Vibration Levels at Macquarie University Astronomical Observatory on 12-09-2024

# Frequency Content of Vibration Levels at Macquarie University Astronomical Observatory on 12-09-2024

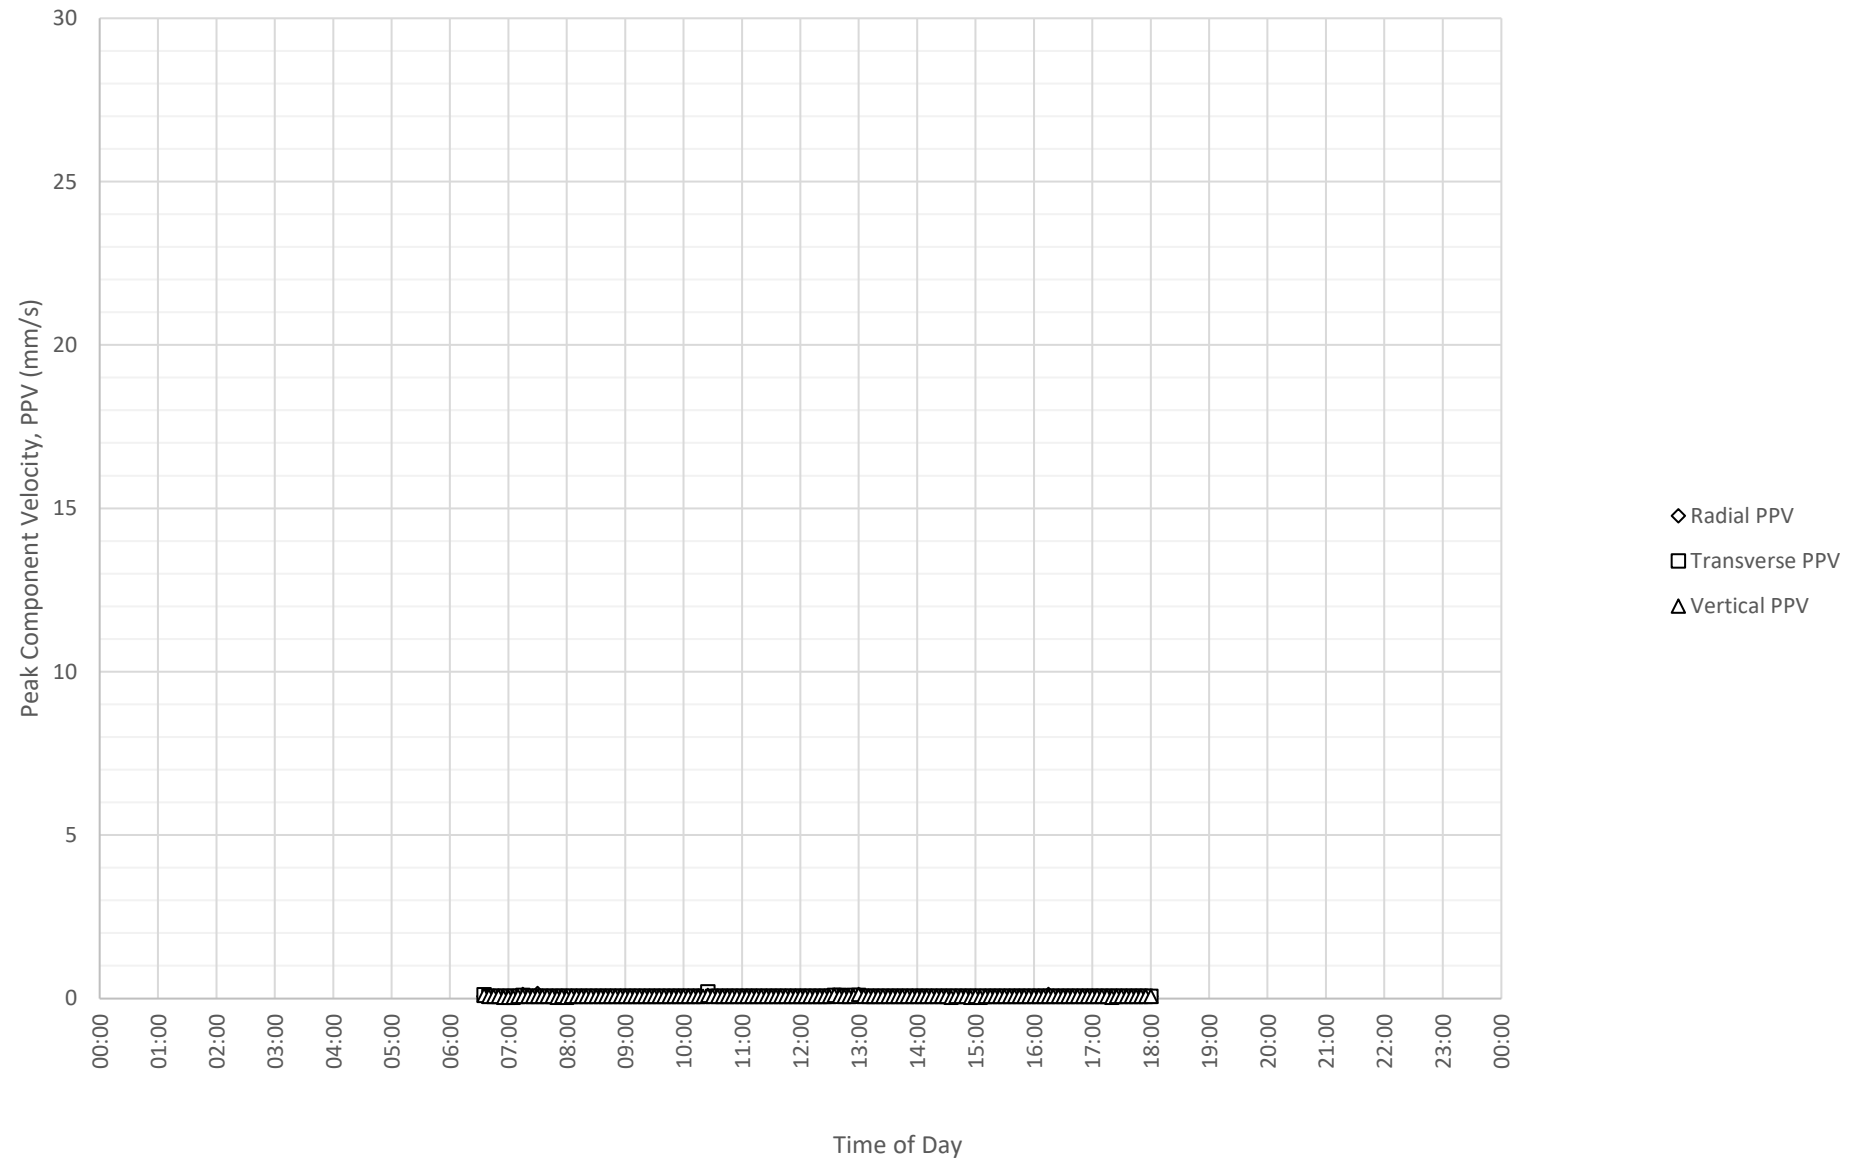
Daily Monitored Vibration Levels at Macquarie University Astronomical Observatory on 13-09-2024

# Frequency Content of Vibration Levels at Macquarie University Astronomical Observatory on 13-09-2024

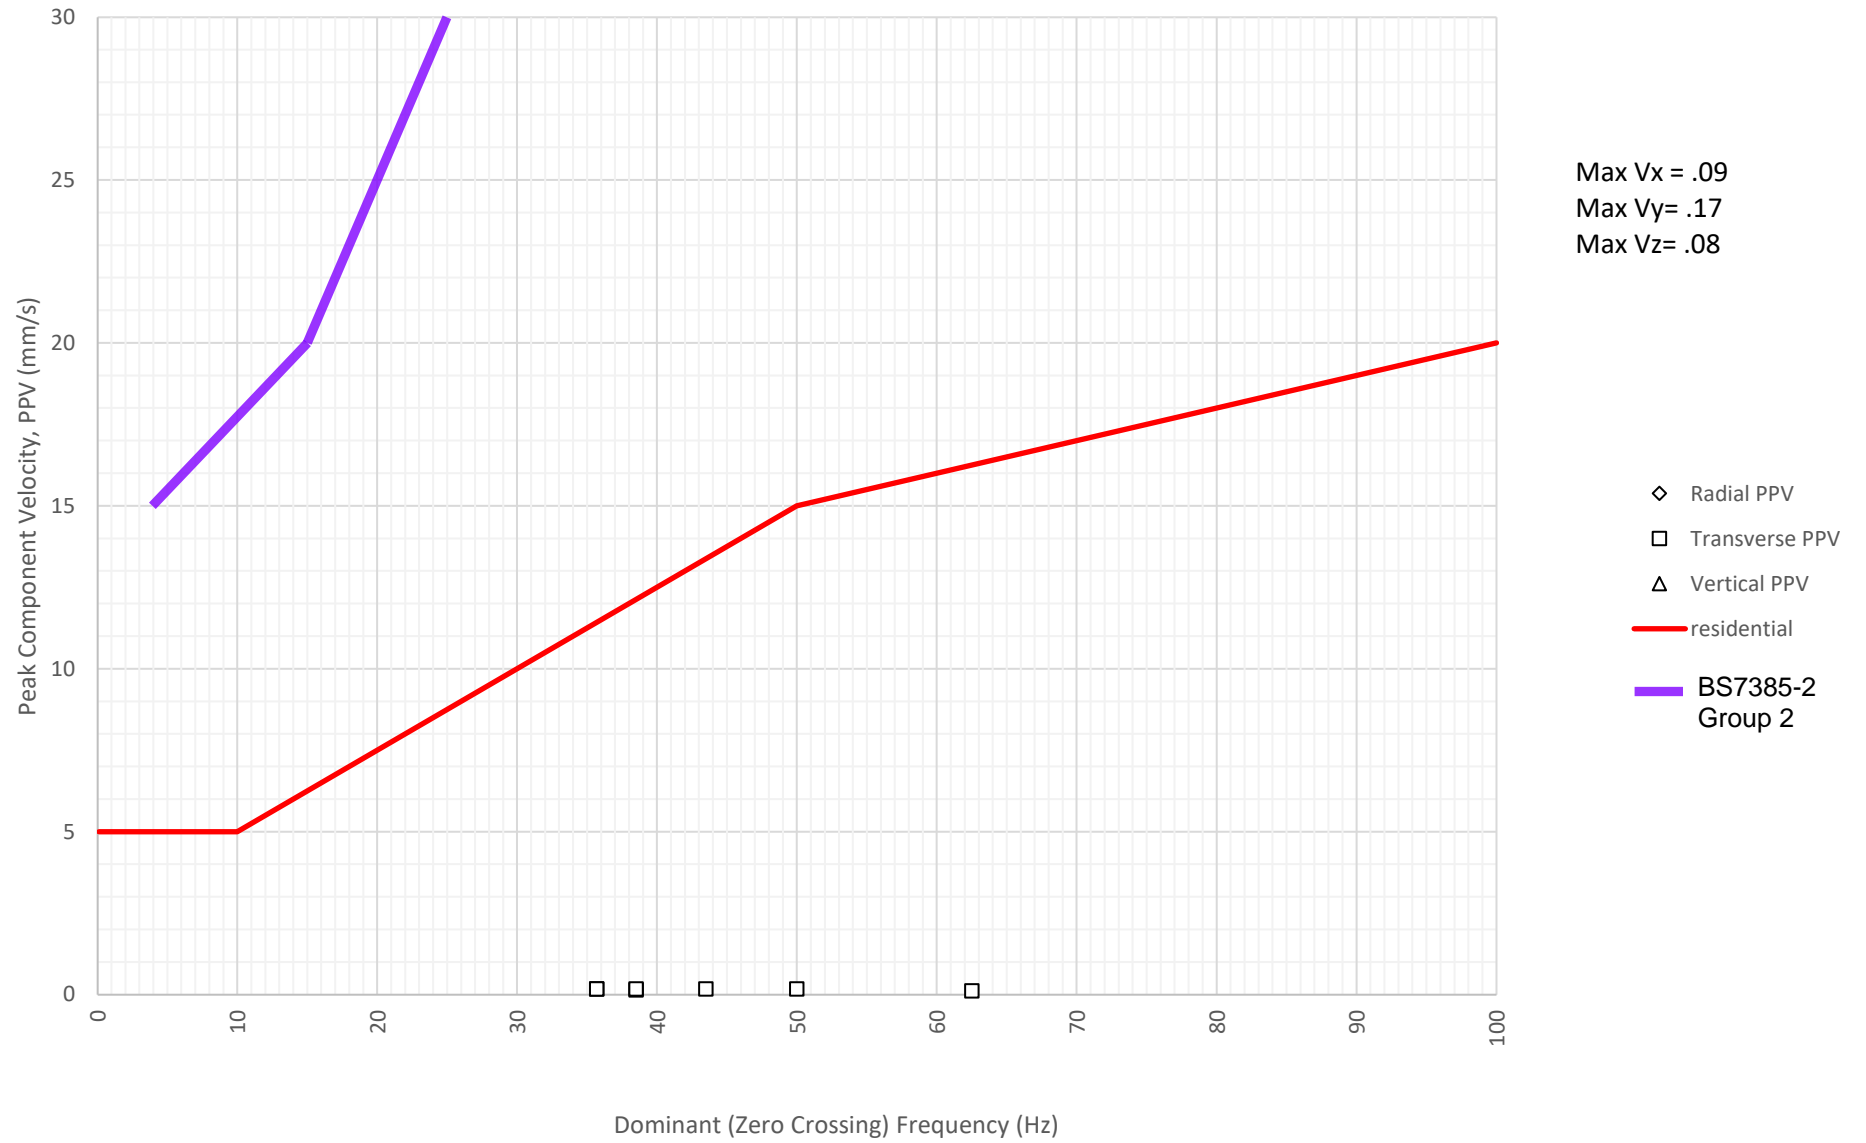
Daily Monitored Vibration Levels at 2 Gymnasium Road, Macquarie Park NSW on 11-09-2024

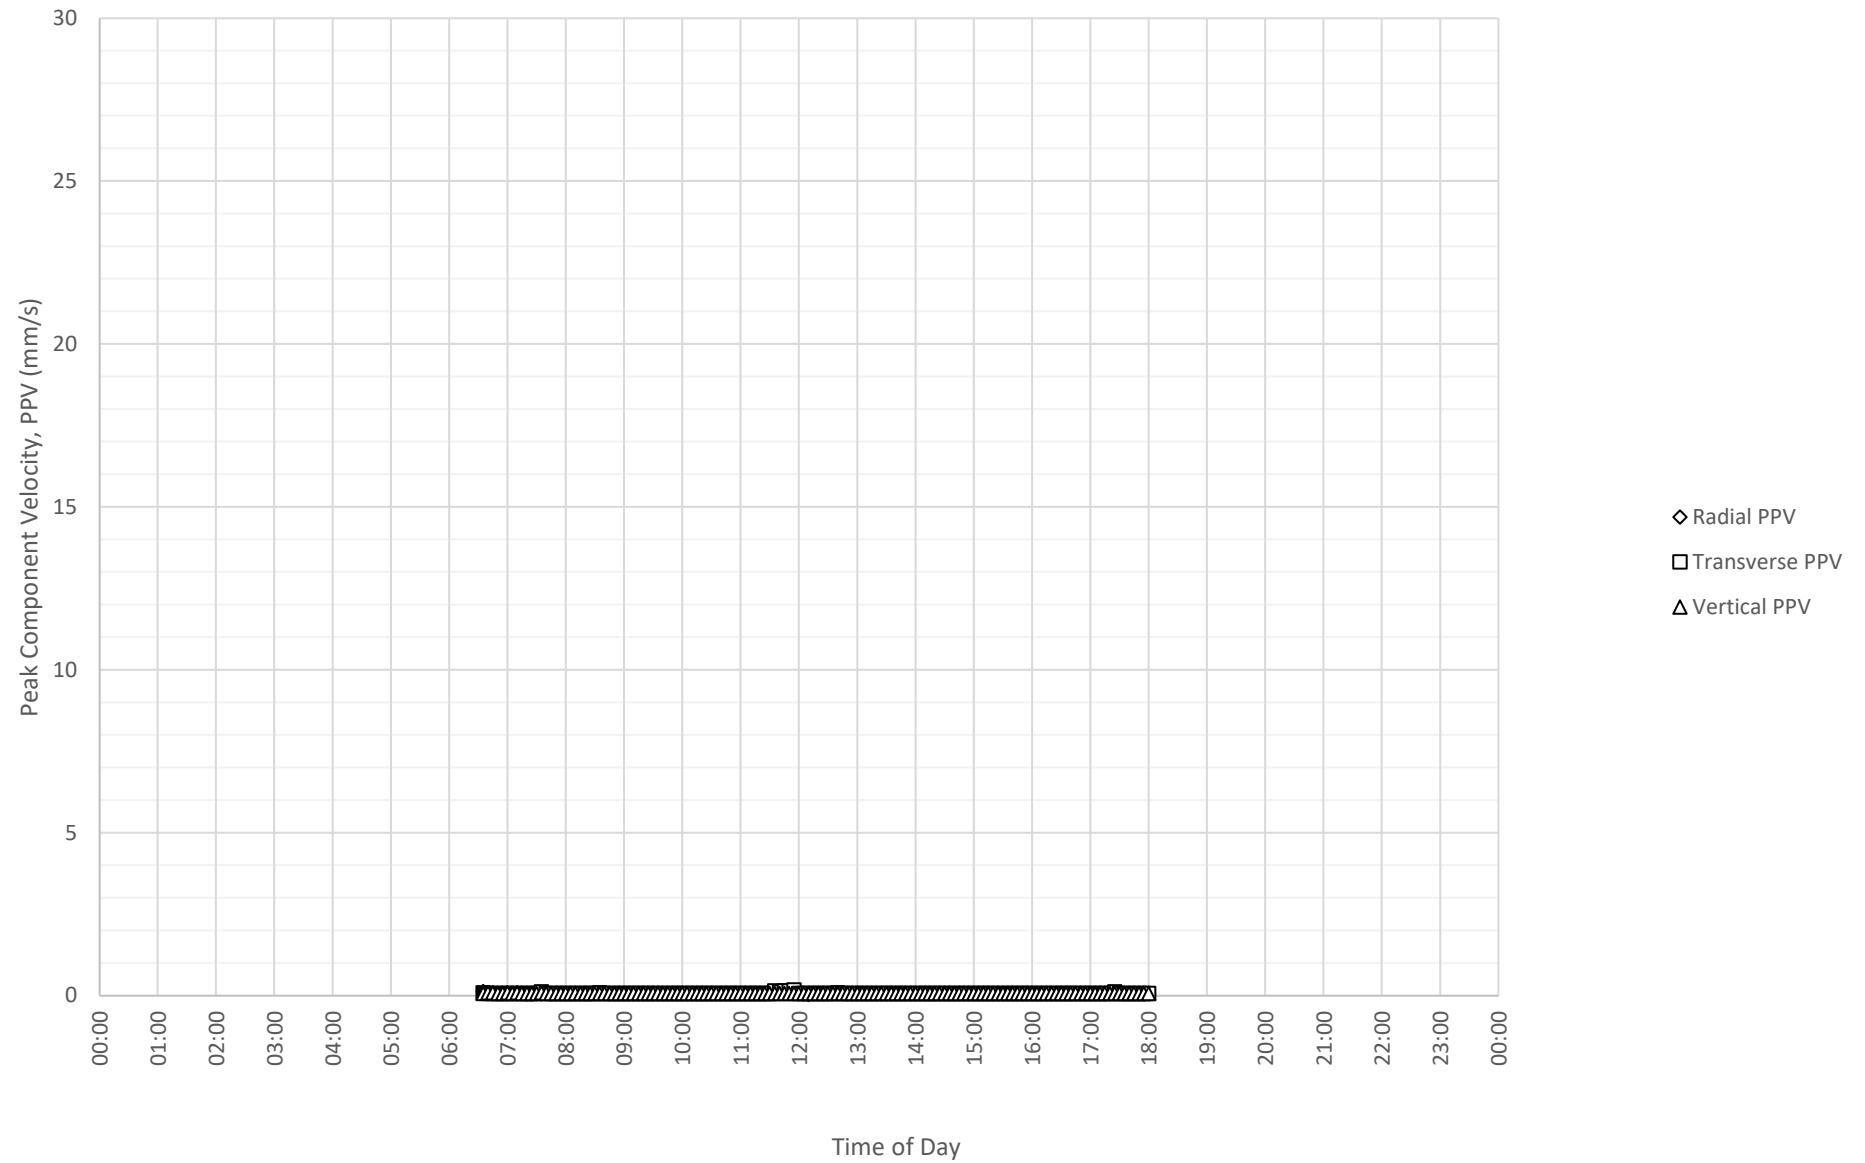
Frequency Content of Vibration Levels at 2 Gymnasium Road, Macquarie Park NSW on 11-09-2024
