## REF REPORT – HAZMAT ASSESSMENT BUILDING – MN03, MN05, MN09

Manning Base Hospital Redevelopment  
**26 York St**  
**Taree NSW 2430**

June 2023

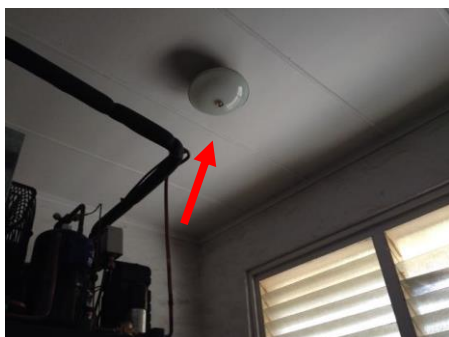
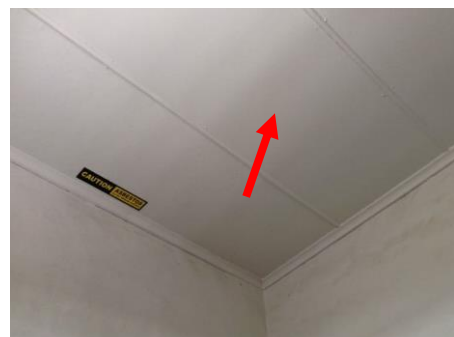
Photo No. 003: Mortuary Storage Room

The FFCS ceiling lining to the Mortuary storage room was referred to a sample previously tested by others that **proved to be an asbestos-containing material**

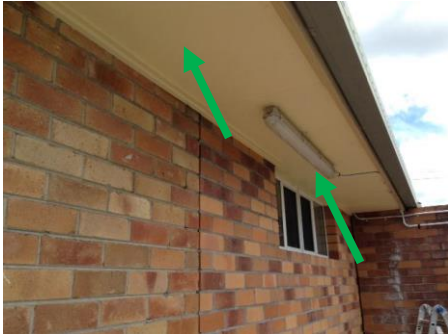
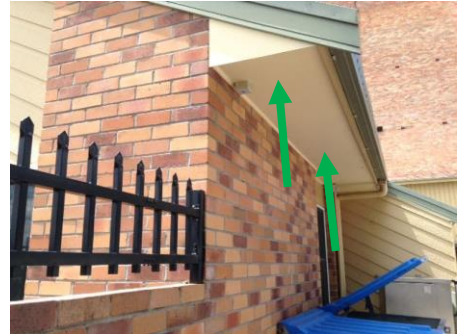
Photo No. 007: Front Extension

The FFCS eave soffit lining to the front extension was tested and **proved NOT to be an asbestos containing material**

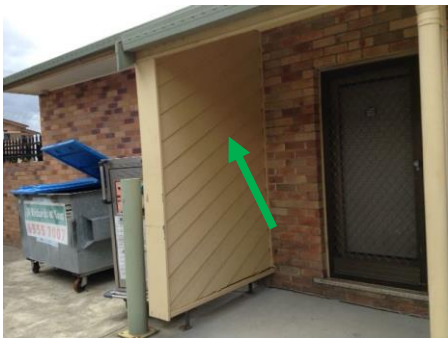
Photo No. 008: South-Western Entrance

The FFCS wall cladding to the partition adjacent to the south-western entrance was tested and **proved NOT to be an asbestos containing material**

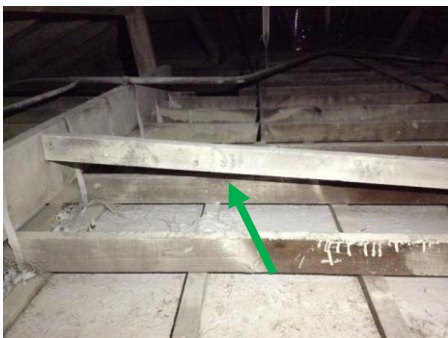
Photo No. 009: Mortuary

The lagging debris in the ceiling cavity of the mortuary has been remediated and as such has **proved NOT to be an asbestos containing material**

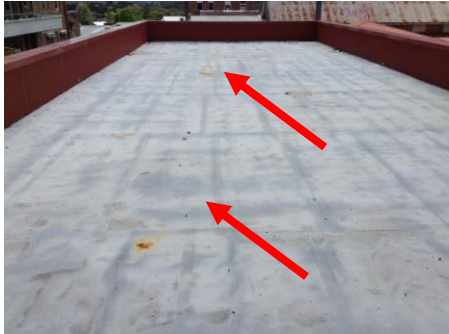
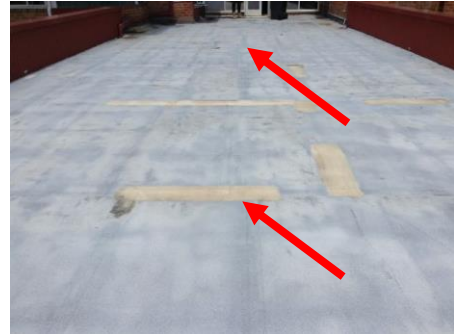
Photo No. 001: 1st Floor Balcony (above Staff Centre)

The Bituminous waterproofing membrane to the 1st floor balcony was previously tested by others and **proved to be an asbestos containing material**

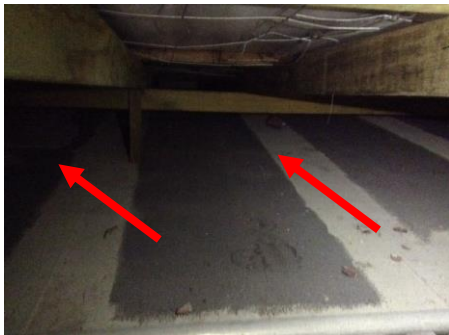
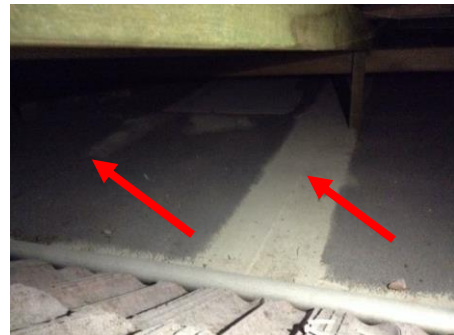
Photo No. 002: 1st Floor Ceiling Void

The Bituminous waterproofing membrane to the 1st floor ceiling void (above Room MN0901059 & 1058) was unable to be sampled **but SHALL be regarded as an asbestos-containing material**

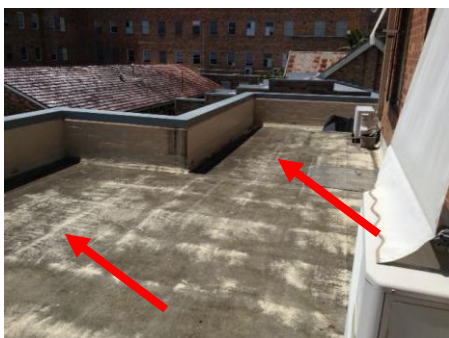
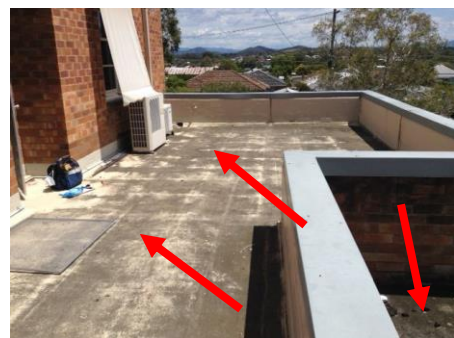
Photo No. 003: 1st floor north east balcony

The Bituminous waterproofing membrane to the 1st floor north east balcony was tested and **proved to be an asbestos containing material**

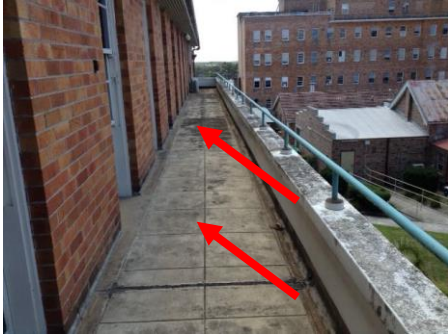
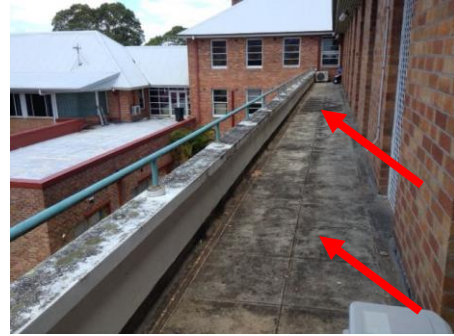
Photo No. 004: 2nd floor eastern balcony

The Bituminous waterproofing membrane to the 2nd floor eastern balcony was concealed but **SHALL be regarded as an asbestos-containing material**

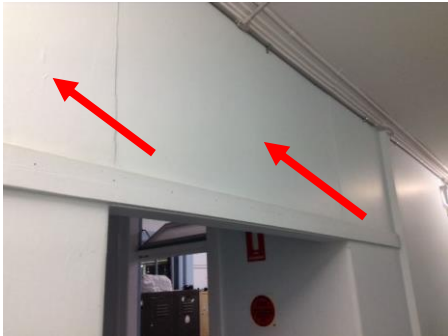
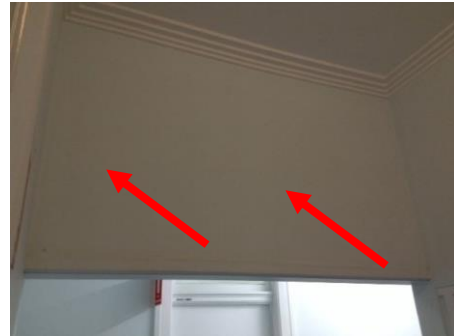
Photo No. 005: Ground Floor, bulkhead outside MN0900059

The FFCS infill panels to the bulkhead outside MN0900059 were tested and **proved to be an asbestos-containing material**

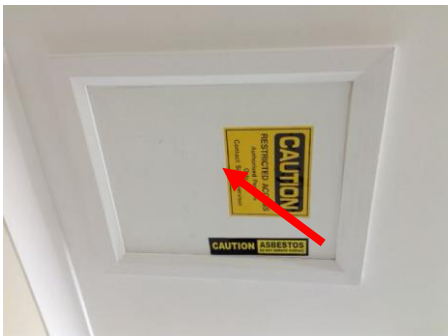
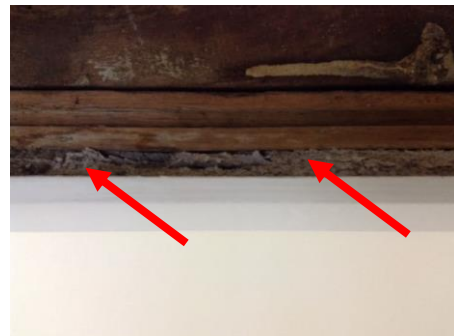
Photo No. 006: Ground Floor, men's bathroom MN0900044

The Flat Fibre Cement Sheet ceiling lining to the Men's bathroom MN0900044 was tested and **proved to be an asbestos containing material**

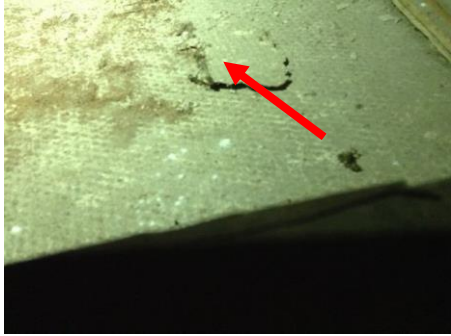
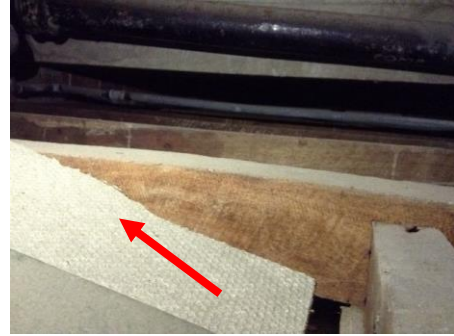
Photo No. 007: Ground Floor, men's bathroom ceiling void MN0900044 and MN0900046

The FFCS double ceiling lining to the Men's bathroom ceiling void MN0900044 and MN0900046 was referred to sample 00704 and **SHALL be regarded as an asbestos-containing material**

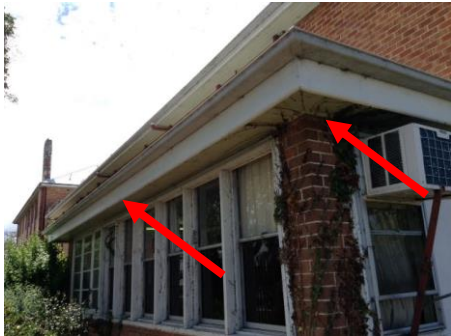
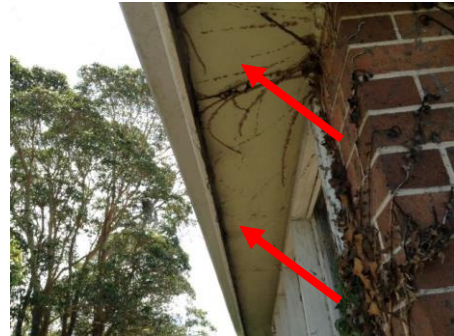
Photo No. 008: Eave soffit outside room MN0900056

The FFCS eave soffit lining outside Room MN0900063 was previously tested by others and **proved to be an asbestos-containing material**

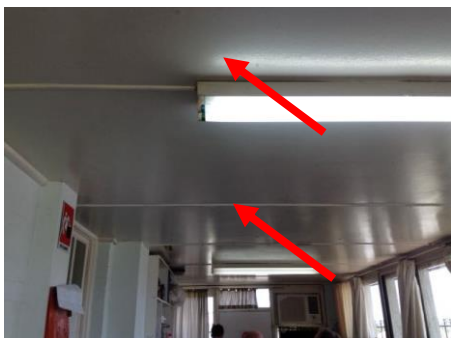
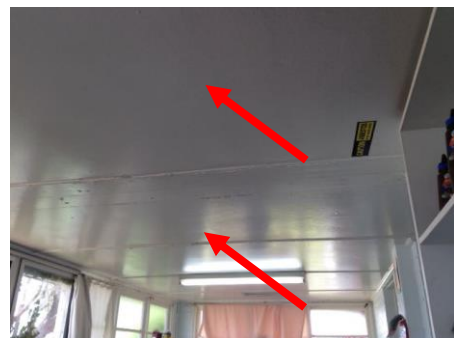
Photo No. 009: Ground Floor MN0900063

The FFCS ceiling lining to MN0900063 was previously tested by others and **proved to be an asbestos containing material**

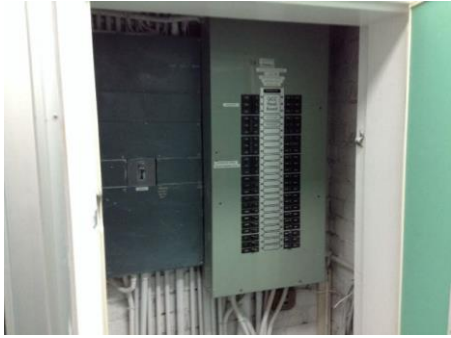
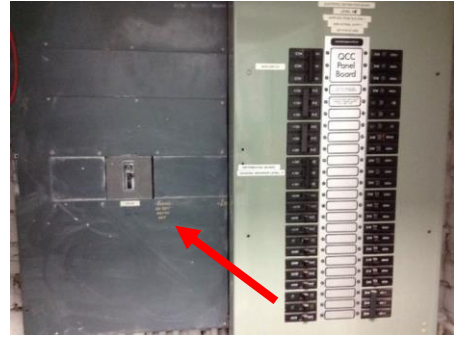
Photo No. 013: Ground Floor Room MN090028

The insulation panel to the electrical switchboard in MN090028 was unable to be sampled **but SHALL be regarded as an asbestos-containing material**

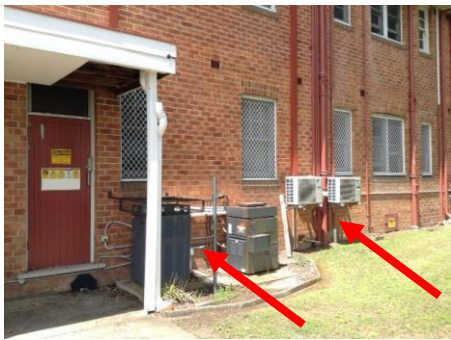
Photo No. 014: Subfloor of Eastern Wing

The thermal “lagging” insulation to pipework in the subfloor of the eastern wing was previously tested by others and **proved to be an asbestos containing material**

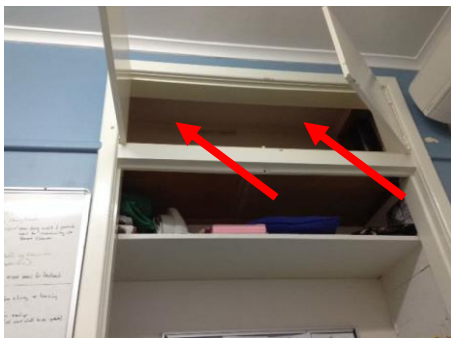
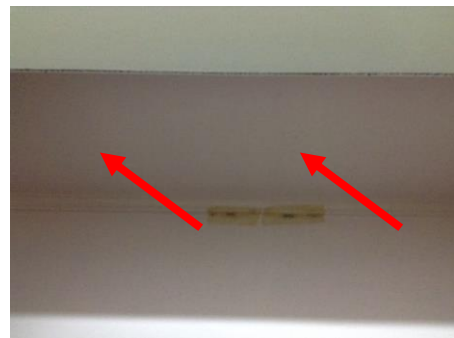
Photo No. 015: 1st Floor, upper cupboard to Room MN0901039

The FFCS ceiling lining to the upper cupboard to MN0901039 **SHALL be regarded as an asbestos-containing material**

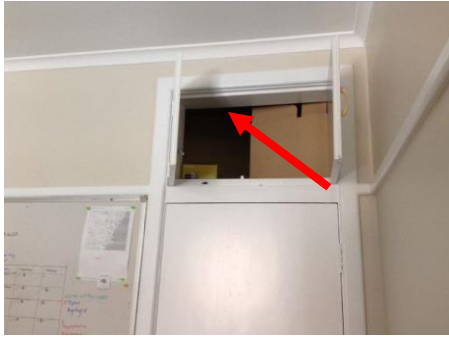
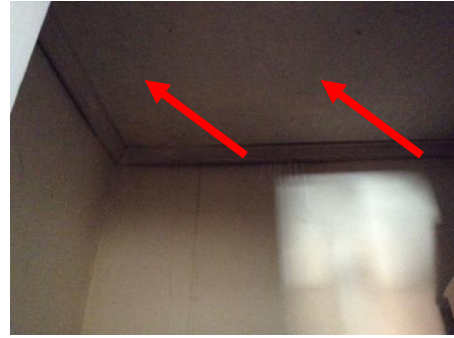
Photo No. 016: 1st Floor, upper cupboard to Room MN0901040 and MN0901041

The FFCS ceiling lining to the upper cupboards to Room MN0901040 and MN0901041 **SHALL be regarded as an asbestos-containing material**

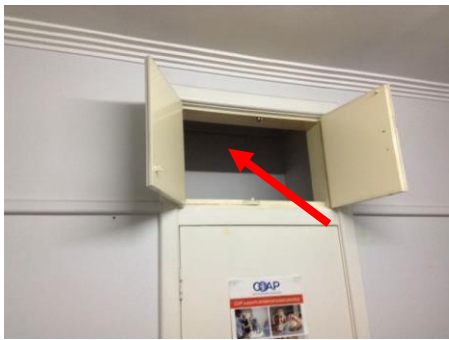
Photo No. 017: 1st Floor, upper cupboard to MN0901042

The FFCS ceiling lining to the upper cupboard in MN0901042 **SHALL be regarded as an asbestos-containing material**

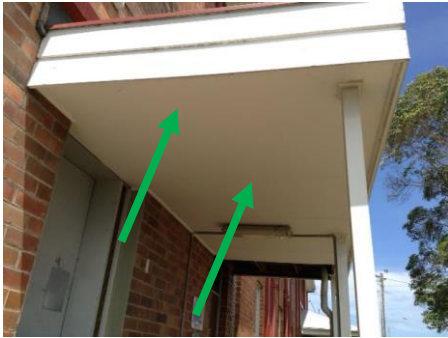
Photo No. 018: Entry Portico (off Room MN0900037)

The FFCS awning soffit lining to the entry portico was previously tested and **proved NOT to be an asbestos containing material**

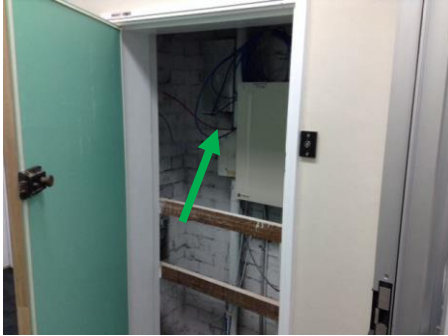
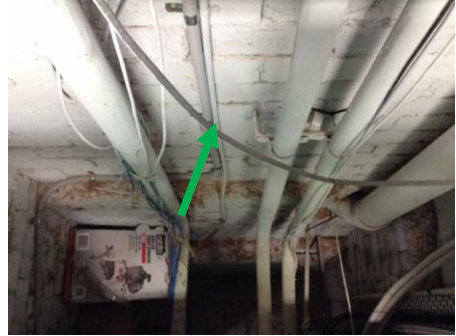
Photo No. 024: Ground Floor Room MN090027

The thermal insulation to pipework in Room MN090027 was remediated and thus **proved NOT to be an asbestos containing material**

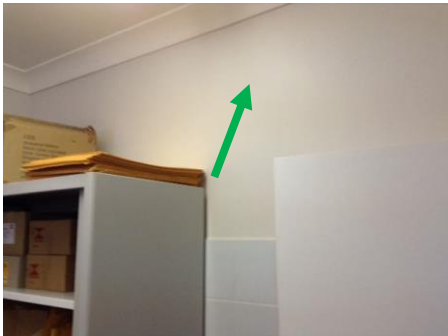
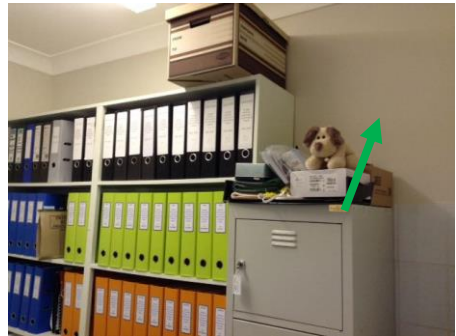
Photo No. 025: Ground Floor Storage Rooms off MN090020 and MN090018

The FFCS wall lining to the storage Rooms off MN090020 and MN090018 was tested and **proved NOT to be an asbestos containing material**
