# STATE SIGNIFICANT DEVELOPMENT ASSESSMENT REPORT

## BUILDINGS – MN06, MN07 & MN08

Manning Base Hospital Redevelopment  
**26 York St**  
**Taree NSW 2430**

July 2023  
*Survey conducted in March 2022*

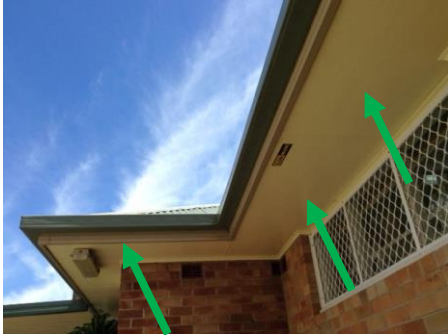
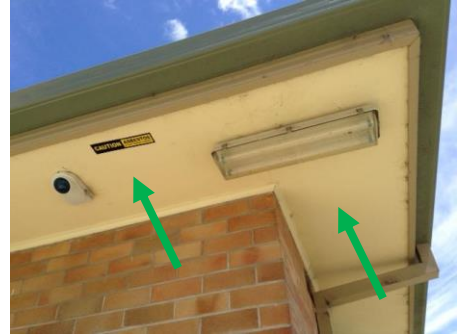
Photo No. 010: Pharmacy

The Flat Fibre Cement Sheet eave soffit lining was previously tested and **proved NOT to be an asbestos containing material**

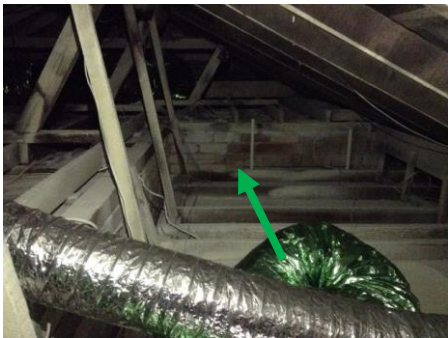
Photo No. 0112: Pharmacy Ceiling Cavity

The thermal insulation "lagging" debris to pipework in the ceiling cavity was remediated and has now **proved NOT to be asbestos containing.**

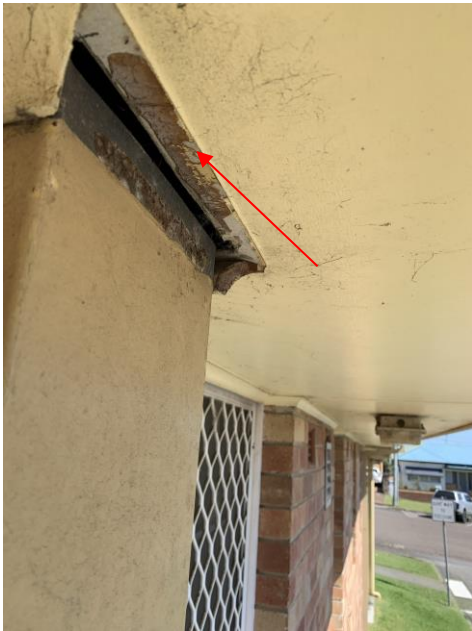
**Photo 1:**

AS10 – 4: No asbestos detected

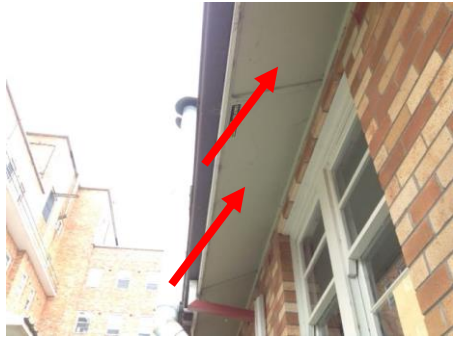
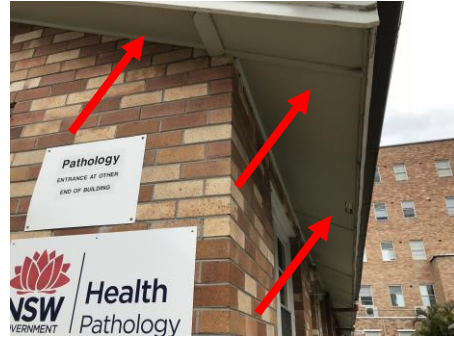
Photo No. 001: External

The FFCS eave soffit lining was previously tested by others and **proved to be an asbestos containing material**

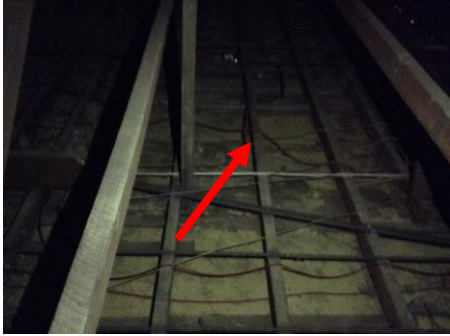
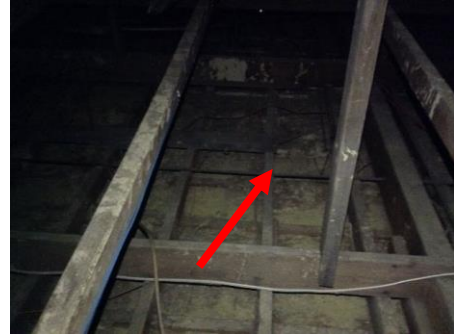
Photo No. 004: Ceiling Void

The thermal insulation “lagging” debris to pipework in the ceiling void was previously tested by others and **proved to be an asbestos containing material**

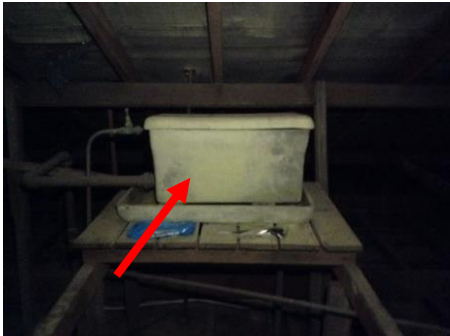
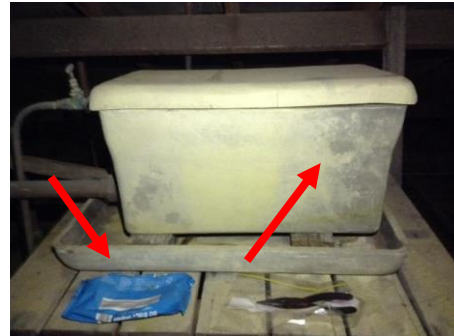
Photo No. 005: Ceiling Void

The Moulded Fibre Cement water tank and berm within the ceiling void was tested and **proved to be an asbestos containing material**

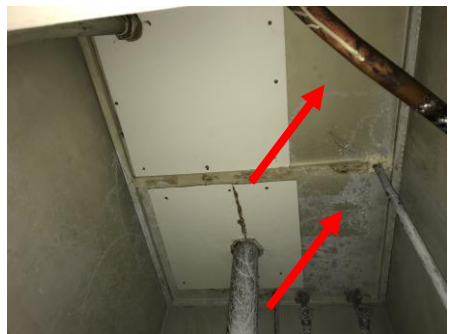
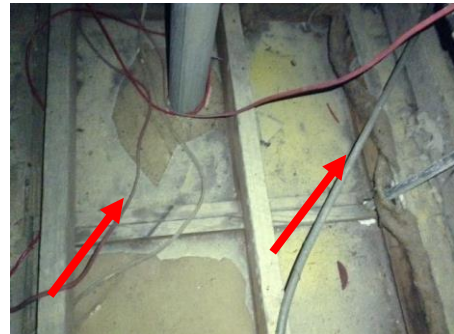
Photo No. 006: Ceiling Void (Above Storage Room)

The FFCS ceiling lining in the ceiling void (above storage room – Room 00014) was tested and **proved to be an asbestos containing material**

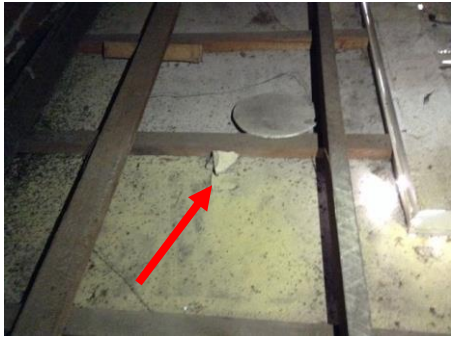
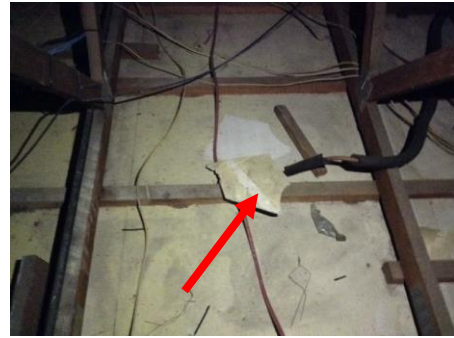
Photo No. 007: Ceiling Void (MN070007)

The Flat Fibre Cement Sheet ceiling lining to the ceiling void (MN070007) was referred to sample 8 and **SHALL be regarded as an asbestos-containing material**

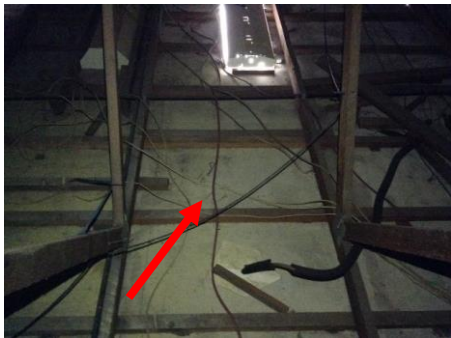
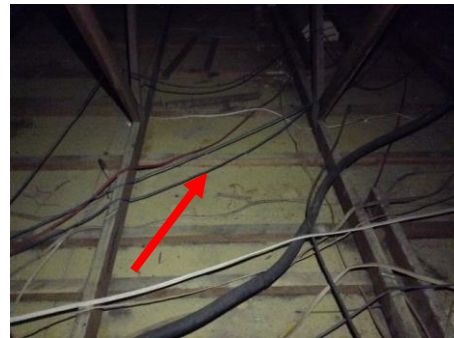
Photo No. 008: Ceiling Void Above MN0700007

The FFCS ceiling lining to the ceiling void above MN0700007 was previously tested by others and **proved to be an asbestos containing material**

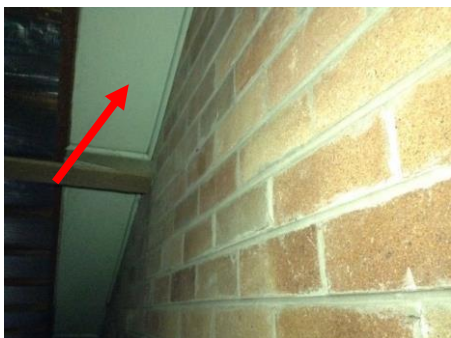
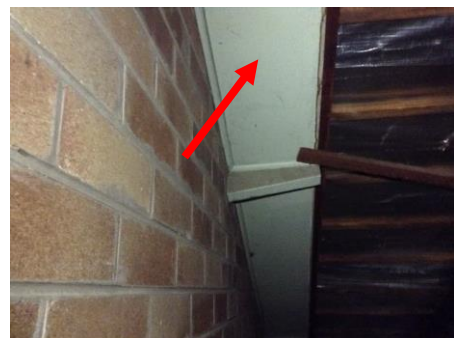
Photo No. 009: Ground Floor ceiling void above MN0700007

The FFCS eave soffit to the ceiling void above MN0700007 was referred to previously tested sample 8 and **SHALL be regarded as an asbestos-containing material**

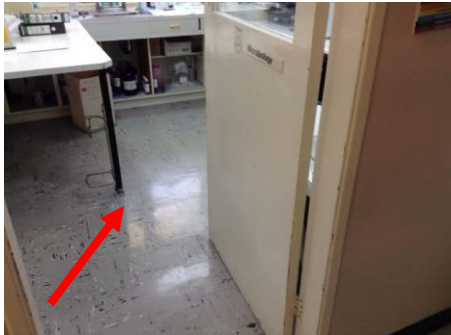
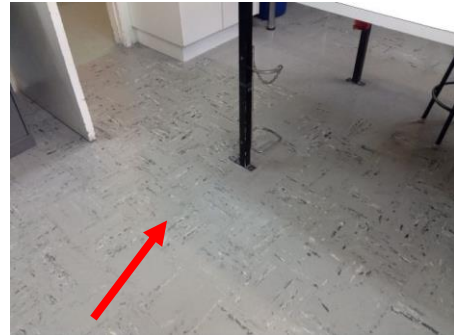
Photo No. 010: Ground Floor MN0700007 (Microbiology)

The grey white VFTs to MN0700007 (Microbiology) were previously tested by others and **proved to be an asbestos-containing material**

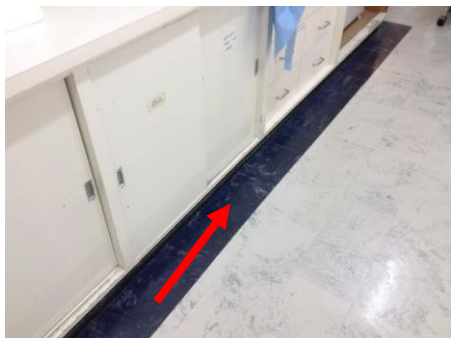
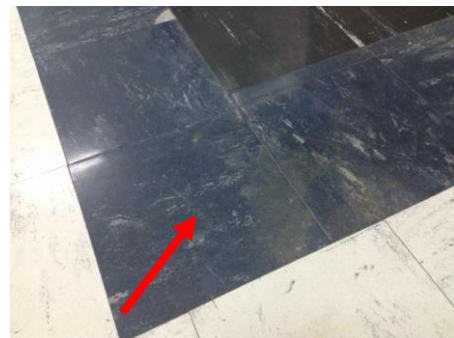
Photo No. 011: Ground Floor MN0700015

The blue VFTs to MN0700015 were previously tested by others and **proved to be an asbestos-containing material**

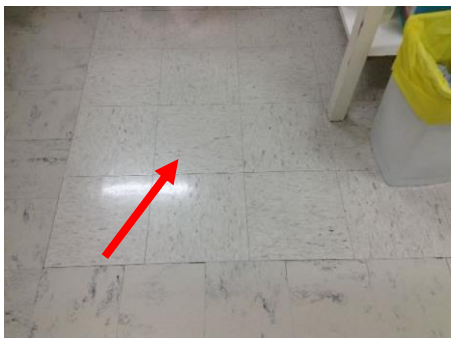
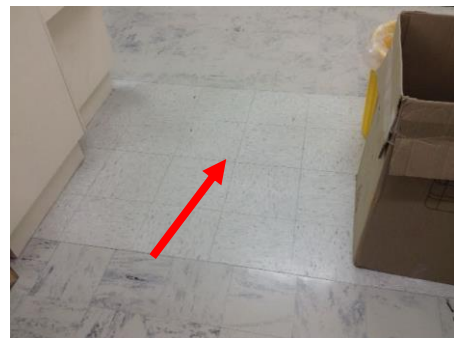
Photo No. 012: Ground Floor MN0700015

The VFTs to MN0700015 were previously tested by others and **proved to be an asbestos-containing material**

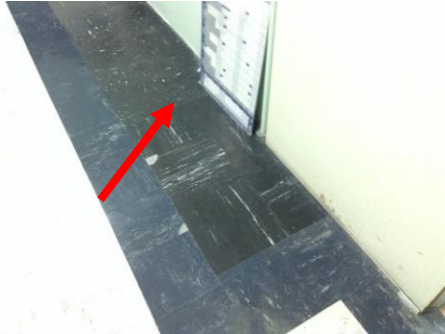
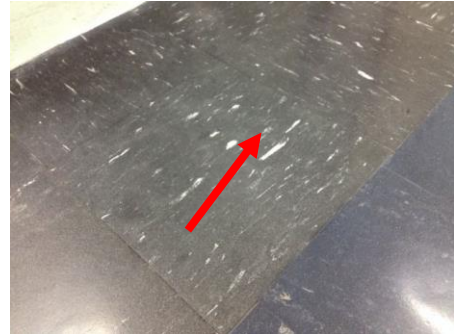
Photo No. 013: Ground Floor MN0700015

The black VFTs to MN0700015 was previously tested by others and **proved to be an asbestos containing material**

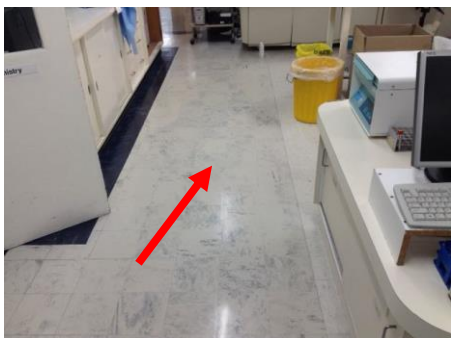
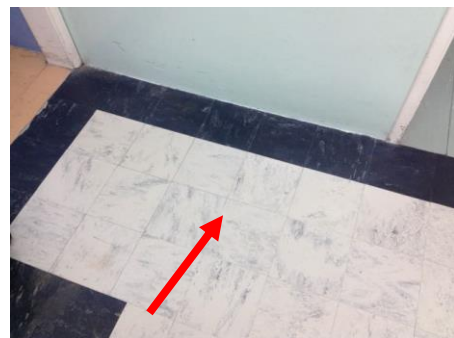
Photo No. 014: Ground Floor MN0700015

The Vinyl Floor Tiles to the MN0700015 was previously tested by others and **proved to be an asbestos containing material**

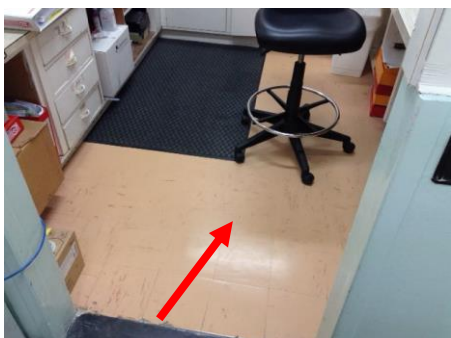
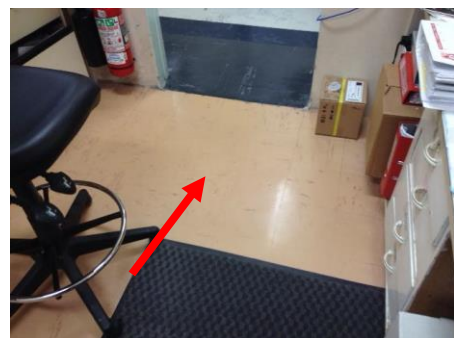
Photo No. 015: Ground Floor tiled area in MN0700018

The VFTs to the tiled area in MN0700018 were referred to sample PL01 and **SHALL be regarded as an asbestos-containing material**

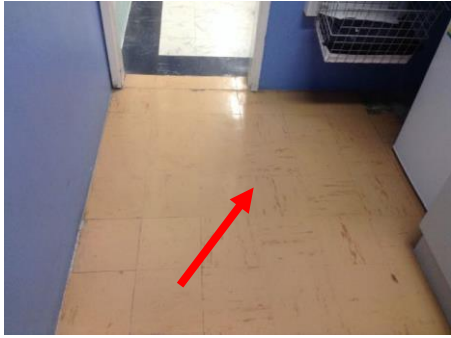
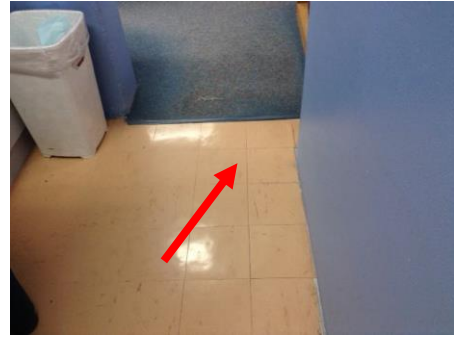
Photo No. 016: Ground Floor tiled corridor off MN0700015 (Specimen Reception Area)

The VFTs to the tiled corridor off MN0700015 (specimen reception area) were tested and **proved to be an asbestos-containing material**

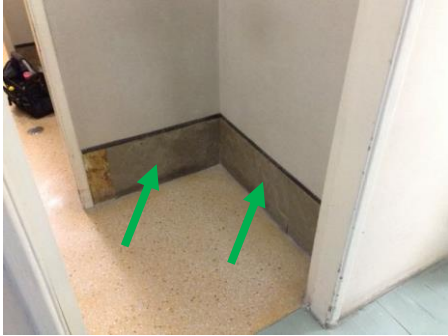
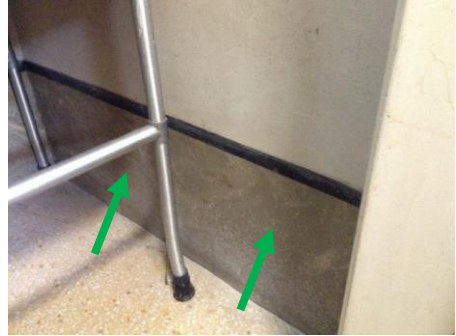
Photo No. 024: Ground Floor MN0700002

The VFT skirting to MN0700002 was tested and **proved NOT to be an asbestos containing material**

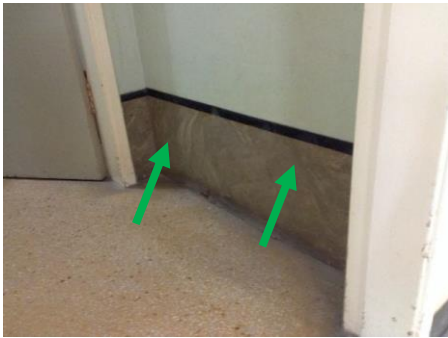
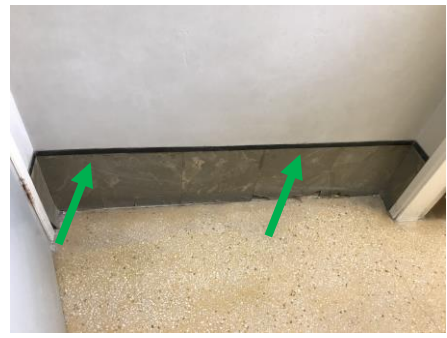
Photo No. 025: Ground Floor MN0700005 (Men's Shower and Toilet)

The VFT skirting to MN0700002 was tested and **proved NOT to be an asbestos containing material**

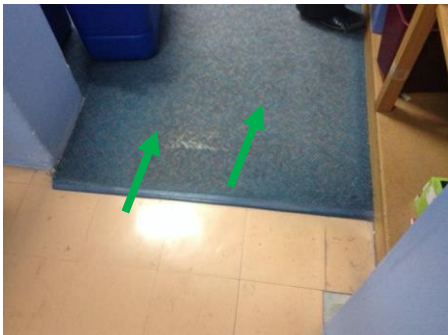
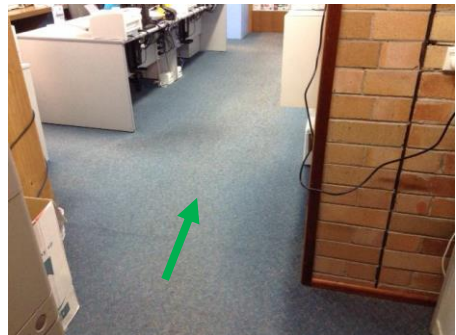
Photo No. 026: Ground Floor (MN0700023)

The VFT floor to MN0700023 (beneath the carpet) was tested and **proved NOT to be an asbestos containing material**

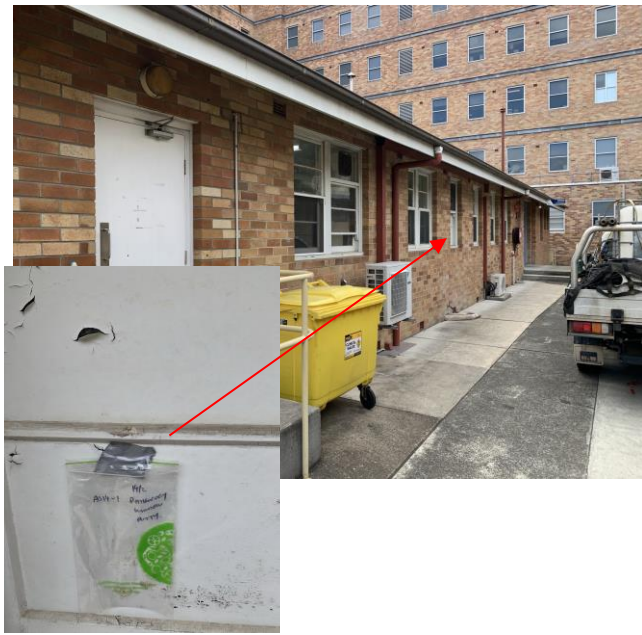
**Photo 1:**

AS14 – 1: No asbestos detected

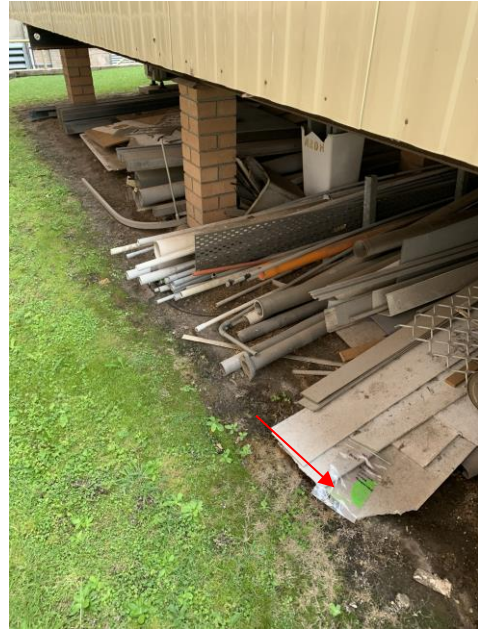
**Photo 2:**

AS14 – 3: No asbestos detected

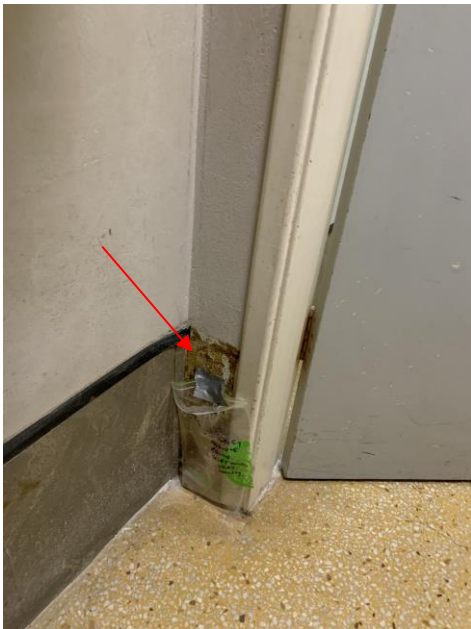
**Photo 3:**

AS14 – 4: No asbestos detected

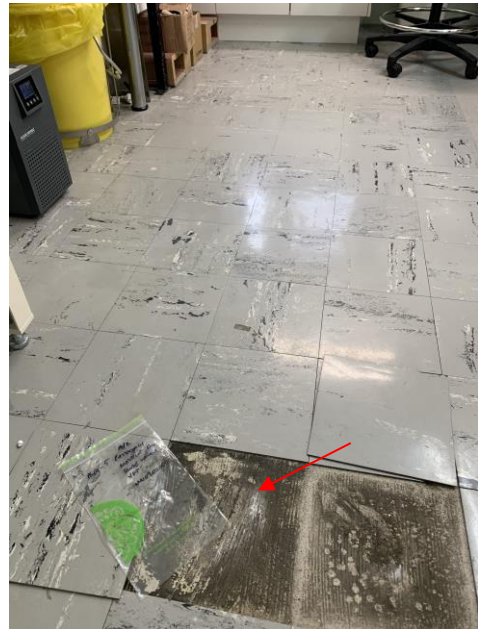
**Photo 4:**

AS14 – 5: No asbestos detected

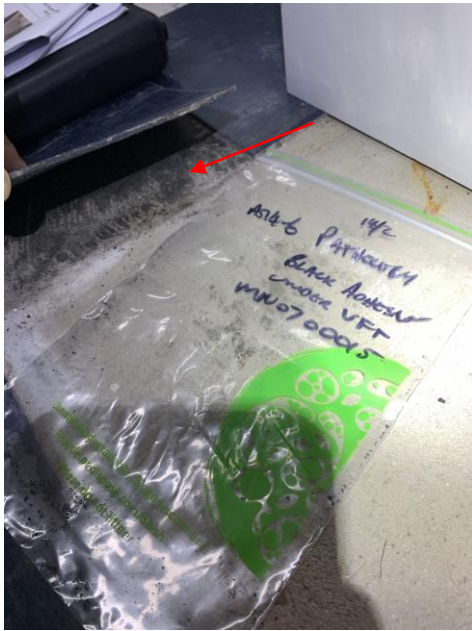
Photo 5:

AS14 – 6: No asbestos detected

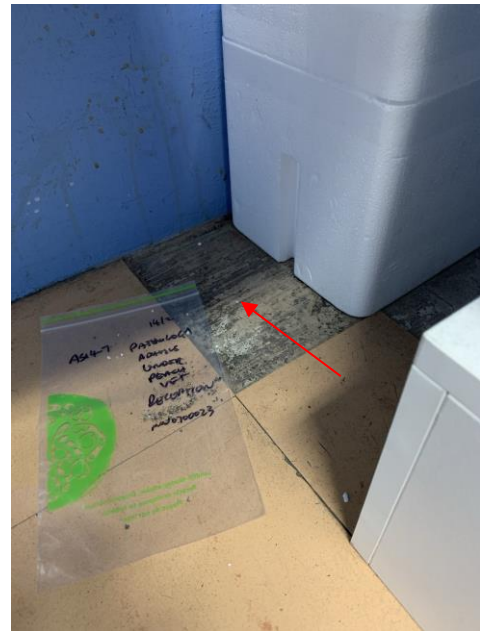
Photo 6:

AS14 – 7: No asbestos detected

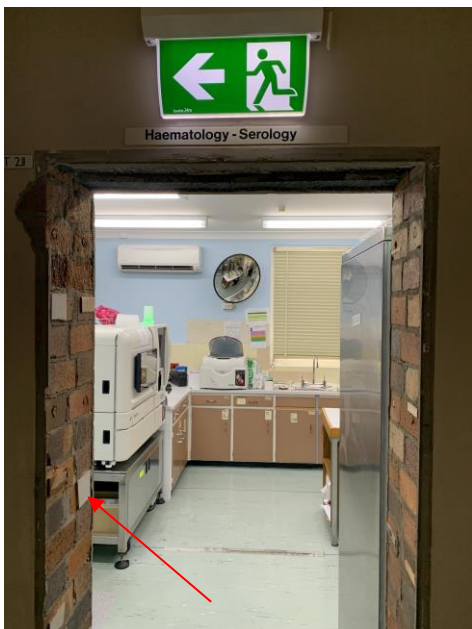
Photo 7:

AS14 – 8: No asbestos detected

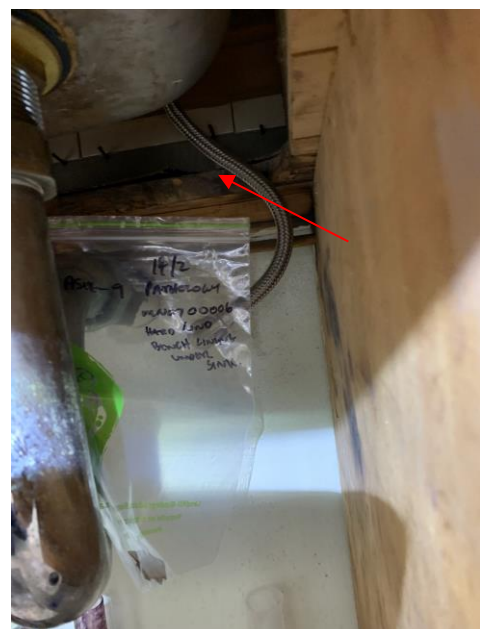
Photo 8:

AS14 – 9: No asbestos detected

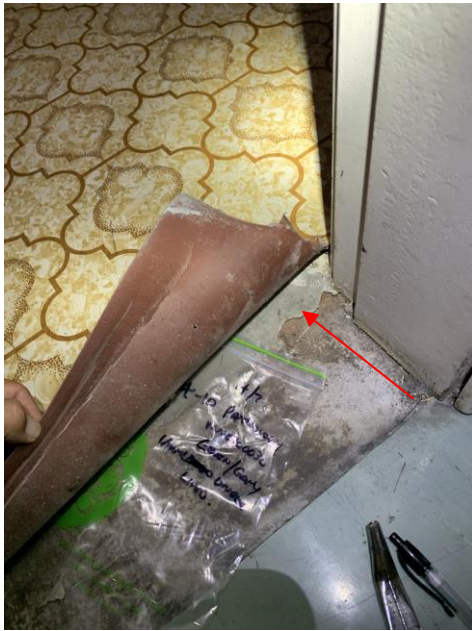
Photo 9:

AS14 – 10: No asbestos detected

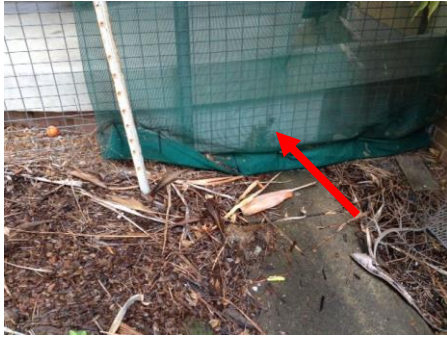
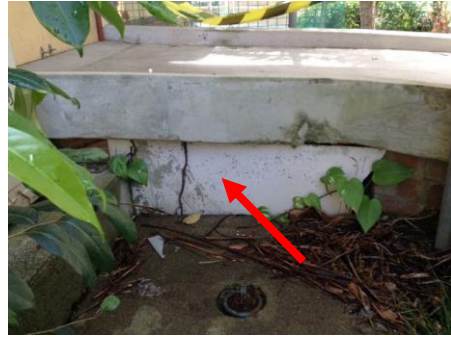
Photo No. 001: Below south entrance ramp

The FFCS infill panel below the south entrance ramp was referred to Sample 19 of the previous register and **SHALL be regarded as an asbestos-containing material**

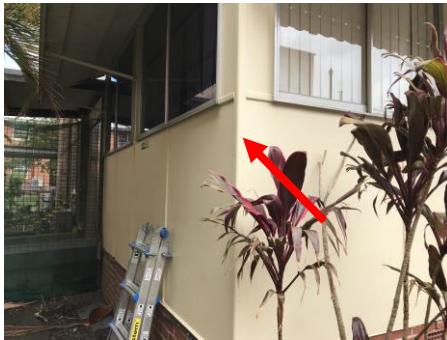
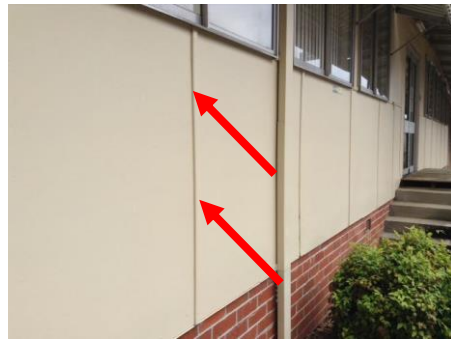
Photo No. 002: South-east extension

The Moulded Fibre Cement batons/cover strips to the south-east extension were referred to Sample 19 and **SHALL be regarded as an asbestos-containing material**

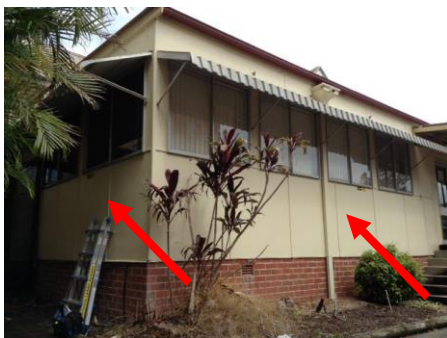
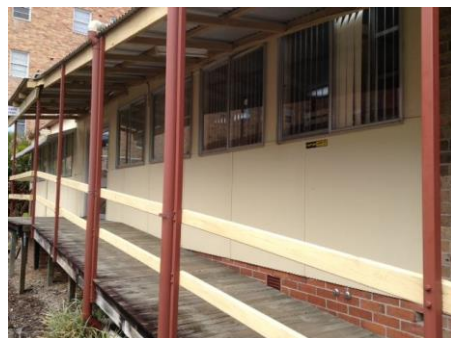
Photo No. 003: South-east extension

8/11/2017	PES	Manning Rural Referral Hospital	Victoria Fever Ward	External	South-east extension	External wall cladding	Flat Fibre Cement Sheet	Asbestos	No	Sample 19	Chrysotile & Amosite	90m²	3	Non Friable 1	Flat Fibre Cement Sheet 1	Moderate Access 2	Labelled 0	Good condition 0	Chrysotile & Amosite	Very Low 4	C1; C2; C3; C4;	good condition, manage in-situ.	8/11/2022	David McQueeney	Noted in Register	7/11/2017		No	AS15-4	Chrysotile		
8/11/2017	PES	Manning Rural Referral Hospital	Victoria Fever Ward	External	South-east extension	Batons/ cover strips	Moulded Fibre Cement	Asbestos	No	Refer to Sample 19	Chrysotile & Amosite	10m²	2	Non Friable 1	Moulded Fibre Cement 1	Moderate Access 2	Labelled 0	Good condition 0	Chrysotile & Amosite	Very Low 4	C1; C2; C3; C4;	Good condition, manage in-situ.	8/11/2022	David McQueeney	Noted in Register	7/11/2017		Yes	AS15-2	Chrysotile		
8/11/2017	PES	Manning Rural Referral Hospital	Victoria Fever Ward	External	Southern elevation (outside Room MN0800008)	Wall cladding	Flat Fibre Cement Sheet	Asbestos	No	Refer to Sample 19	Chrysotile & Amosite	9m²	4	Non Friable 1	Flat Fibre Cement Sheet 1	Moderate Access 2	No Labelling 1	Good condition 0	Chrysotile & Amosite	Very Low 5	C1; C2; C3; C4;	Good condition, manage in-situ.	8/11/2022	David McQueeney	Noted in Register	7/11/2017		Yes	AS15-1	NAD	Sheeting directly around door - NAD. Sheeting and capping strips surrounding window positive for Chrysotile

The FFCS wall cladding to the south-east extension was previously tested as "Sample 19" by others and **proved to be an asbestos containing material**

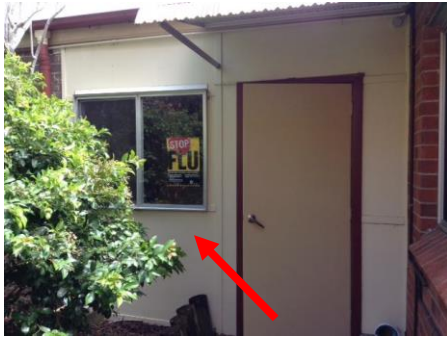
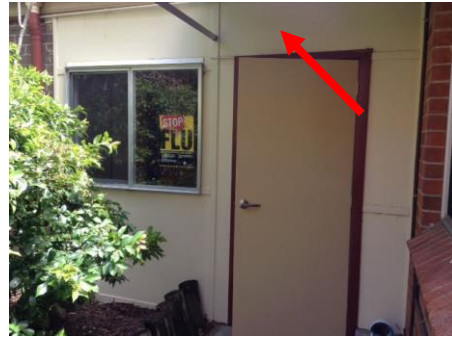
Photo No. 004: Southern elevation (outside Room MN0800008)

The FFCS wall cladding to the southern elevation (outside Room MN0800008) was referred to Sample 19 and **SHALL be regarded as an asbestos-containing material**

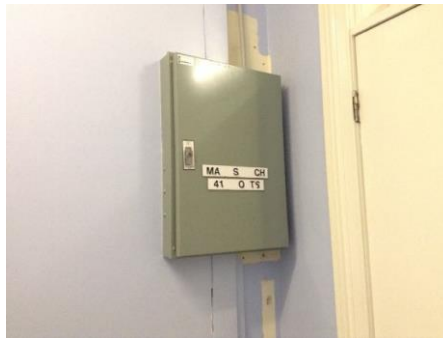
Photo No. 005: Room MN0800006

The FFCS insulation panel to the electrical switchboard in Room MN0800006 ("Female") was unable to be sampled **but SHALL be regarded as an asbestos-containing material**

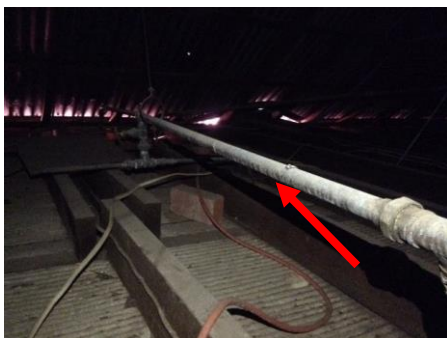
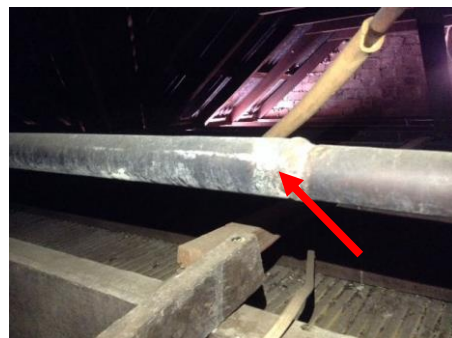
Photo No. 006: Ceiling void MN0800006

The thermal Insulation residue to pipework to the ceiling void above Room MN0800006 was previously tested by others and **proved to be an asbestos containing material**

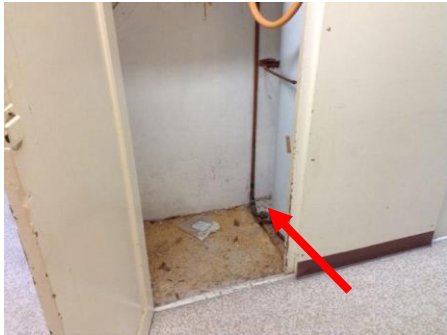
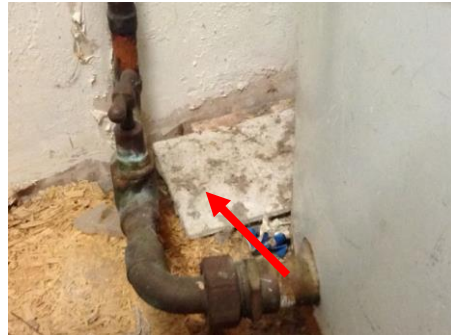
Photo No. 007: Cupboard off MN0800008

8/11/2017	PES	Manning Rural Referral Hospital	Victoria Fever Ward	Ground Floor	Cupboard off MN0800008	Fragments	Flat Fibre Cement Sheet	Asbestos	No	SP	Chrysotile	>1m²	7	Non Friable 1	Flat Fibre Cement Sheet 1	Limited Access 1	Labelled 0	Low Damage 1	Chrysotile	Very Low 4	C2; C14 C15	Consider removal	8/11/2022	David McQueeney	Noted in Register	7/11/2017		No				
8/11/2017	PES	Manning Rural Referral Hospital	Victoria Fever Ward	Ground Floor	Ramp off Room MN0800002	Ceiling lining	Flat Fibre Cement Sheet	Asbestos	No	Refer to Sample 20	Chrysotile & Amosite	8m²	8	Non Friable 1	Flat Fibre Cement Sheet 1	Limited Access 1	Labelled 0	Good condition 0	Chrysotile & Amosite	Very Low 3	C1; C2; C4;	Good condition, manage in-situ.	8/11/2022	David McQueeney	Noted in Register	7/11/2017		Yes	AS15-8	Chrysotile		
8/11/2017	PES	Manning Rural Referral Hospital	Victoria Fever Ward	Ground Floor	Room MN0800002	Wall lining	Flat Fibre Cement Sheet	Asbestos	No	Refer to Sample 20	Chrysotile & Amosite	12m²	9	Non Friable 1	Flat Fibre Cement Sheet 1	Moderate Access 2	Labelled 0	Good condition 0	Chrysotile & Amosite	Very Low 4	C1; C2; C4;	Good condition, manage in-situ.	8/11/2022	David McQueeney	Noted in Register	7/11/2017		Yes	AS15-7	NAD	Previously assumed positive, however, NAD.

The FFCS fragment in the cupboard off MN0800008 was referred to Sample 20 in the previous register **and SHALL be regarded as an asbestos-containing material**

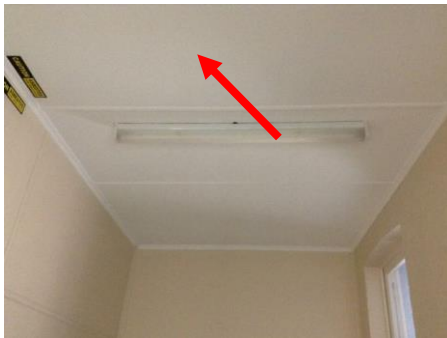
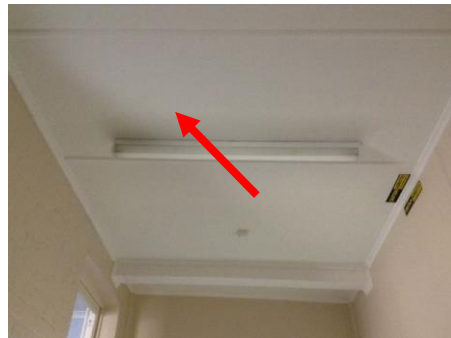
Photo No. 008: Ramp off Room MN0800002

The FFCS ceiling lining to the ramp off Room MN0800002 was referred to Sample 20 **and SHALL be regarded as an asbestos-containing material**

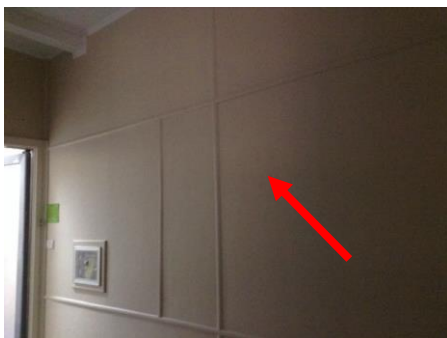
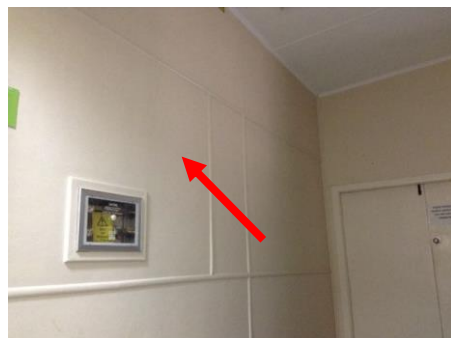
Photo No. 009: Room MN0800002

The FFCS wall lining to Room MN0800002 was referred to Sample 20 **and SHALL be regarded as an asbestos-containing material**

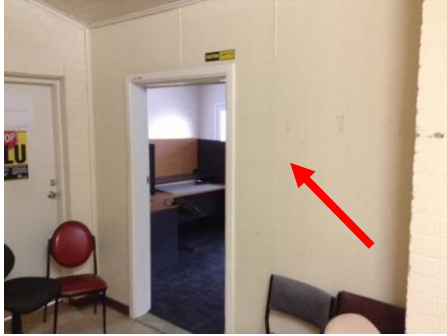
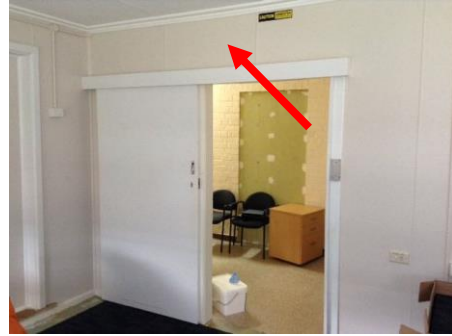
Photo No. 010: Room MN0800008 and MN0800014

8/11/2017	PES	Manning Rural Referral Hospital	Victoria Fever Ward	Ground Floor	Room MN0800008 and 00014	Wall lining	Flat Fibre Cement Sheet	Asbestos	No	Sample 22	Amosite	12m²	10	Non Friable 1	Flat Fibre Cement Sheet 1	Moderate Access 2	Labelled 0	Low Damage 1	Amosite	Very Low 5	C1; C2; C4; C8;	Good condition, manage in-situ.	8/11/2022	David McQueeney	Noted in Register	7/11/2017		No				
8/11/2017	PES	Manning Rural Referral Hospital	Victoria Fever Ward	Ground Floor	Room MN0800009	Ceiling lining	Flat Fibre Cement Sheet	Asbestos	No	VW02	Chrysotile	3m²	11	Non Friable 1	Flat Fibre Cement Sheet 1	Limited Access 1	No Labelling 1	Good condition 0	Chrysotile	Very Low 4	C1; C2; C3; C4;	Good condition, manage in-situ. Only remove fan under controlled conditions.	8/11/2022	David McQueeney	Noted in Register	7/11/2017		No				
8/11/2017	PES	Manning Rural Referral Hospital	Victoria Fever Ward	Ground Floor	Room MN0800010	Ceiling lining	Flat Fibre Cement Sheet	Asbestos	No	Refer to Sample 20	Chrysotile & Amosite	6m²	13	Non Friable 1	Flat Fibre Cement Sheet 1	Limited Access 1	Labelled 0	Good condition 0	Chrysotile & Amosite	Very Low 3	C1; C2; C3; C4;	Good condition, manage in-situ.	8/11/2022	David McQueeney	Noted in Register	7/11/2017		Yes	AS15-9	Chrysotile, Amosite & Crocidolite

The FFCS wall lining to Room MN0800008 and MN0800014 was previously tested by others and **proved to be an asbestos containing material**

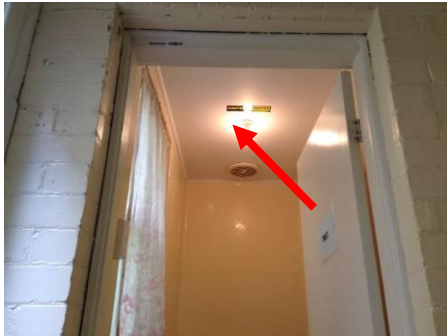
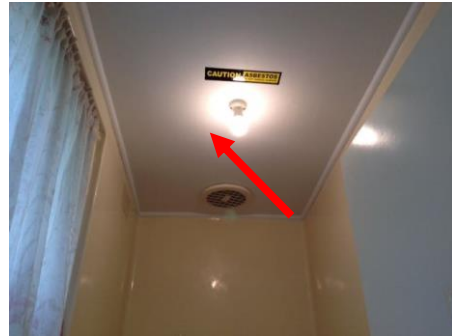
Photo No. 011: Room MN0800009

The FFCS ceiling lining to Room MN0800009 was tested and **proved to be an asbestos containing material**

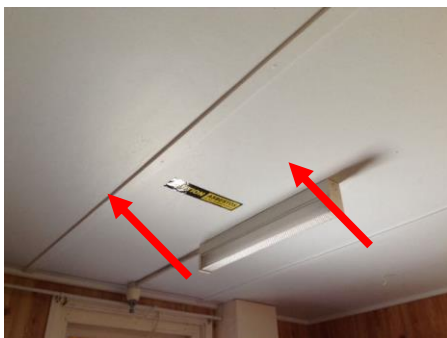
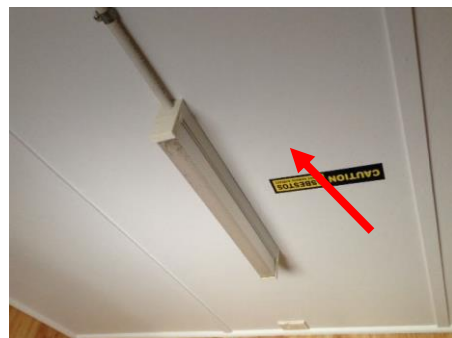
Photo No. 012: Room MN0800010

The FFSC ceiling lining to Room MN0800010 was referred to Sample 20 and **SHALL be regarded as an asbestos-containing material**

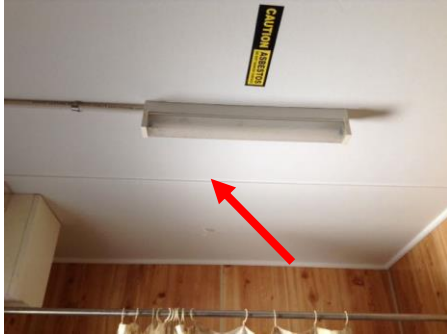
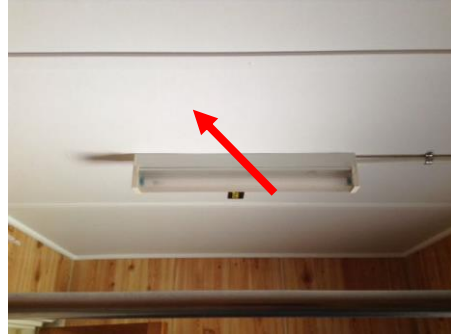
Photo No. 013: Room MN0800010

The FFCS ceiling lining to Room MN0800010 was referred to Sample 20 and **SHALL** be regarded as an **asbestos-containing material**

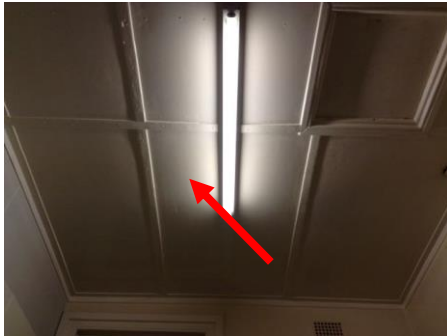
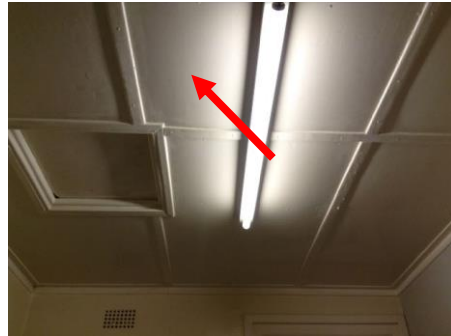
Photo No. 014: Room MN0800011

The FFCS ceiling lining to Room MN0800011 was previously tested by others and **proved to be an asbestos containing material**

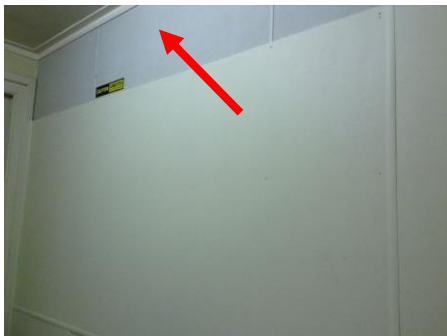
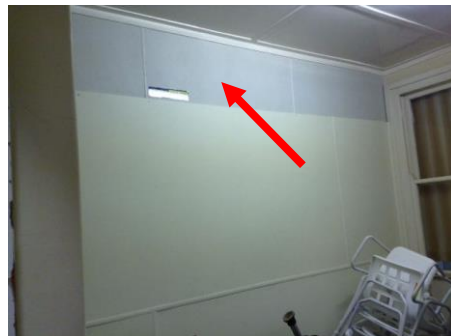
Photo No. 015: Room MN0800011

The original FFCS wall lining to Room MN0800011 was referred to Sample 20 and **SHALL** be regarded as an **asbestos-containing material**

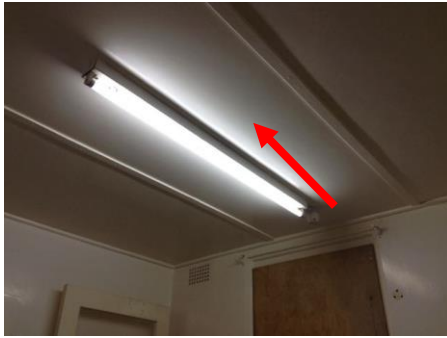
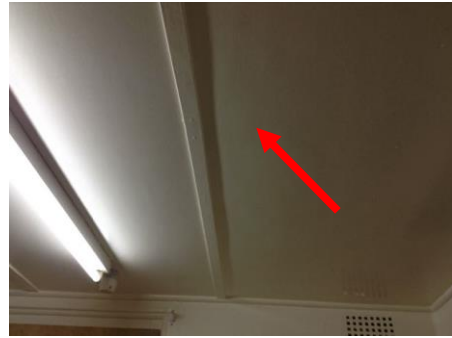
Photo No. 016: Room MN0800012

The FFCS ceiling lining to Room MN0800012 was referred to Sample 20 and **SHALL** be regarded as an **asbestos-containing material**

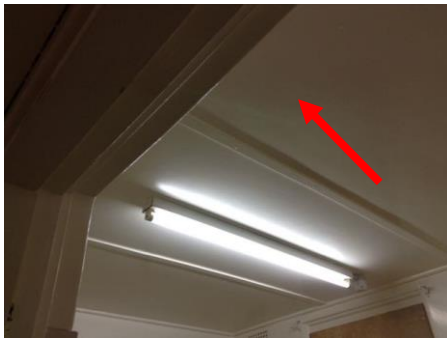
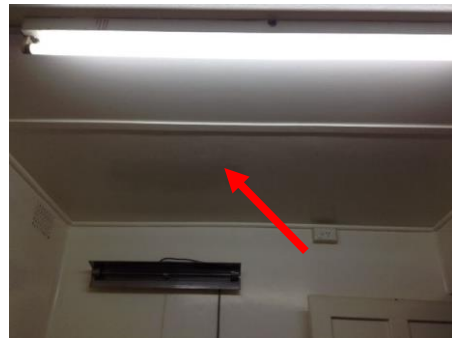
Photo No. 017: Room MN0800012

The FFCS ceiling lining to Room MN0800012 was referred to Sample 20 and **SHALL** be regarded as an **asbestos-containing material**

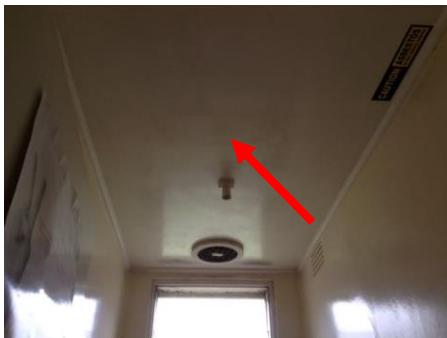
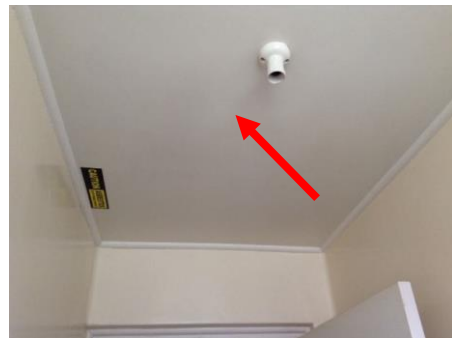
Photo No. 018: Room MN0800013

The FFCS ceiling lining to Room MN0800013 was referred to Sample 20 and **SHALL** be regarded as an **asbestos-containing material**

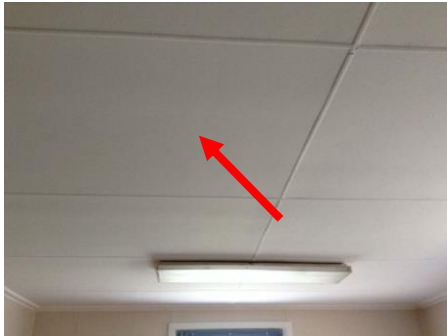
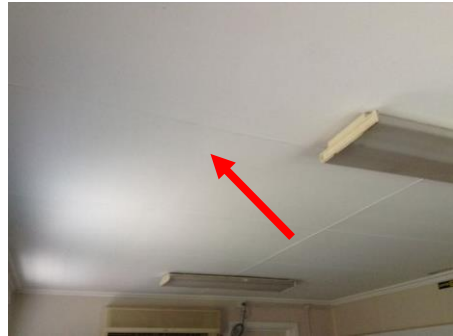
Photo No. 019: Room MN0800014

The FFCS ceiling lining to Room MN0800014 was referred to Sample 20 and **SHALL be regarded as an asbestos-containing material**

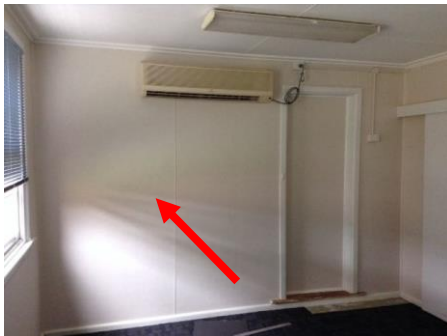
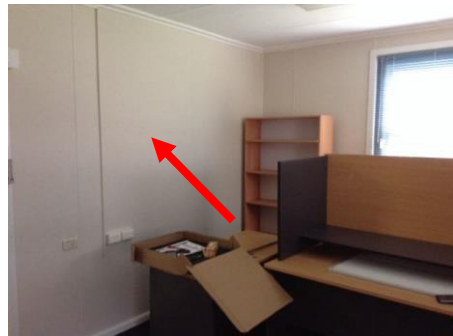
Photo No. 020: Room MN0800014

The FFCS wall lining to Room MN0800014 was tested and **proved to be an asbestos containing material**

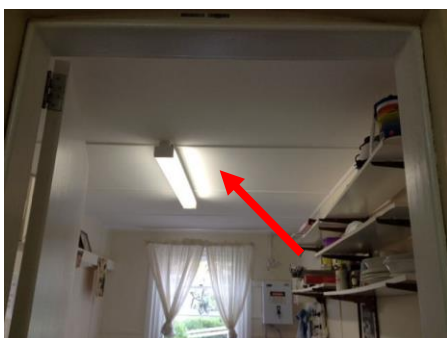
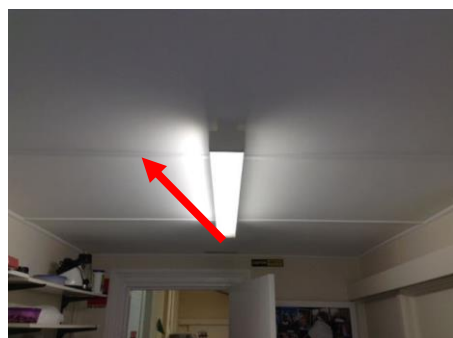
Photo No. 021: Room MN0800015

The FFCS ceiling lining to Room MN0800015 was referred to Sample 20 and **SHALL be regarded as an asbestos-containing material**

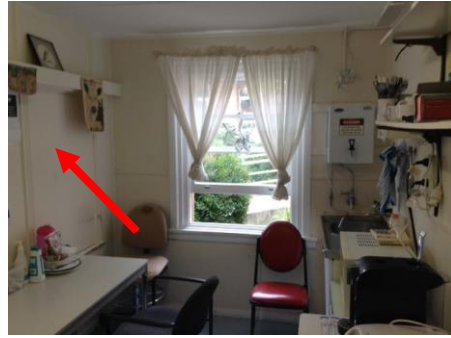
Photo No. 022: Room MN0800015

The FFCS wall lining to Room MN0800015 was referred to Sample 20 and **SHALL** be regarded as an asbestos-containing material

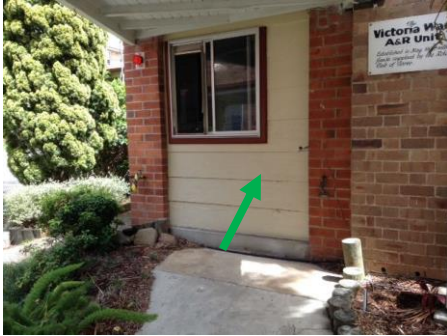
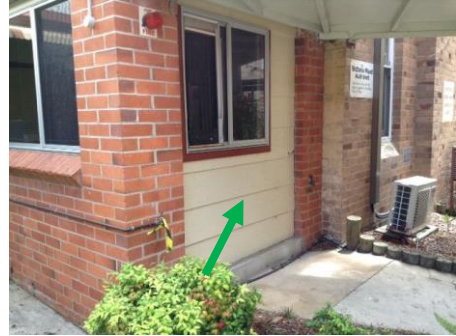
Photo No. 024: Southern Elevation

The Fibre Reinforced Cement 'Hardiplank' weatherboard cladding to the southern elevation was tested and **proved NOT to be an asbestos containing material**

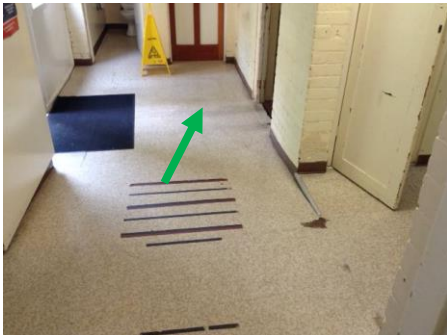
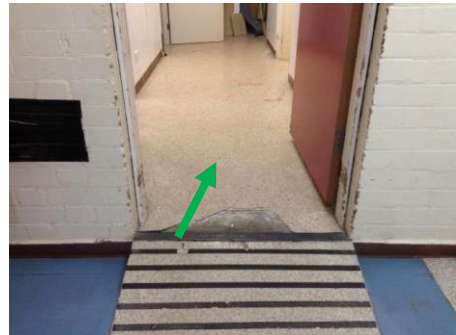
Photo No. 025: Ground Floor Room MN080005, MN080008, MN080009, MN080013, MN080016, MN080018

The Vinyl Broadsheet / Linoleum Floor to the Room MN080005, MN080008, MN080009, MN080013, MN080016, MN080018 was tested and **proved NOT to be an asbestos containing material**

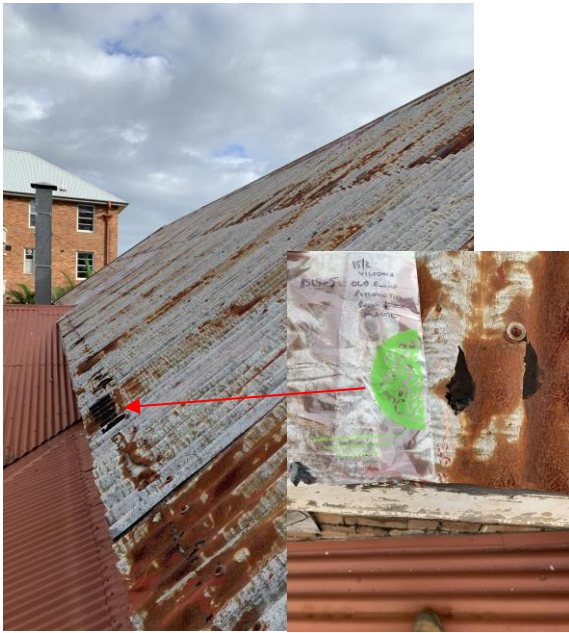
Photo 1:

AS15 – 5: No asbestos detected

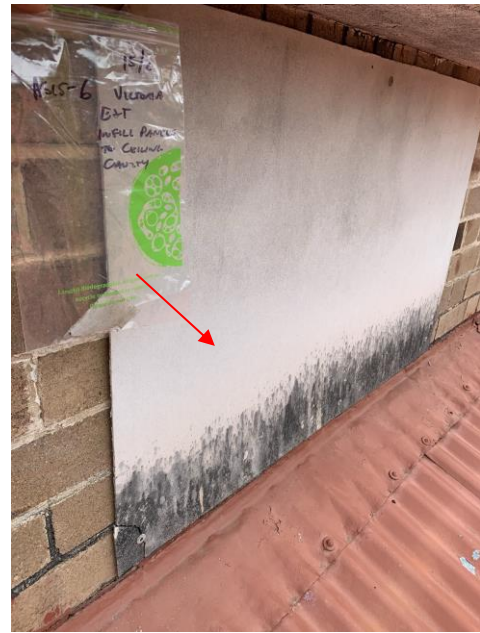
Photo 2:

AS15 – 6: No asbestos detected

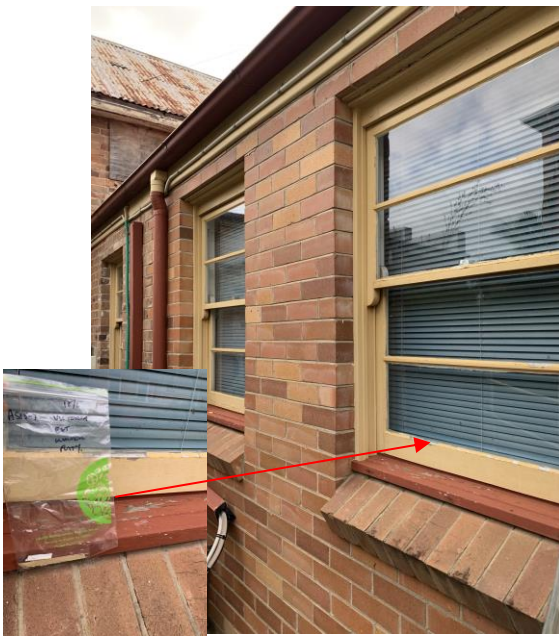
Photo 3:

AS15 – 7.1: No asbestos detected

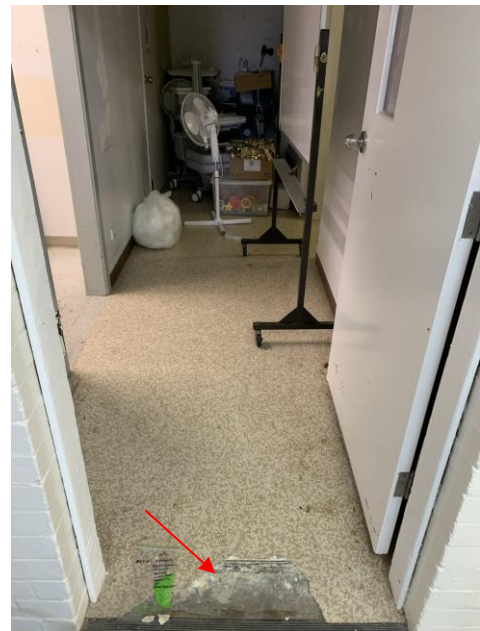
Photo 4:

AS15 – 11: No asbestos detected

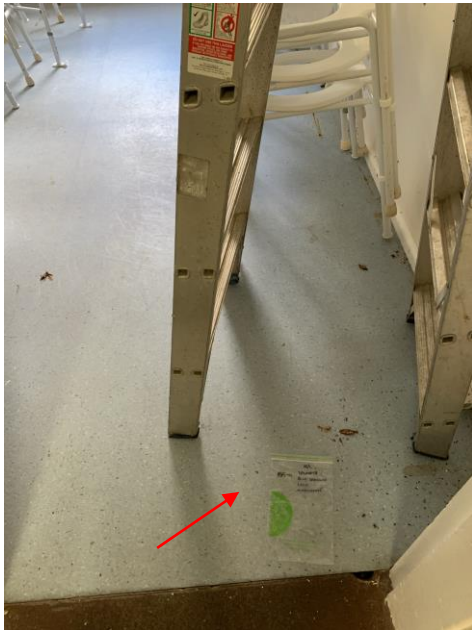
Photo 5:

AS15 – 12: No asbestos detected

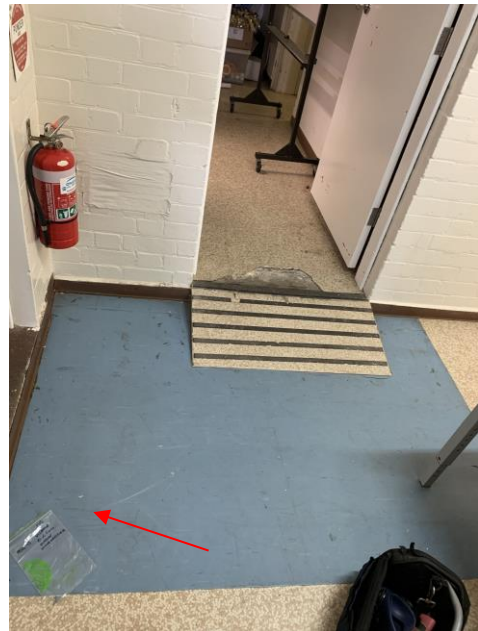
Photo 6:

AS15 – 13: No asbestos detected

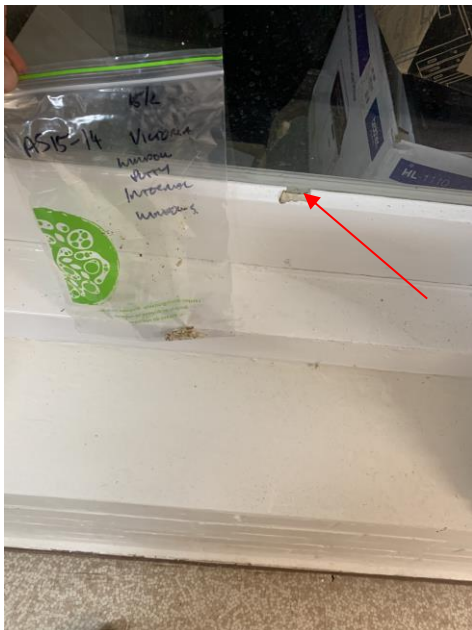
Photo 7:

AS15 – 14: No asbestos detected

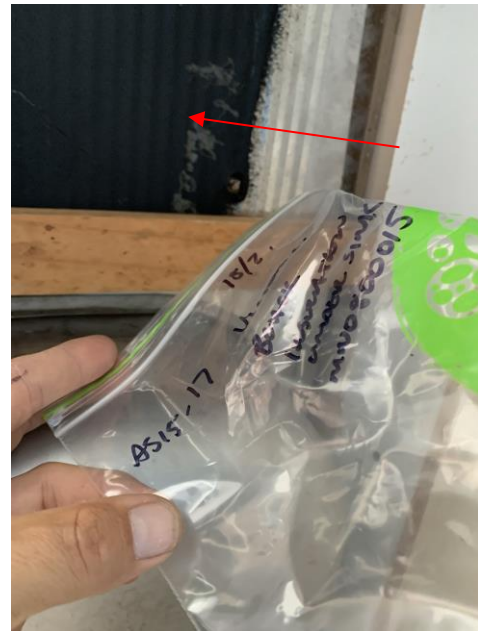
Photo 10:

AS15 – 17: No asbestos detected
