Cessnock Hospital Redevelopment Civil Earthworks Statement

This statement is to describe the existing conditions of the site and to provide a methodology on how to reduce the cost bulk earthworks for the project.

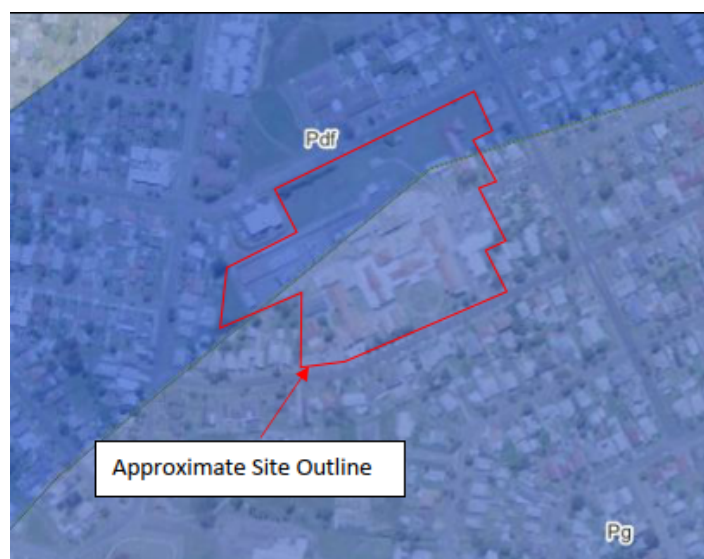
The Singleton 1:250,000 Geological Series Sheets indicate that the southern portion of the site is underlain by the Greta Coal Measures, which typically comprises sandstone, conglomerate, shale and coal seams. The northern portion of the site is mapped as being underlain by the Farley Formation which typically comprises mudstone, sandstone, shale and limestone. Reference should be made to Plate 3 below.

Plate 3 – Excerpt from Singleton 1:250,000 Geological Series Sheet (Pdf-Farley Formation, Pg-Greta Coal Measure)
