Construction Noise and Vibration Monitoring Report 10

Client Doc. No. RPA-ACO-ACL-RPT-MW-000013 - Rev A

Project ID	20230239.17	
Document Title	Construction Noise and Vibration Monitoring	
Attention To	CPB Contractors Pty Limited

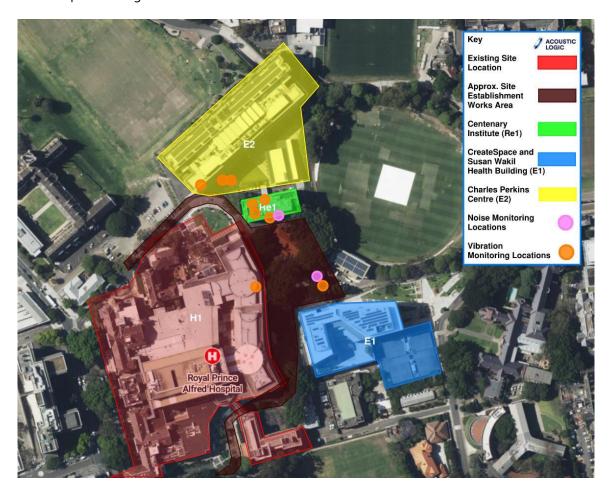
Figure 1: Aerial Site Map with Nearest Sensitive Receivers (Sourced from Sixmaps)

See an aerial photo in Figure 1 below for detailed receiver locations.

Please refer to Figure 1 for detailed monitoring locations. Appendix C provides photos of the monitors installed at the project site.

Please refer to Figure 1 for detailed monitoring locations.

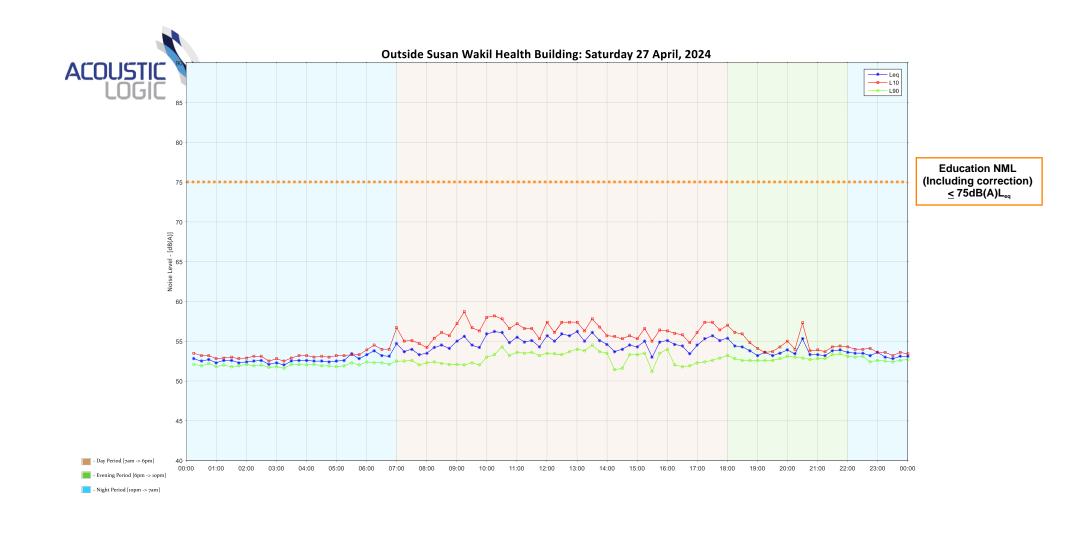
Outside Susan Wakil Health Building: Friday 26 April, 2024 ACOUSTIC LOGIC 85 Leq * L10 - L90 Education NML (Including correction) ≤ 75dB(A)L_{eq} Noise Level - [dB(A)]

- Noting this increased distance attenuation, in conjunction with the transmission loss experienced
 through the inoperable façade of the Susan Wakil Health Building when comparing internal and
 external noise levels, Acoustic Logic expect that, at minimum, there is a 30dB reduction between the
 measured noise levels by the monitor, when compared with the resultant internal noise levels within
 the receiver.

- Noting this and based on this reduction, measured noise levels have not been observed to be above the noise management level throughout the noise monitoring period.

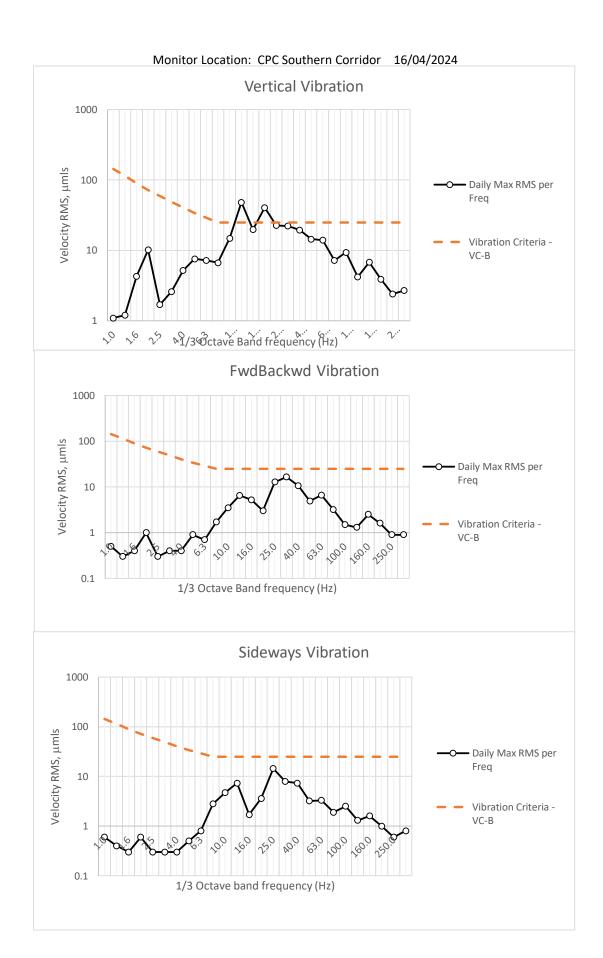
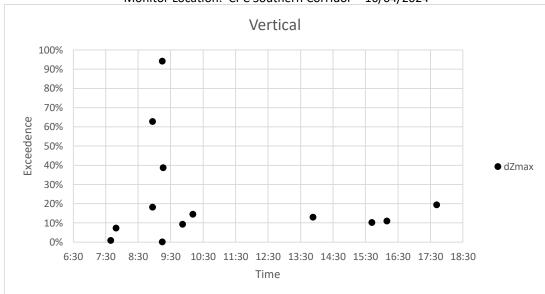
Monitor Location: CPC Southern Corridor 16/04/2024

- 16/04/2024 9.00am.
 - 17/04/2024 8.30am.
 - 18/04/2024 10.00am.
 - 19/04/2024 9.30am.
 - 22/04/2024 11.30am.
 - 23/04/2024 11.45am and 12.15pm.
 - 24/04/2024 2.30pm.

- Exceedances are generally observed at 12.5Hz, likely to be the natural frequency of the CPC suspended slab. Exceedances at frequencies exclusive of 12.5Hz, 16Hz and 20Hz are rarely observed.

- Notwithstanding, and due to the lack of correlation between the significant spikes measured by the B2 monitor and exceedances at other monitoring stations surrounding the project site, it is likely that some or most of these spikes have been caused by factors exclusive of the construction activity within the RPA Hospital project area.

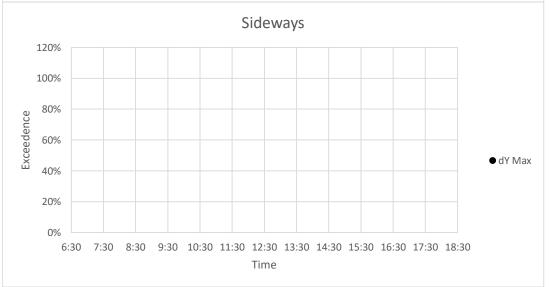
Monitor Location: CPC Southern Corridor 17/04/2024

- 26/04/2024 12.30pm.
 - Exceedances are generally observed to result at up to a maximum of 100% of the VC-B criteria at a given frequency (Approximately measured at 50μms⁻¹). The maximum level measured during the monitoring period was 75μms⁻¹ at 12.5Hz on 17/04/2024.

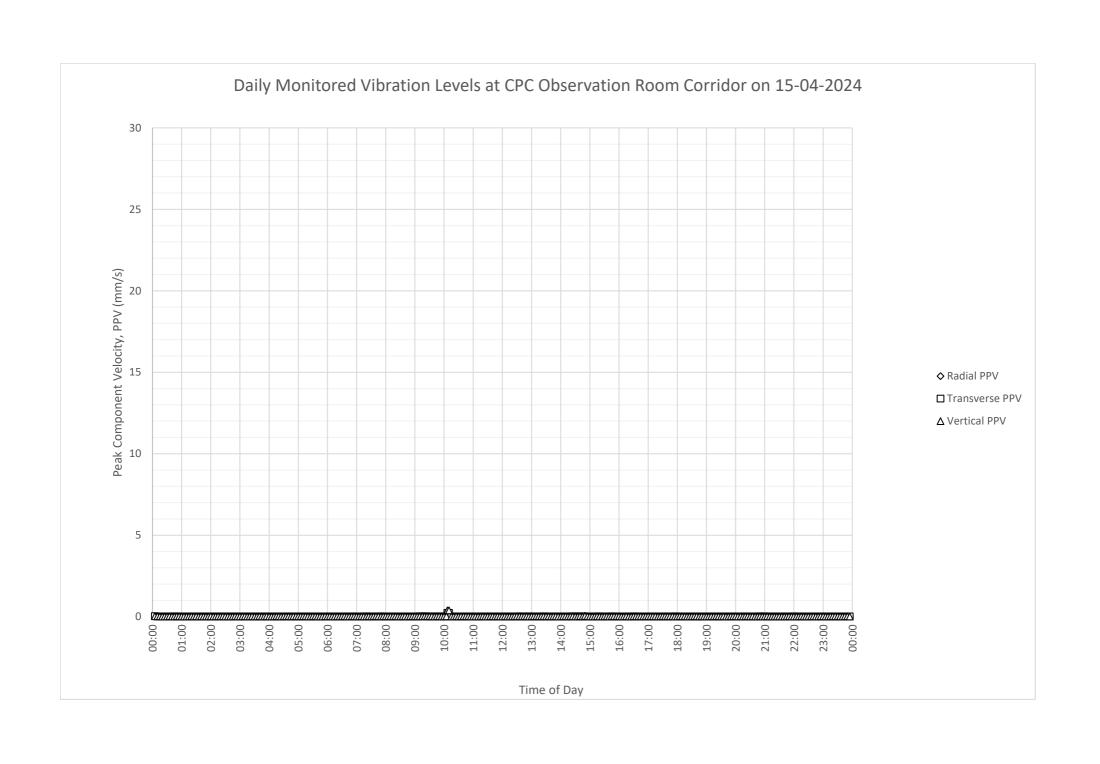
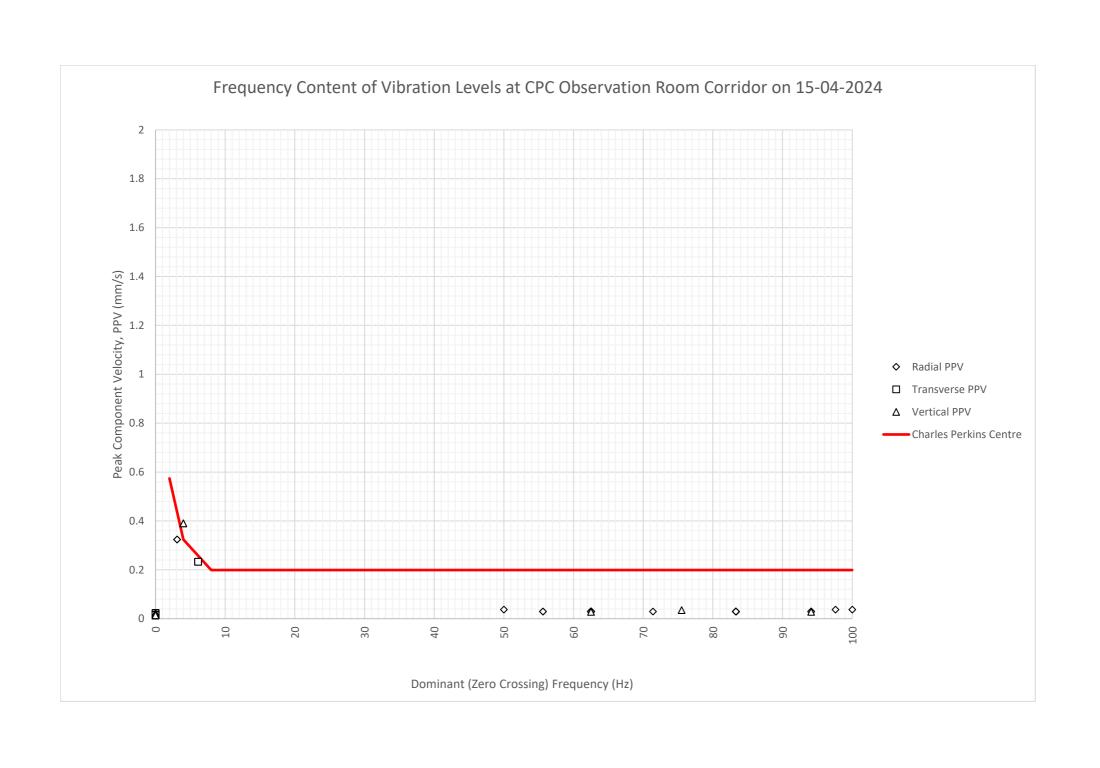
CHARLES PERKINS CENTRE – LEVEL B1 SOUTHERN WING OBSERVATION ROOM E

- One exceedance of criteria was measured at approximately 10.00am on 15/04/2024. This
 exceedance was measured by the less-sensitive Texcel monitor but was not measured by
 the more-sensitive B & K monitor installed adjacent to the Texcel monitor.

- This is not indicative of construction vibration, noting that construction-borne vibration would be expected to impact the monitors equally and similar results would be measured.

- As the Texcel monitor is operating at it's floor of measurement, it is possible that a small
 perturbation measured by both of the monitors was artificially inflated by the Texcel
 monitor due to it's relatively lower accuracy and the relatively low vibration levels
 measured.

- Alternatively, this may have been caused by operational activity within the facility such as
 a step or a trolley movement, which occurred closer to the texcel monitor however did
 not register an exceedance at the B & K monitor.
